# PROPERTY INSPECTION REPORT

Concerning: 2112 Westlake Dr, Plano, TX 75075

By: Mason Johnson, Lic. #20598

04/18/2020

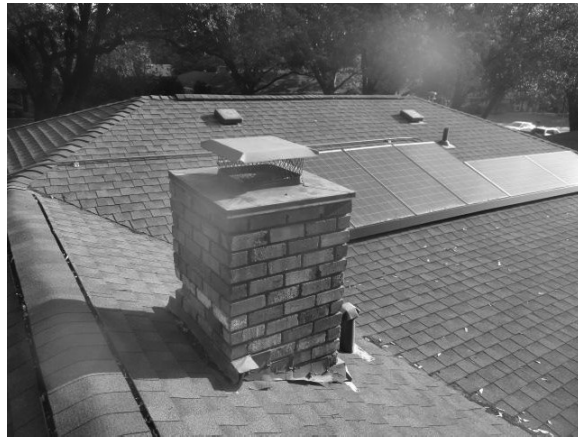
*Chimneys:*

The chimney was in serviceable condition at the time of our inspection.

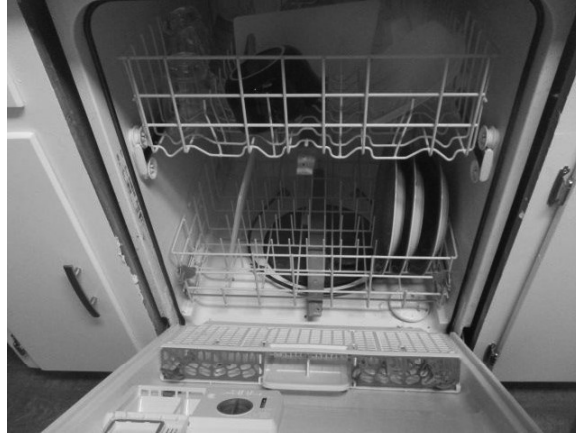
The dishwasher was operational and all visible components were in serviceable condition at the time of our inspection.

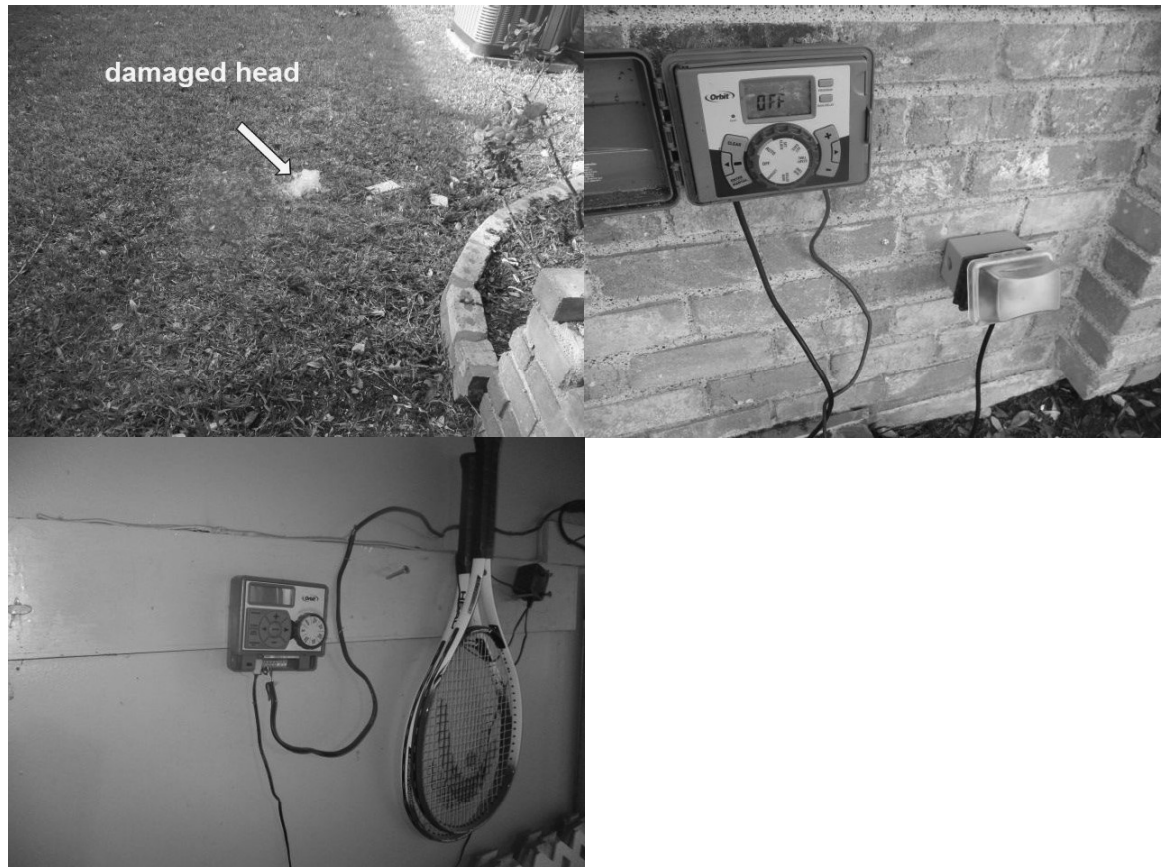
A rain/freeze sensor has not been installed. Some municipalities require such devices. Recommend installation by a qualified irrigation installer.

**The backyard system would not operate. We recommend any repairs necessary to return the system to service.**
