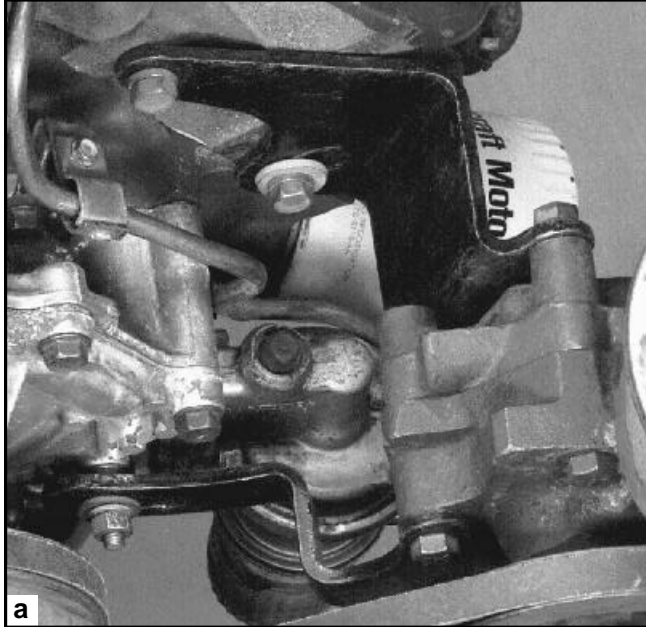
5K3: The 1965 Eaton system moved the pump 1" forward by incorporating large S-turns in the front and back brackets **(a)**. Though some P/S systems may have come through without further bracing, most included an extra support at the top of the pump. To achieve this extra bracing, Ford had to add a small plate to the water pump **(b)** in order to establish a brace pivot point that matched that of the rear P/S pump mount (see arrows). The first brace consisted of a short bar between mount and pump **(c & d)**. However, continued pump vibration and noise prompted Ford to replace the front bracing early in the model year with a single piece, heavy duty steel plate **(e & f)**. The new bracket mounted in exactly the same manner as the previous two-piece system. The exact date of transition

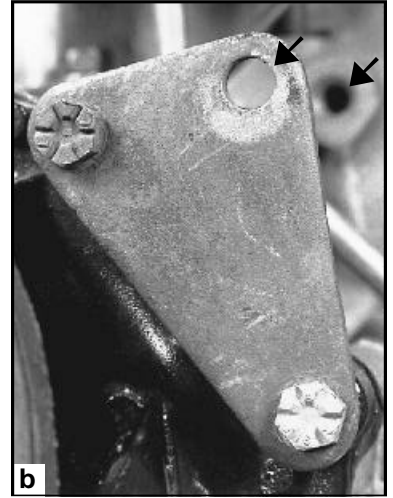
b

on Ford cars is unknown, but Mercury announced in its 1965 TSB #15, dated 11/20/64, that Comets changed on 9/28/64. Mercury also recommended retro-fit of the heavy duty plate for customers complaining of P/S noises.
