Nav. Aer. 01-85VA-3

**HANDBOOK OF INSTRUCTIONS
STRUCTURAL REPAIR**

**for
MODELS**

JRF-1, 2, 3, 4, 5 and 6B

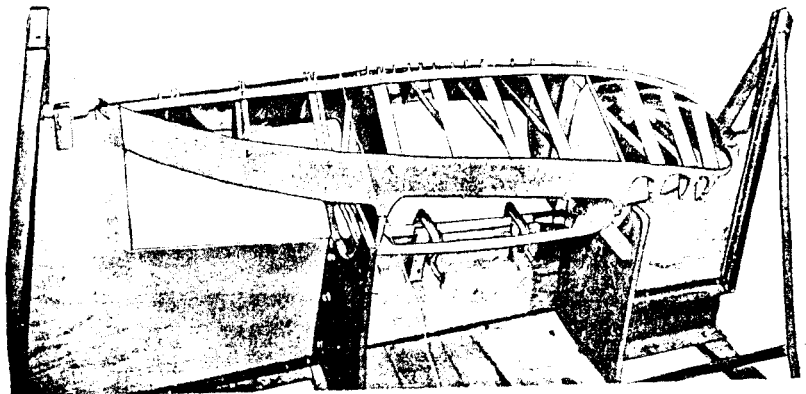
Figure 35 - Wing Tip Float Jigs

- UPPER LEFT - Wing Tip Float Bottom Skin Jig.
- RIGHT TOP - Wing Tip Float Bulkhead and Bottom Frame Jigs.
- RIGHT CENTER - Wing Tip Float Center Compartment Jig.
- RIGHT BOTTOM - Wing Tip Float Bottom Jig.

b. Reference should be made to Figures 33, 34 and 35.

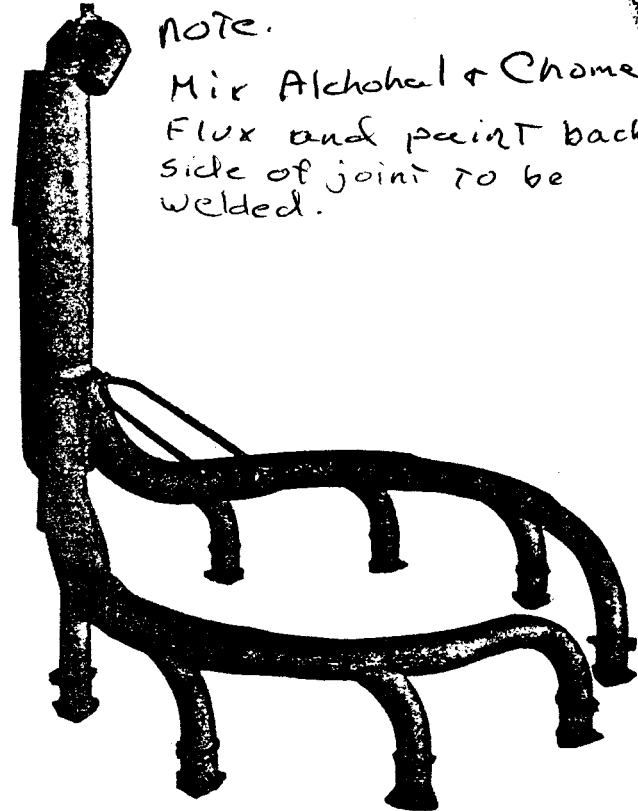
Figure 105 - Exhaust Manifold Assembly

NOTE.

Mix Alcohol & Chrome Molys
Flux and paint back
side of joint to be
welded.

27. GENERAL.-The exhaust manifold is a welded steel assembly. (See Figure 105).

The exhaust manifold should be torch normalized after welding.

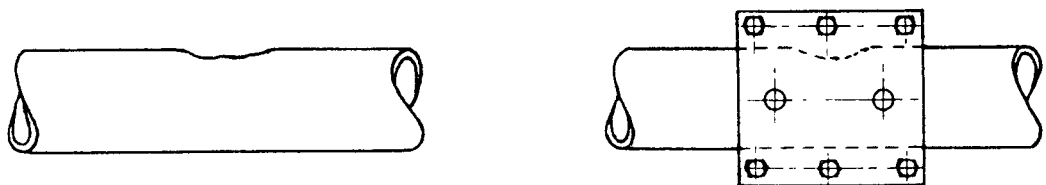
Figure 121 - Torque Tube Repair

REPAIR PLATE:- NEAREST GAGE 24ST
AL. ALLOY SHEET AS TORQUE
TUBE, CUT TO SIZE AND PREFORMED.

NOTE:- D= DIAMETER OF RIVET

ALTERNATE REPAIR - AN23 BOLTS
MAY BE USED INSTEAD OF RIVETS.
MINIMUM OF 6 BOLTS EACH
SIDE OF JOINT.

JOINT REPAIR

3/16 TAPER PIN

1/4" BOLT, LOCK WASHER & NUT

SMALL HOLE OR DENT REPAIR

TORQUE TUBE REPAIRS
SEE FIGS. 121 & 122

TORQUE TUBE REPAIRS, SEE FIGS. 121 & 122.
