PROJECT PROFILE

St. Pauls United Methodist

Houston, Texas

Services Provided:
Assessment

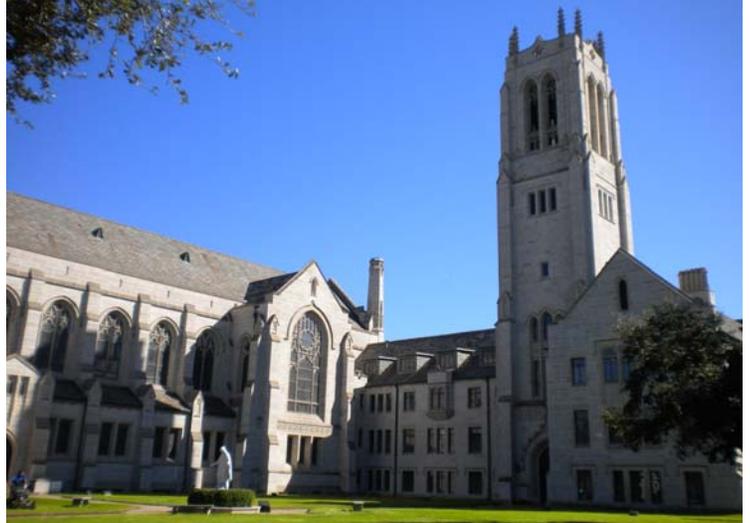
St. Paul's United Methodist Church was constructed between 1929 and 1930 and is designated as one of Houston's 50 iconic buildings. The architecture is Modified English Gothic with Indiana limestone exterior cladding. The roof on the facility consists of 1-inch thick slate shingles over felt underlayment. The roof sustained damage during Hurricane Ike on September 13, 2008. The slope on the main roof areas is approximately 11-inches vertical to 12-inches horizontal. The slate shingles vary in width from 14 inches to 24 inches and were secured with copper nails driven through two punched holes in each shingle.
