**CMA File #1903-001AC**

**inspection notes:**

Inspected insured's side x side (2,121 miles ... 101.1 hours listed on the meter) at the repair shop on 2/26/2019. Assignment contention stalls and shuts off ... leaking oil). The vehicle is fully assembled, with the two issues outwardly visible.

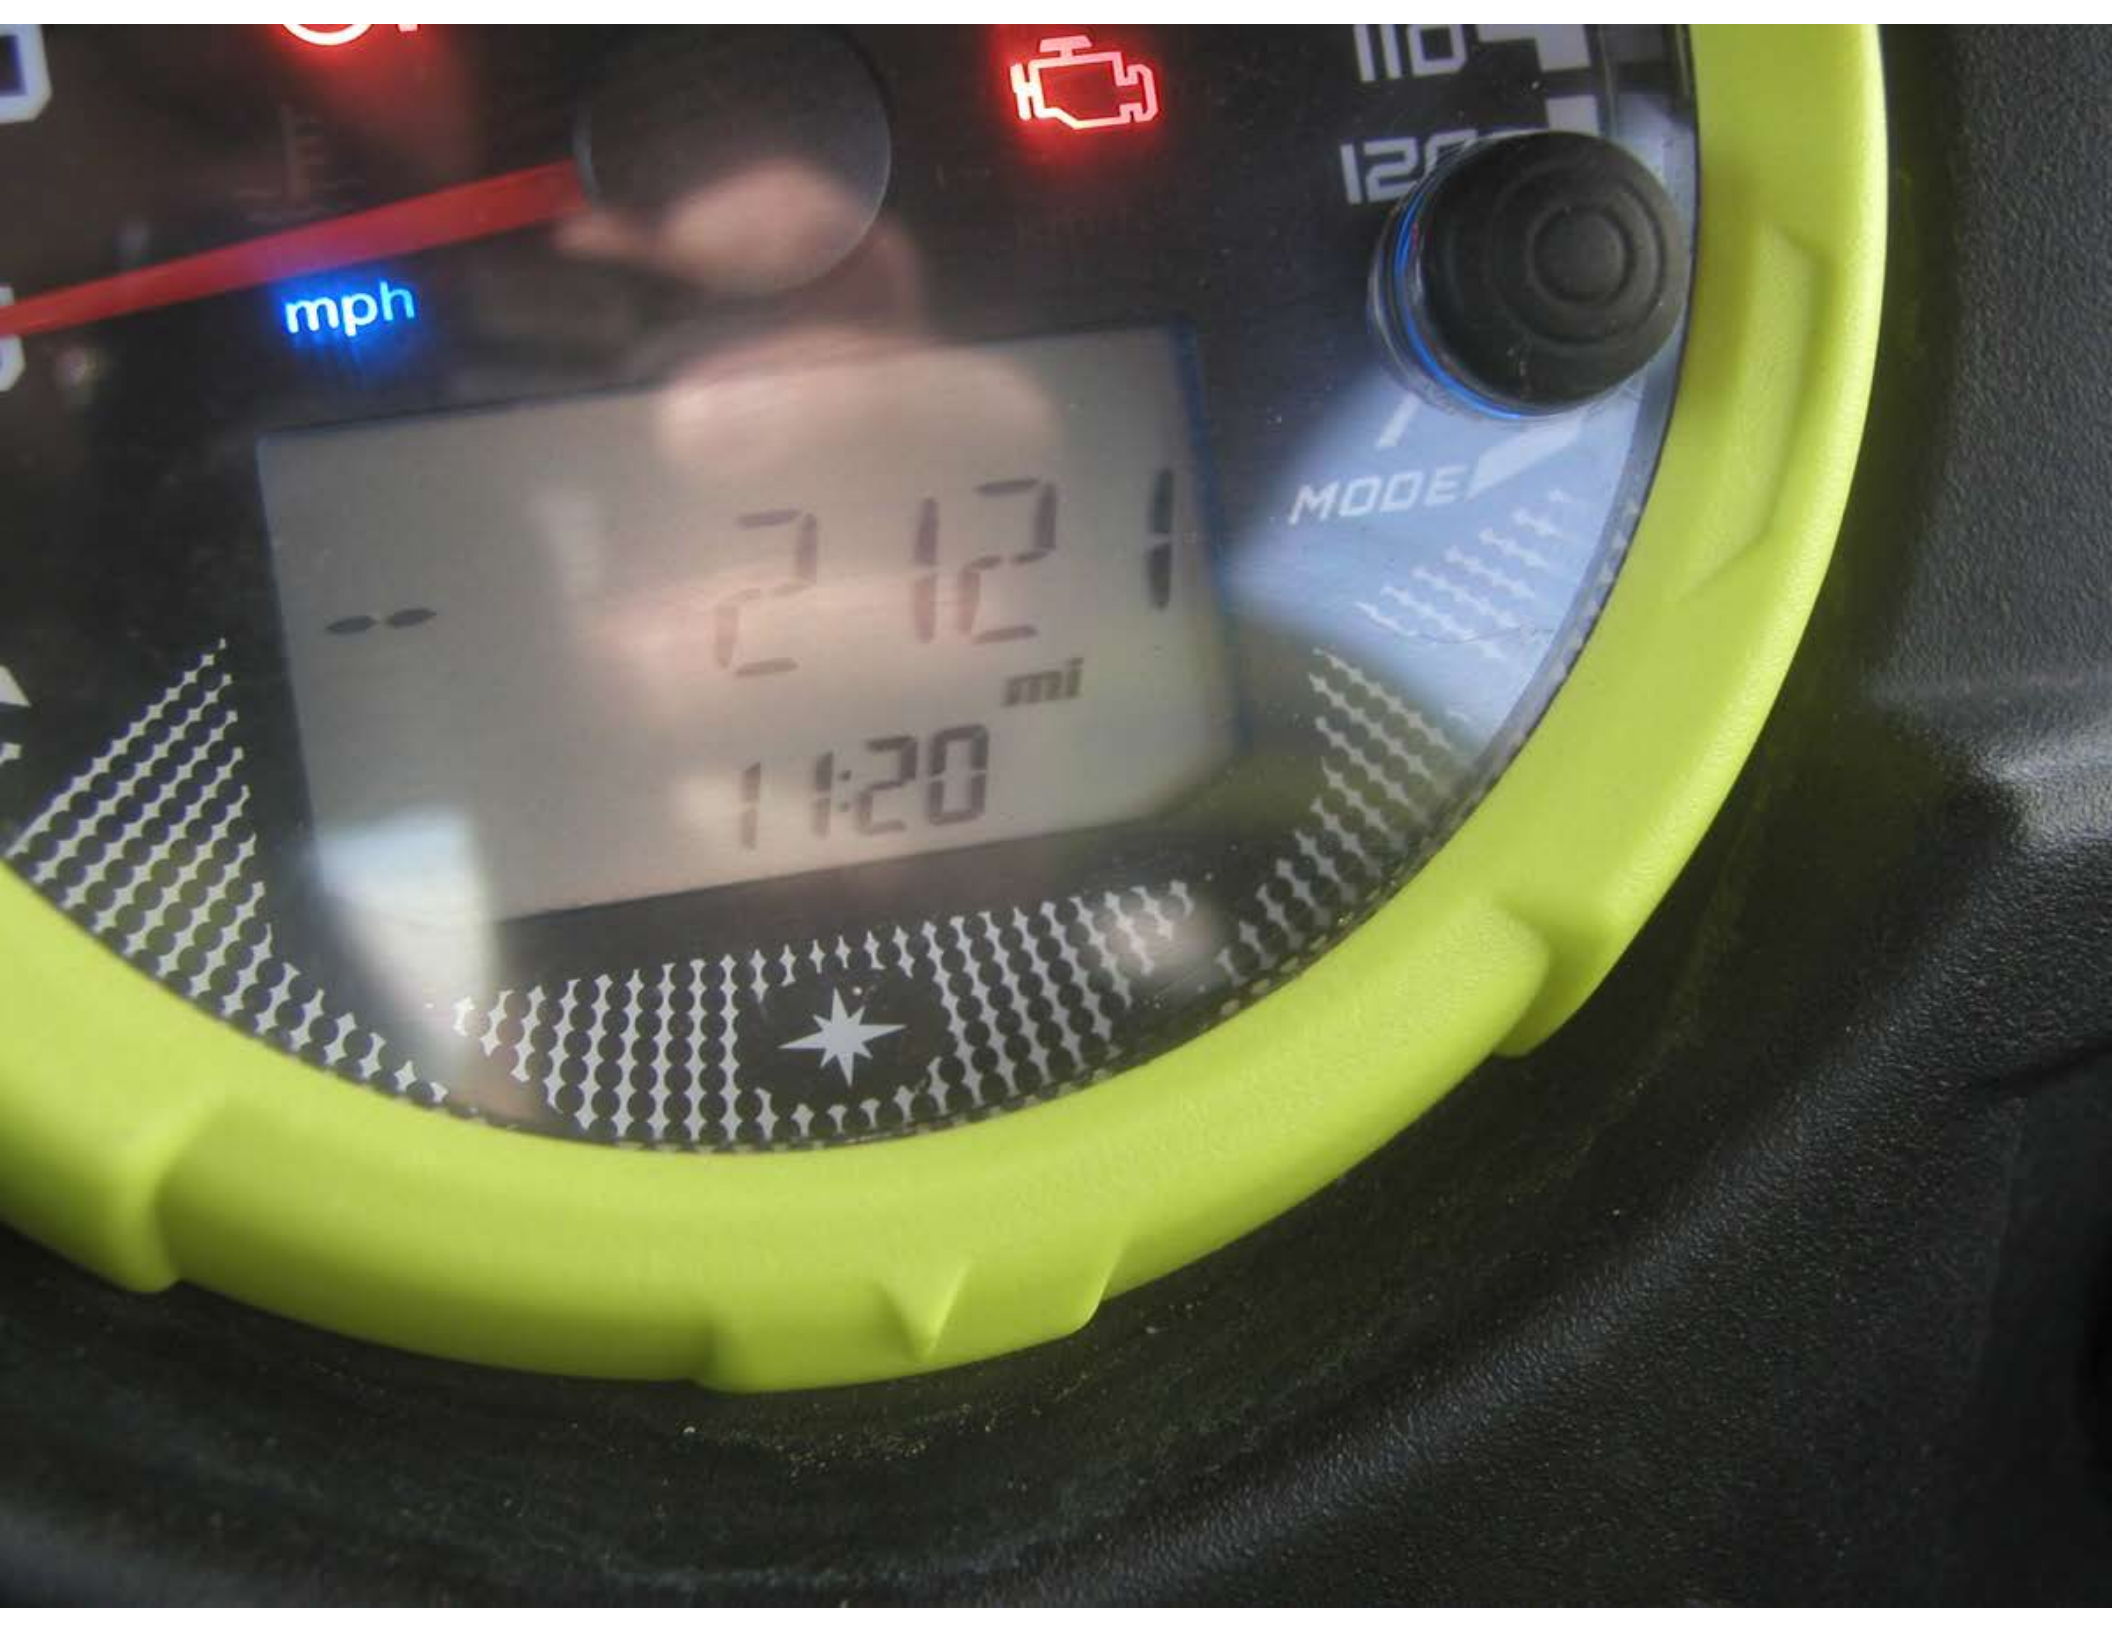
mph

212.1

mi

11:20

CALIFORNIA OFF HIGHWAY

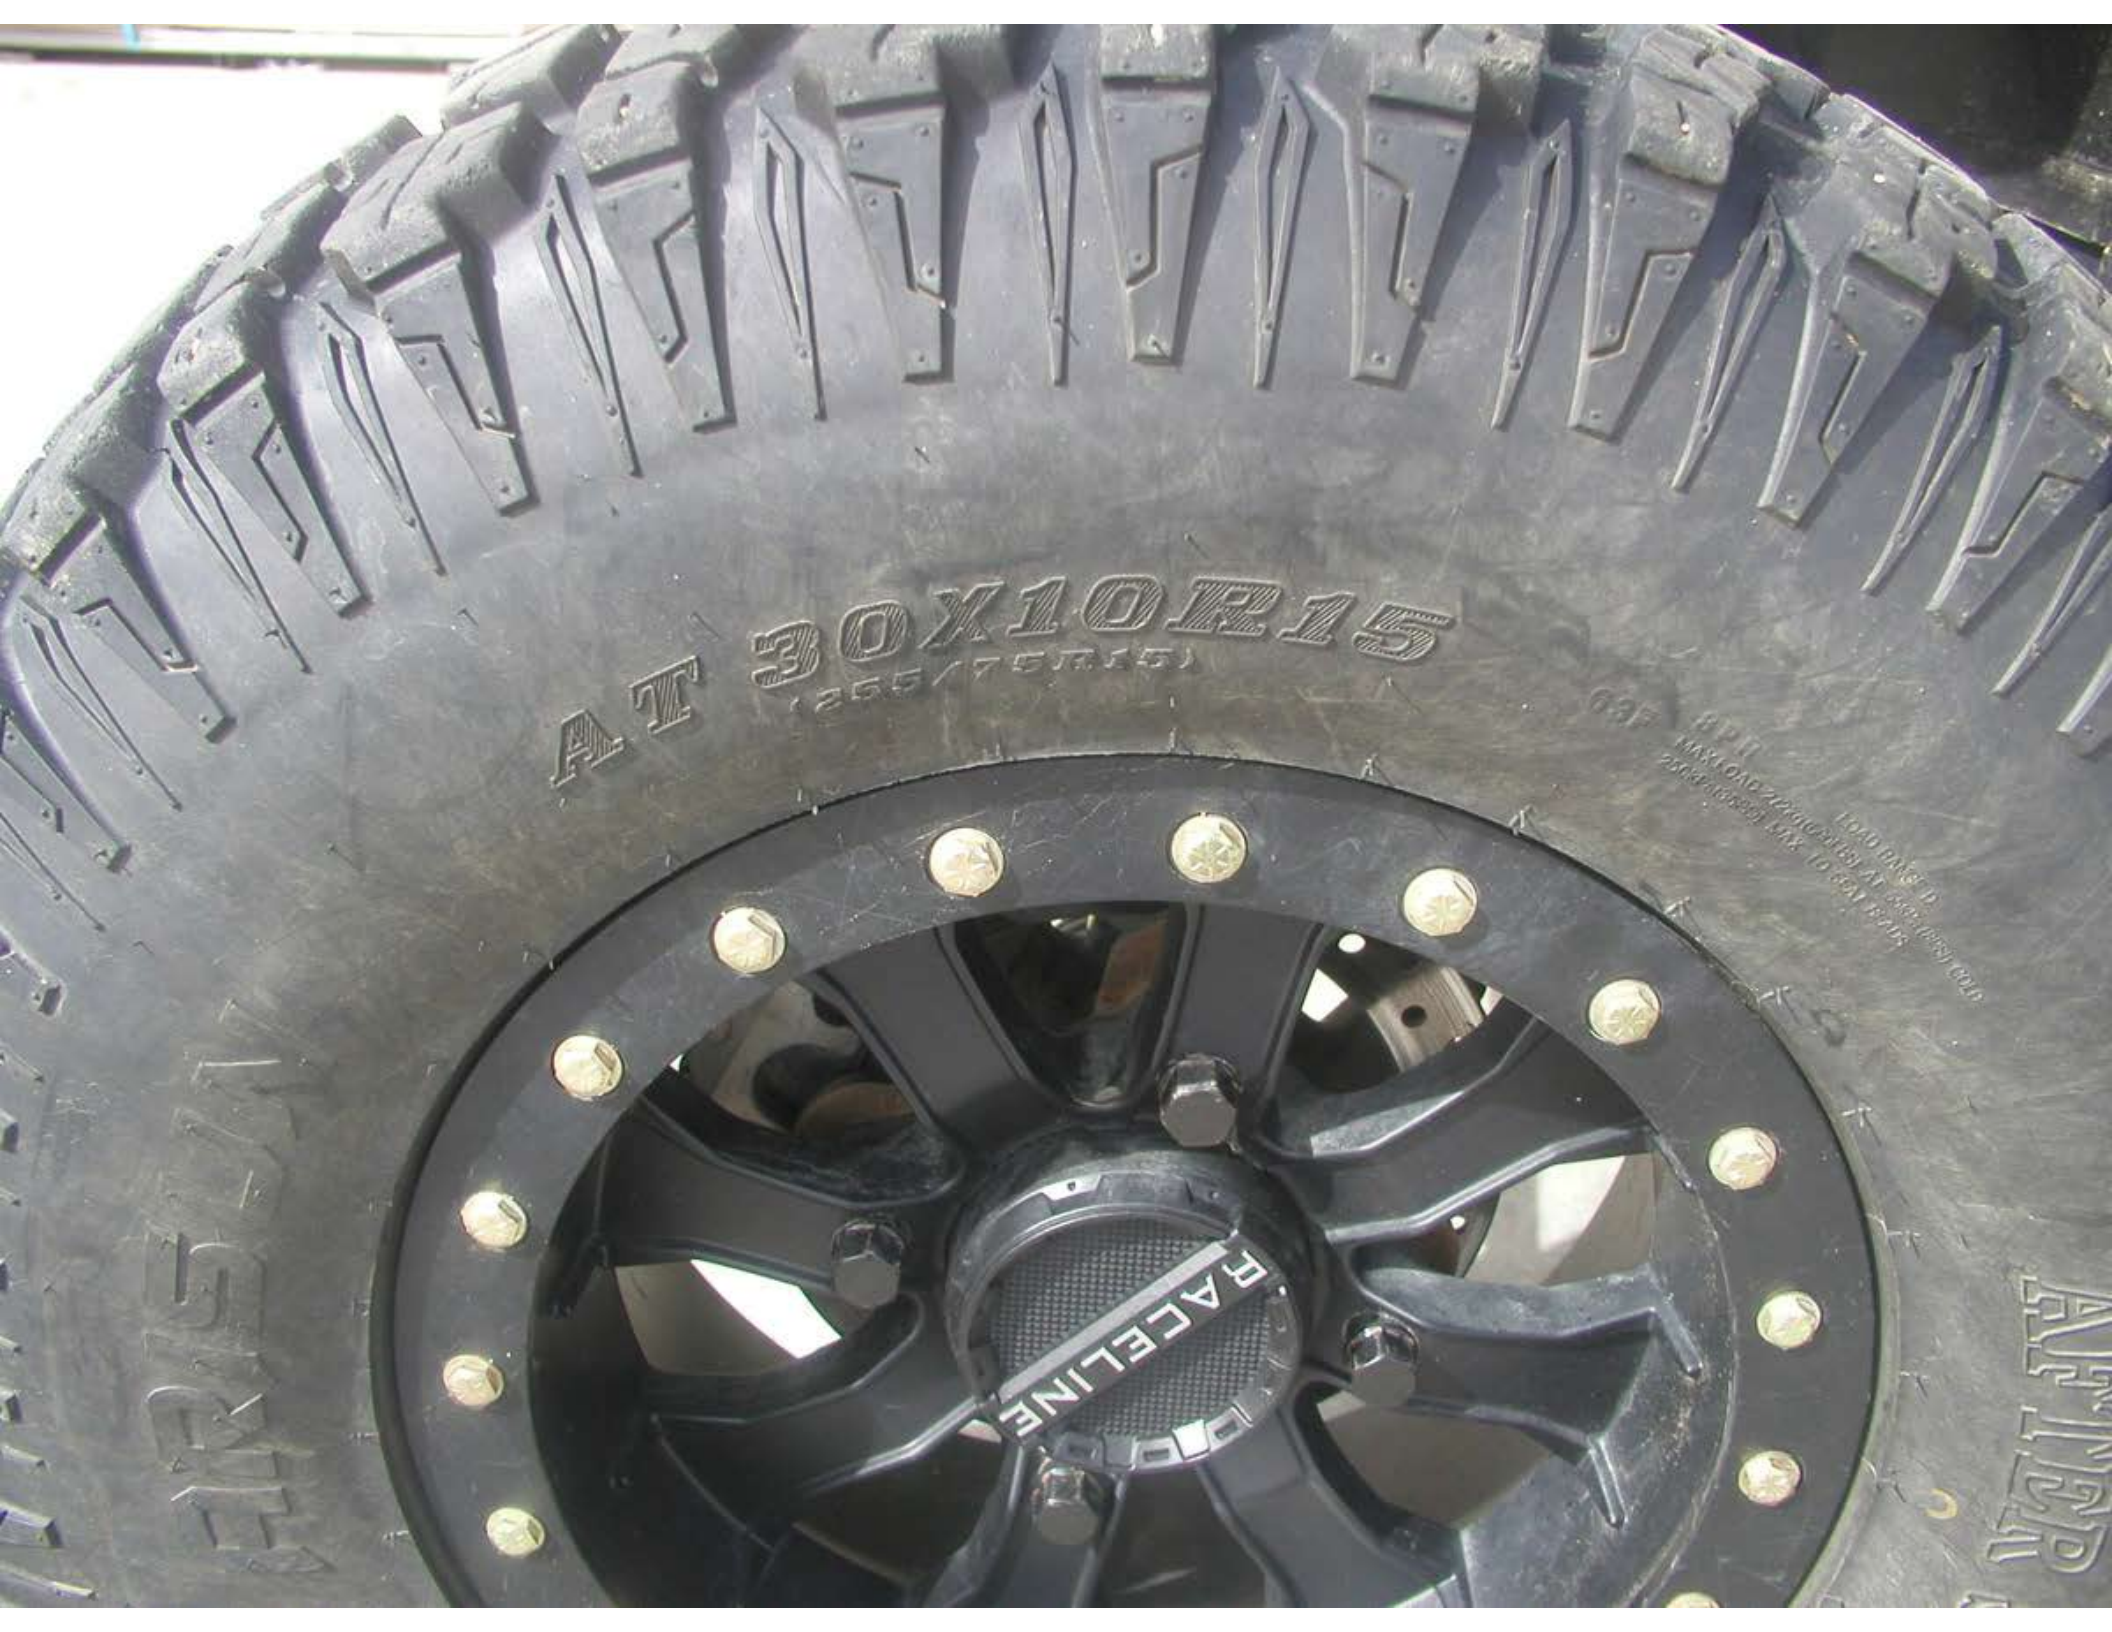
AT 30X10R15  
(255/75R15)

63F 8PR  
MAX LOAD 2200KG (4850LB) AT 80PSI (5.5BAR)  
SPEED RATING MAX 100KM/H (62MPH)

RACELINE

ALL-TEMP

Turning my attention to the chassis. Showing after market lighting, seat restraints, wheels and tires, etc. OE intake and exhaust. Clean vehicle, minimal cumulative wear and tear.

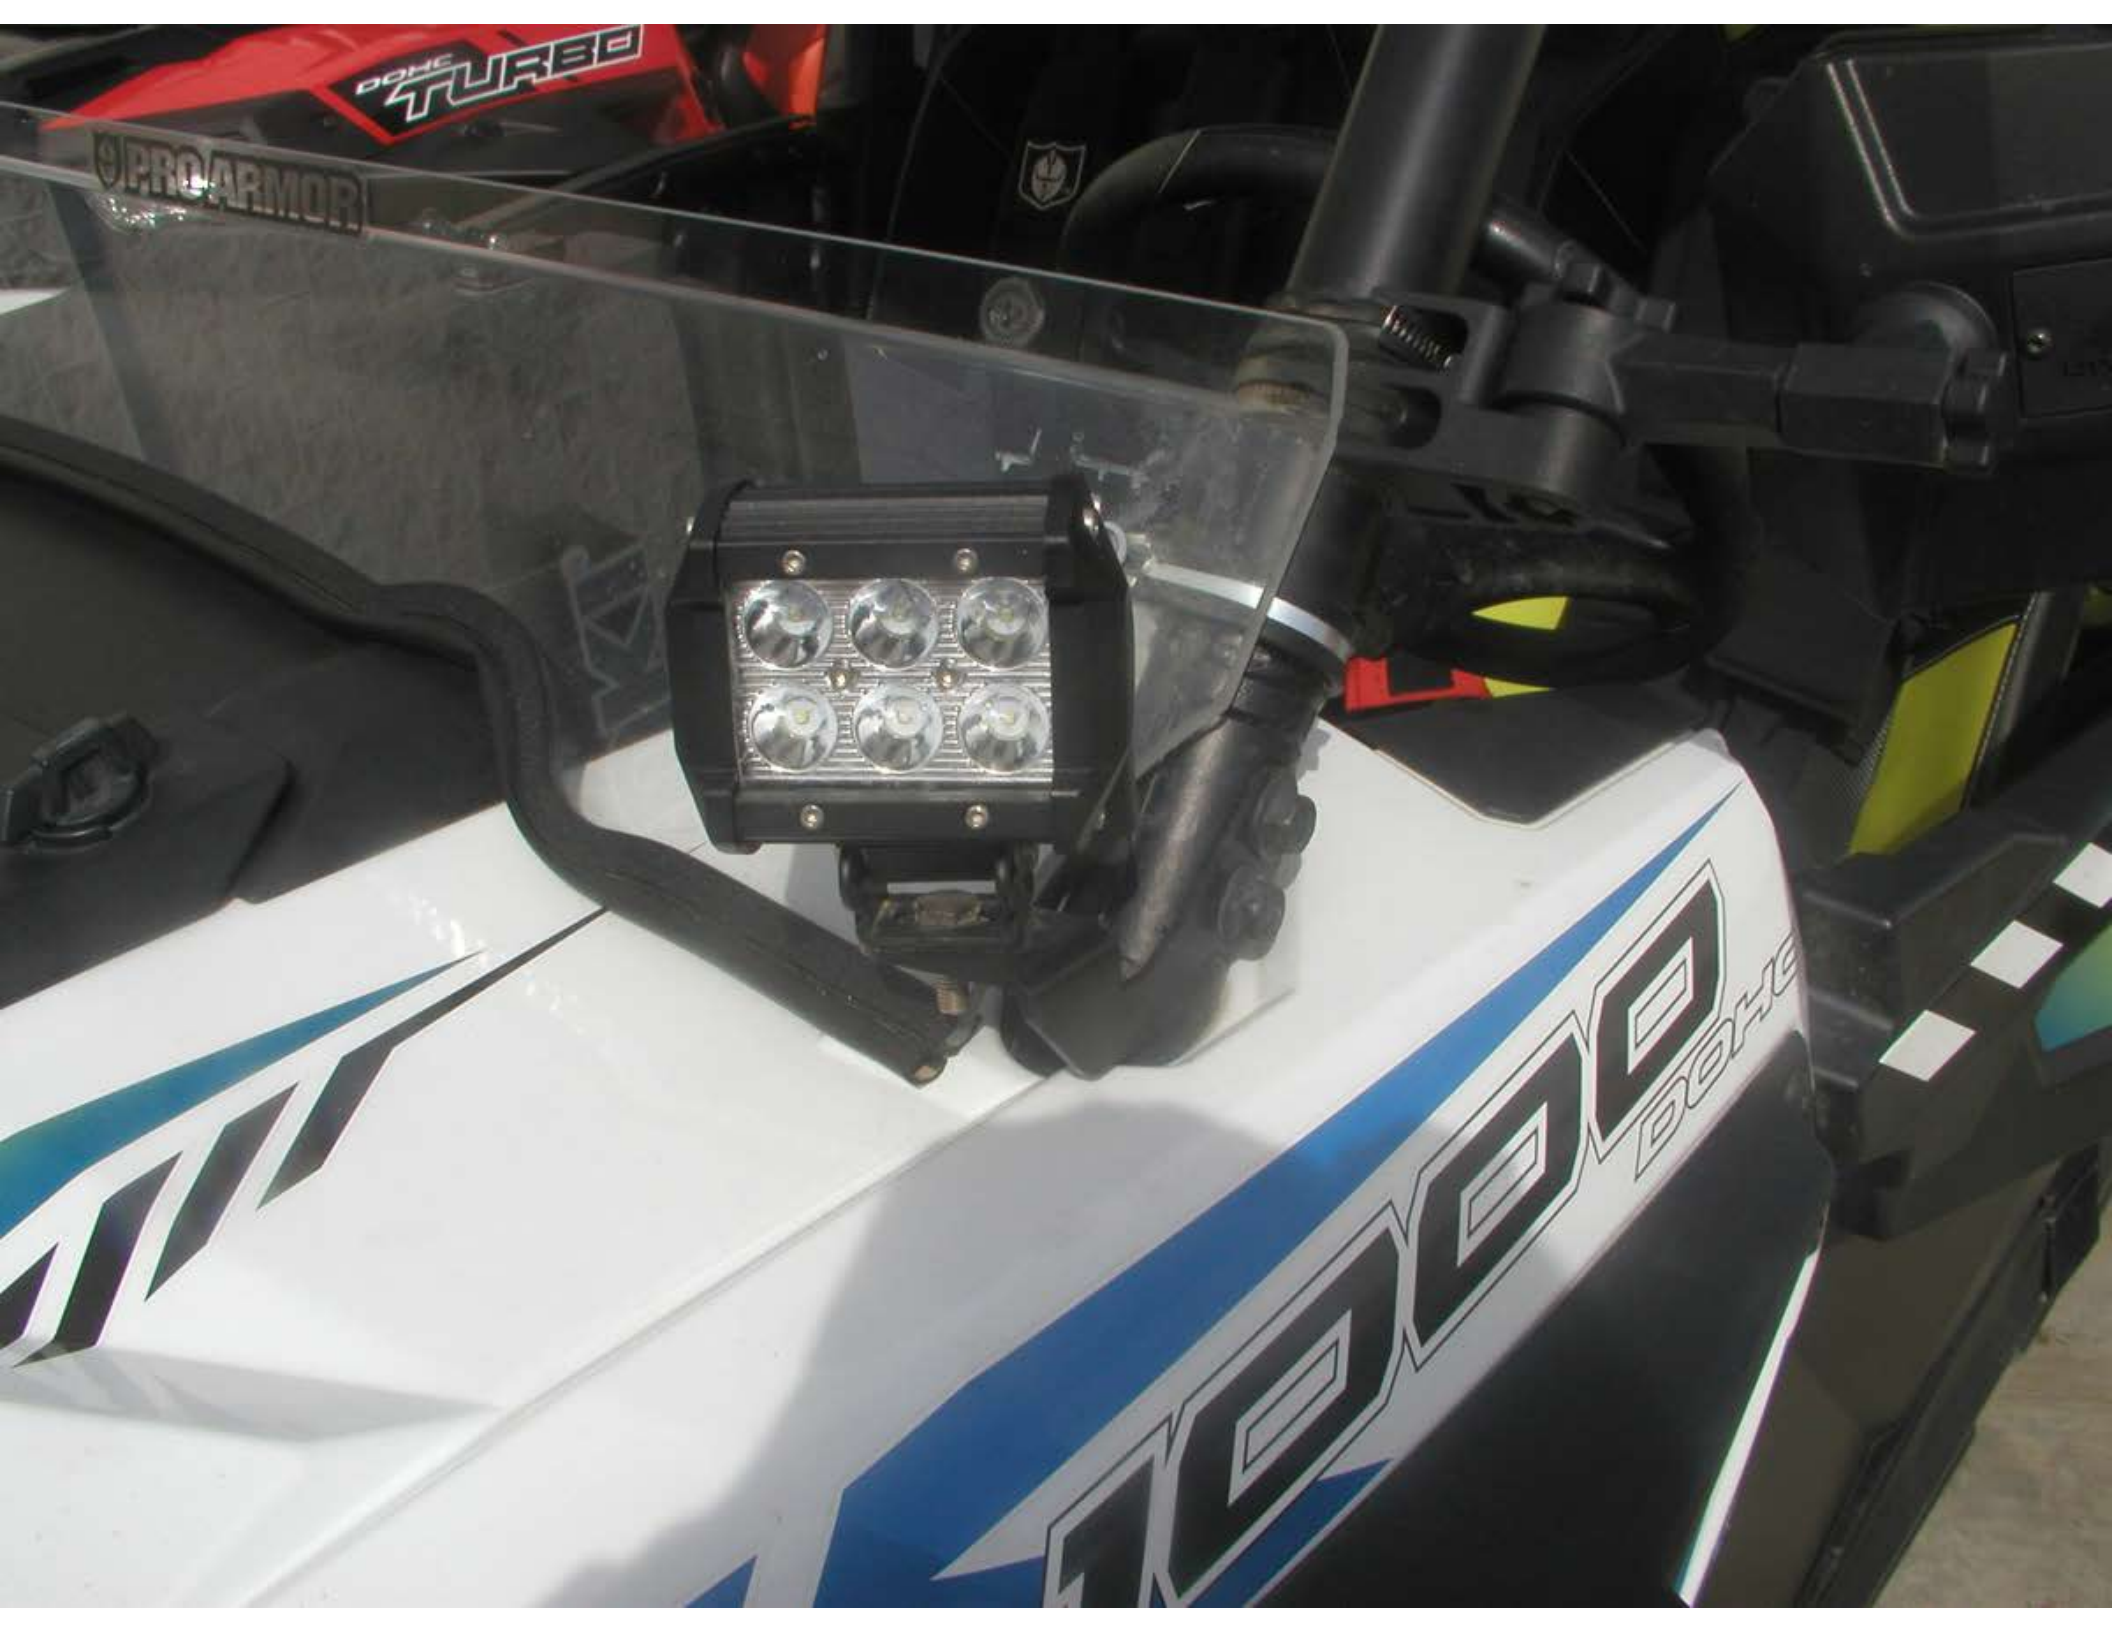
DOHC  
TURBO

PRO ARMOR

1000 DOHC
