PESM: Madagascar Water Project

Phase II Project Summary

February 2016

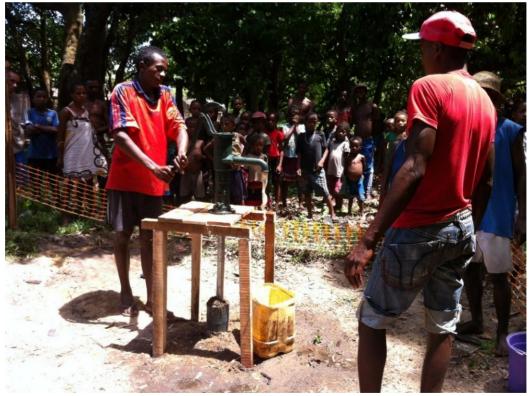
Ambilabe Well-1: Clean-up and Flow Test

- Location: North of Mahonoro, in center of village on the old road
- Number of people served: 350
- Top of water table: 2.0 below surface
- Lithology: Sand 100%
- Water: Fresh
- Initial Flow Rate: 30 liters / minute
- Time to drill well: 6 hours
- Well Design: 2.8mGalva+2mGalva+1mFilter = 5.8mTotal in which 5..2m under the ground, with check valve
- Comments: drilled in wet season, supplemented 1 existing well in village

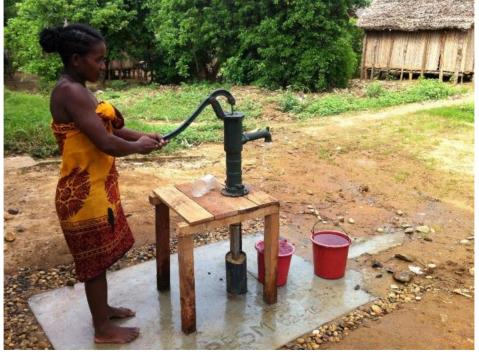
Tsivangina Well – 1: Serving the Community

- Location: in center of village, next to the market, on a hill
- Number of people served: 250
- Top of water table: 3.0 below surface
- Lithology: Variable: sand, silty sand and claystone
- Water: Fresh
- Initial Flow Rate: 30 liters / minute
- Time to drill & complete well: 10 hours
- Well Design: 4.5mGalva+2mGalva+1mFilter = 7.5mTotal in which 7.1m under the ground, with check valve
- Comments: screen had to be positioned in optimal lithology, well initially drilled to 8.5m but 1m had to be cut off due to limitations of the hand pump – this is as deep as can be pumped with unassisted hand pumps, drilled well at invitation of local Peace Corp Volunteer, supplements water sourced from several bucket wells in village which have muddy water due to clay and some seasonally go dry
- Frequent maintenance will likely be required as pump is operating at its maximum limits

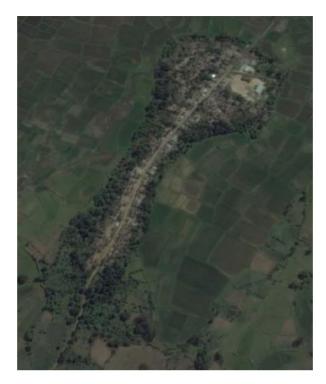
Village of Ampasimbe

Ampasimbe is a very nice village but lacks easy access to water. In addition to the well recently drilled by PESM, it has two bucket wells that go dry seasonally and are thought by some to be contaminated. The project concept is to drill water wells every 300m along the long axis of the village, which would require up to 5 wells.

The lithology is not ideal as it is interbedded sands, silty sands and claystone overlying the weathered basement "red rock". A test hole was drilled along the road that runs through the village to confirm the lithology and to determine the top of the water table and where it lies relative to reservoir quality sands and the weathered basement.

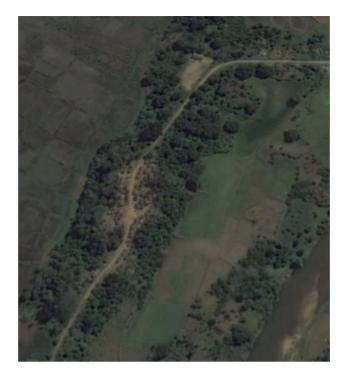
Village of Ambodiloranjy

On inspection, the village appears to be built on the red basement rock, below which the potential for finding an aquifer is low to none. Three test holes were drilled to confirm the lithology with results as noted below:

Test Hole 1: Location: at the bottom of the hill on the river side of the village: drilled 1.75m and found only weathered basement "red rock" which has no aquifer potential. No water found.
Test Hole 2: Location: next to the rice paddy: drilled 4.3m, found water at 1m, all the rock was clay which has no aquifer potential. If there is any hope, this would be the area, albeit small.
Test Hole 3: in Litchi trees on left side as you approach the village: drilled 3m, no water seen, all rock was the weathered basement "red rock". It appears there is little hope to be able to drill a water well within the Village of Ambodiloranjy.
