# SPYGLASS LANDING CONDOMINIUM MARSHFIELD, MASSACHUSETTS

## CAPITAL RESERVE FUND ANALYSIS

Per the request of Spyglass Landing Condominium Association, Continental Building Consultants (CBC) of Hampton, New Hampshire, has prepared a limited study of the operation and condition of the Condominium to determine the required annual funding levels for the Condominium capital reserve fund.

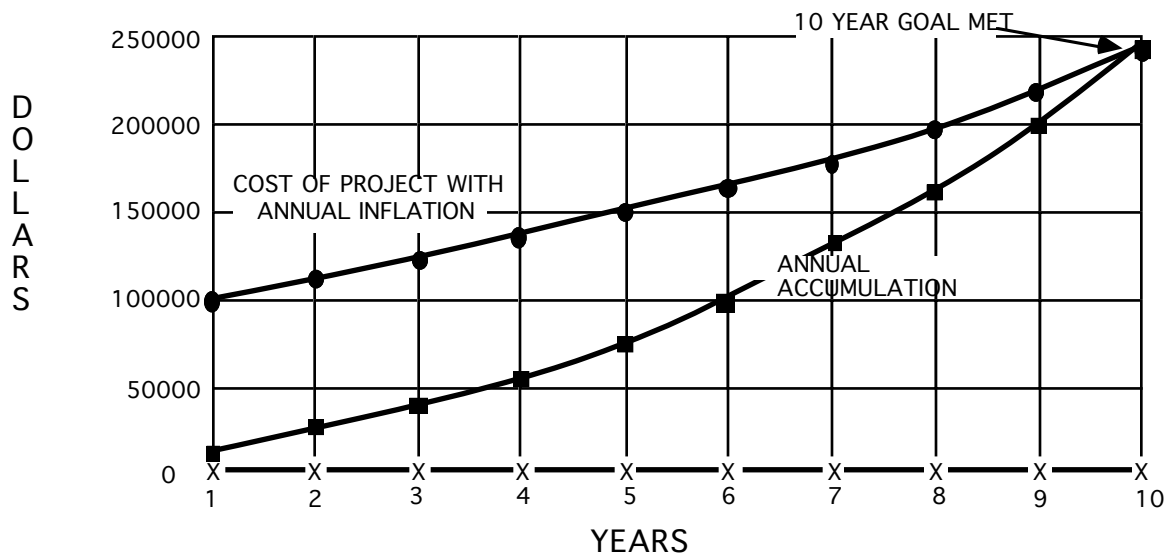
\*ANNUAL DEPOSIT IS INCREASED BY 2% TO OFFSET INFLATION  
THIS ILLUSTRATION REFLECTS A PROJECT WHICH WOULD COST \$100,000 IN PRESENT DAY DOLLARS AND IS EXPECTED TO BE UNDERTAKEN IN 10 YEARS. IF THE RESERVE SCHEDULE IS UPDATED ON AN ANNUAL BASIS, TOTAL FUNDING FOR PROJECT WILL BE ADEQUATE.

**ACCUMULATION OF FUNDS FOR SAMPLE  
PROJECT SHOWN ABOVE**

**RESERVE ACCUMULATION BY YEAR USING ANNUAL UPDATES**
