**RIDGE UTILITIES, INC.  
REGULAR MEETING  
OF THE BOARD OF DIRECTORS  
July 21, 2018**

Utility Name Ridge Utilities Incorporated

Tank Name North side

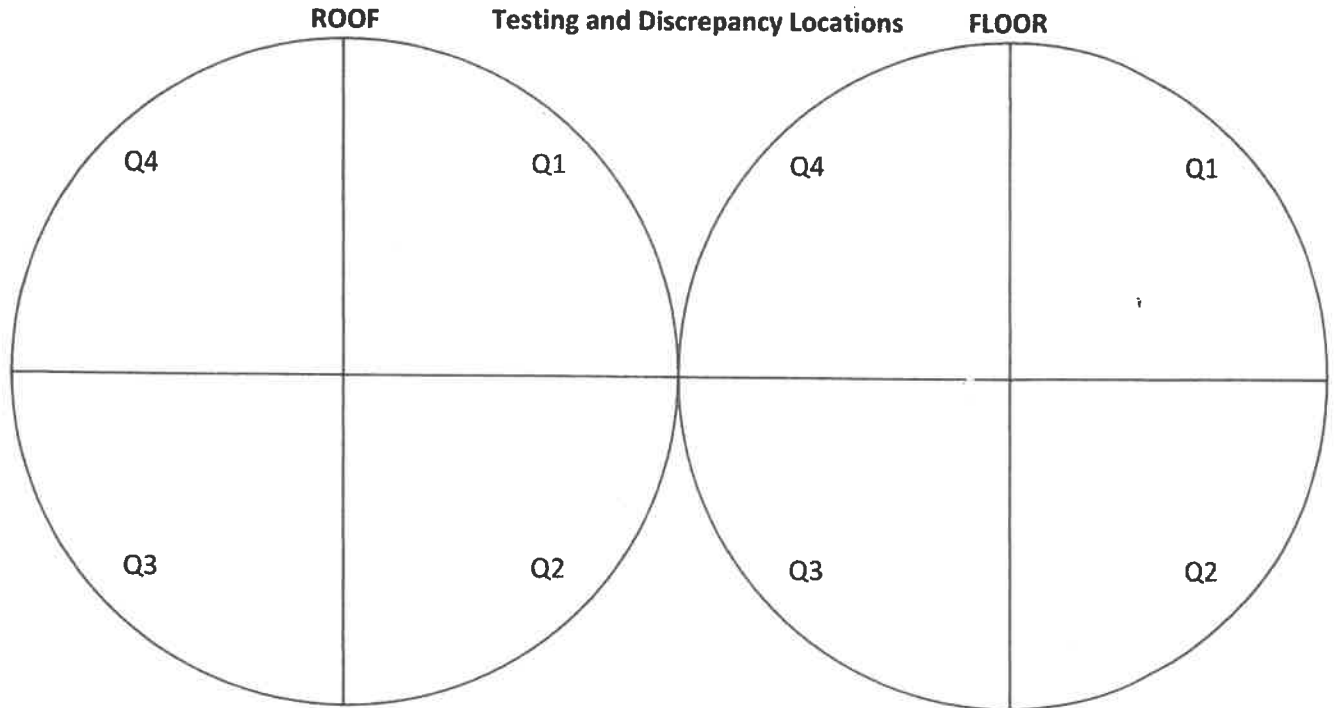
**Sediment Depth Measurements**

Average Sediment Depth = The sum of all measurements taken, divided by the number of measurements taken

The reservoir is in overall good condition. We removed an estimated "Skiff" of iron manganese sediment from the reservoir floor.

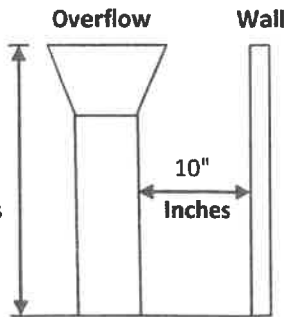
<b>Inlet Riser</b>	<b>Outlet Riser</b>		<b>Overflow</b>

<b>Floor</b>	<b>Floor</b>		<b>Floor</b>

Overflow- Had no notable defects with the screen intact.

Floor- Looked in excellent condition with only minor staining.
