The Journal of RCI Interface

November 2012 • Vol. XXX • No. 10 • \$10.00

23 IN TODAY'S ROOFING WORLD **INFRARED THERMOGRAPHY**

By Karl Schaack, RRC, PE

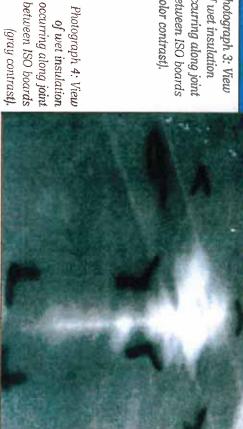
of wet insulation (color contrast). between ISO boards occurring along joint Photograph 3: View

anomaly, when viewed through an infrared camera, is observed and typically occurs during the initial occur within cellular insulation material such as the cut or formed edges of these boards. This type of wetting as the moisture becomes absorbed along cellular glass and foamed plastics. This anomaly (Photos 3 and 4). lation board or joints between adjacent boards borders around the perimeter edges of the insutypically appears as irregular-shaped brightened The board joint thermal anomaly can also

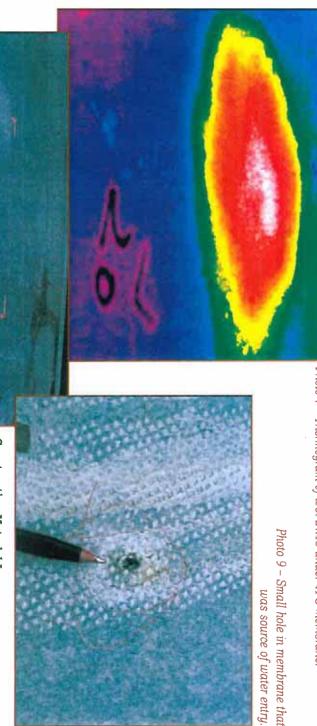
Photo 8 - View of demarcated anomaly.

can be detected with infrared thermography (Photos 7, moisture intrusion has occurred, entrapped moisture applied directly over cellular insulation or LWIC, and challenges for thermographers. If the roof system is and over various substrates that provide additional currently installed in more widespread applications single-ply membranes with white-colored surfacing are above the surface of the LWIC. Modified-bitumen and without incorporating any type of rigid board insulation branes, have also been installed directly over LWIC 6). Single-ply membranes, as well as bituminous memwithout the use of a cover board (Photographs 5 and modified-bitumen—installed directly on top of composed of a roof membrane—either single-ply or In today's roofing market, applications can OSI

anomalies may appear as ghost-like images, depending on the On smooth-surfaced, white, single-ply membranes, thermal as discernible compared to other darker-colored membranes 8, and 9). On white-colored membranes, the images may not be weather conditions during the day and survey time.

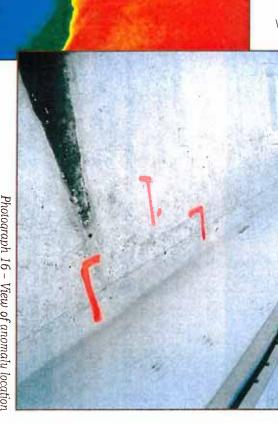
Photograph 16 – View of anomaly location of water in TPO base flashing.

Water entrapped in base flashings (most likely occurring when the flashing was installed during construction and an adequate tie-in/night seal was not provided) can often be readily detected with infrared imaging.

മ nology (Photos 15 and 16). detectable with infrared techal and, therefore, within the flashing materisignificant quantity an insulation material or the may not be contained mulate moisture. The water taped seams can also accuinsulation with a facer and blister or a balloon shape but it can be of 6 become within form
