**ARCHAEOLOGICAL INVESTIGATIONS
AT SHREWSBURY CHURCH, 2021-2022**

**Interim Report 1 - 5 April 2022
Interim Report 2 – 31 August 2022**

**John L. Seidel, Ph.D.
Elizabeth A. Seidel**

Re: Interim Letter Report - Investigations of Foundation Remains on Church Grounds

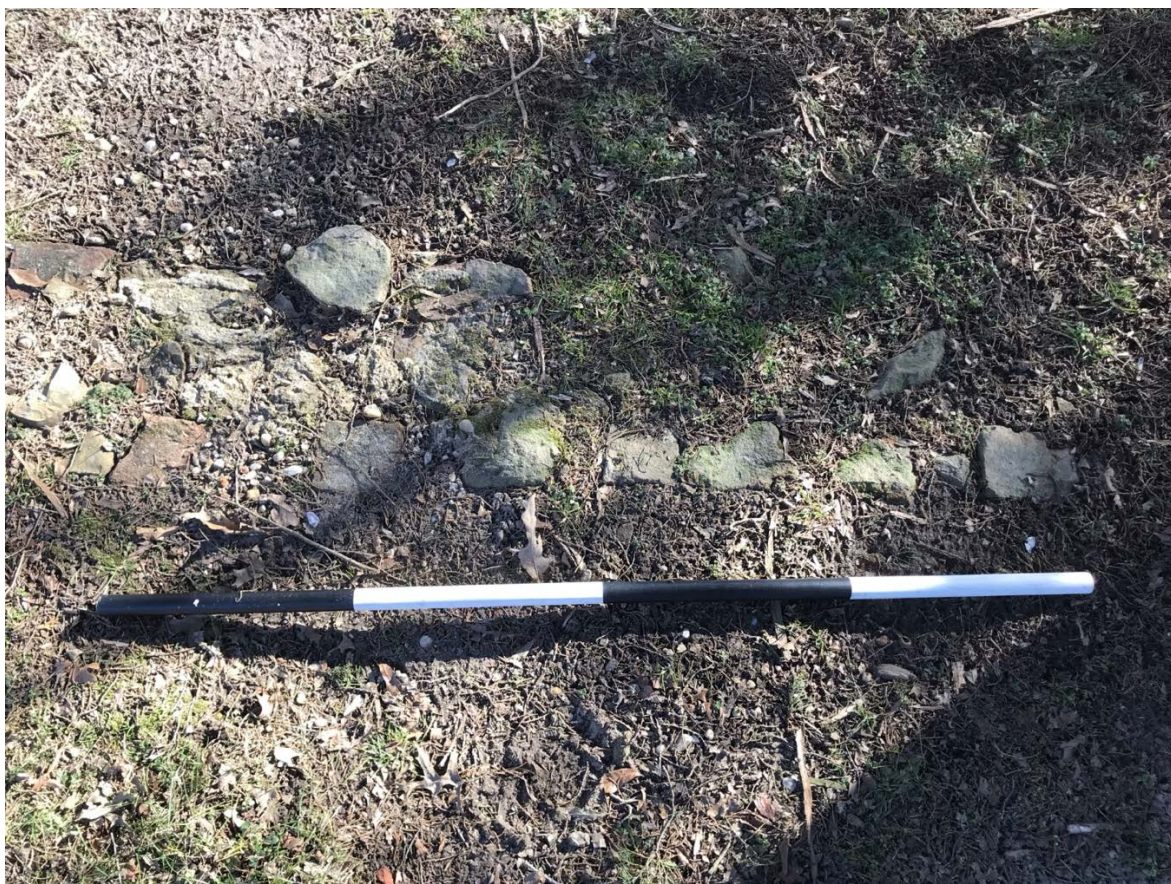
Figure 1: Brick and stone feature as seen on February 8, 2021 looking south
(scale is 4 ft in length)

When first observed by the archaeological team, the foundation in question (Figure 1, next page) appeared to be comprised of fragmented brick (hand-made) and both native and non-native stone (some of the latter possibly being ship's ballast). It ran in a roughly east-west line in the southwest corner of the cemetery. The materials seemed to only be visible seasonally, from the surface, but clearly were mortared together. The visible portions of the feature's width measured approximately 0.6 - 1.1ft (18.3 - 33.5 cm), and it extended for at least 7.5 ft (2.29 m) before disappearing underground to the east and being disrupted by a cedar tree in the west. There was evidence of possibly related stone on the far side of the tree, potentially extending the feature's total length.

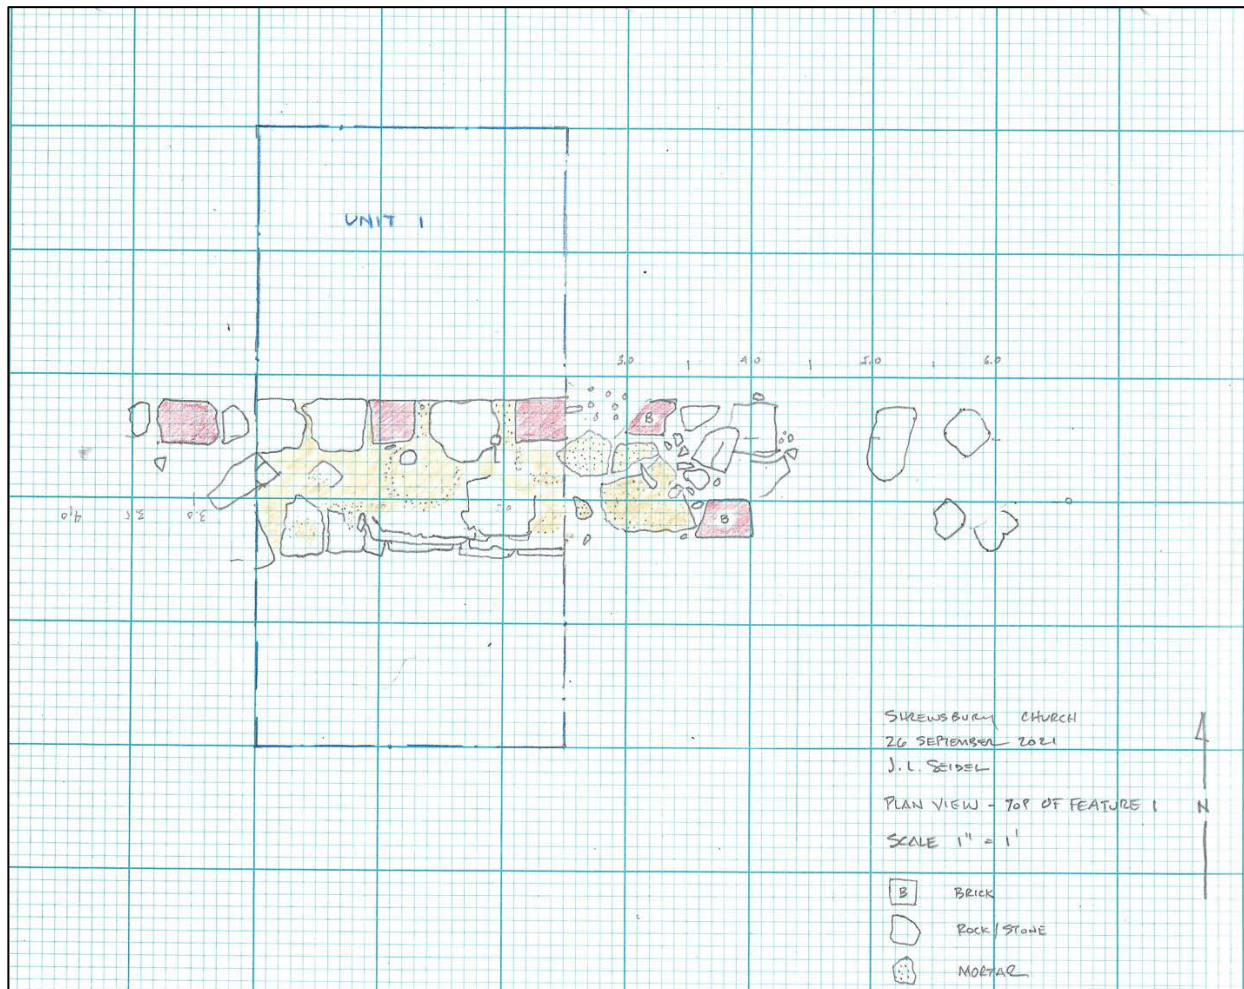
Figure 3: Unit 1 in plan view – field drawing (bricks depicted in red; mortar in yellow)

The original field drawing showing the feature in plan (from above) is shown as Figure 3.

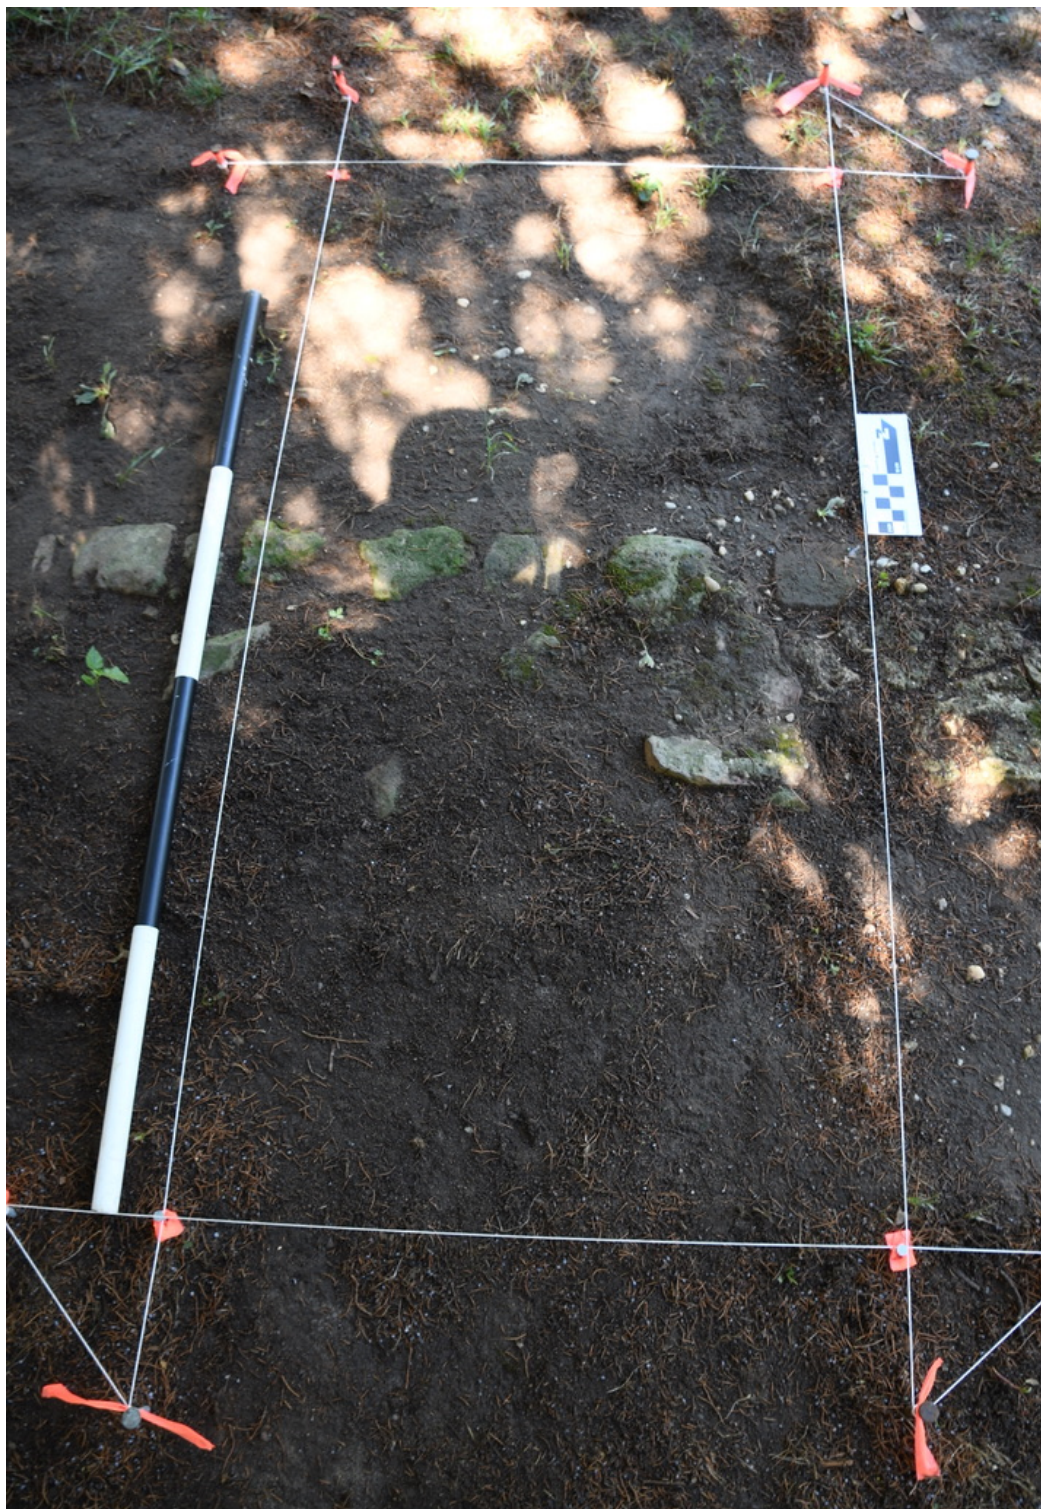
Figure 5: Excavation Unit 1 before excavation; looking north.

Excavation of Unit 1 was done on September 24-25, 2021 using standard archaeological methods, digging stratigraphically by hand, with trowels and small tools. The layout of the unit is shown in Figure 5. Artifacts recovered were segregated by stratum, with provenience information recorded for all finds. Excavated soil was screened through mesh measuring a maximum of $\frac{1}{4}$ inch. All features and deposits were recorded using photography and scaled drawings, including plan views and section drawings of the excavation walls. Daily notes and standardized record forms were used to record all relevant evidence and information.

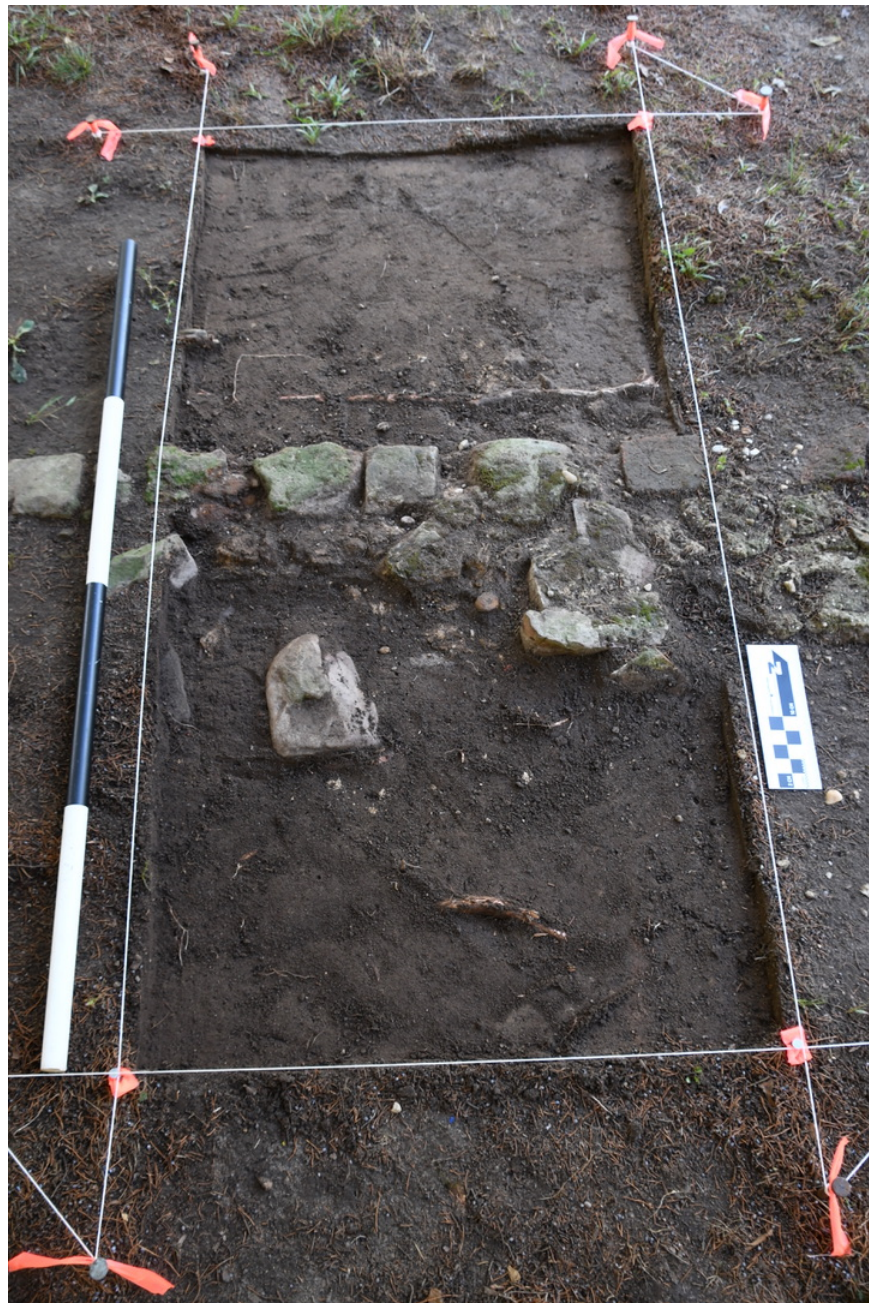
Figure 6: Excavation Unit 1 with Level 1 being removed; looking north.

The initial step in excavation was to peel back the topsoil, revealing more clearly the top of the rock and brick feature, designated Feature 1, and the soils on either side of Feature 1. The upper level of soil on either side of the feature was designated Level 1, ranging from 0.05-0.10 ft (1.5-3 cm) in depth. The unit is shown with Level 1 being removed in Figures 6-7.

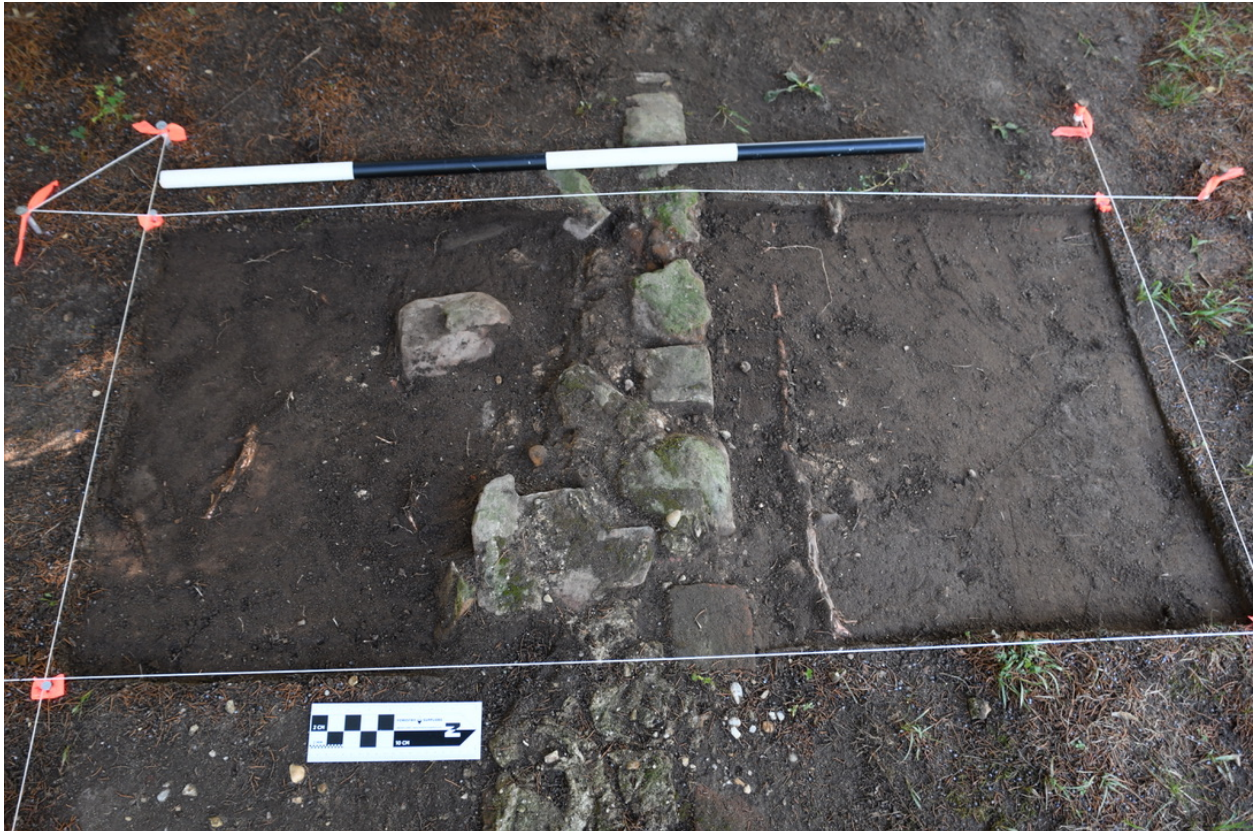
Figure 7: Unit 1 with Level 1 being removed; looking west.

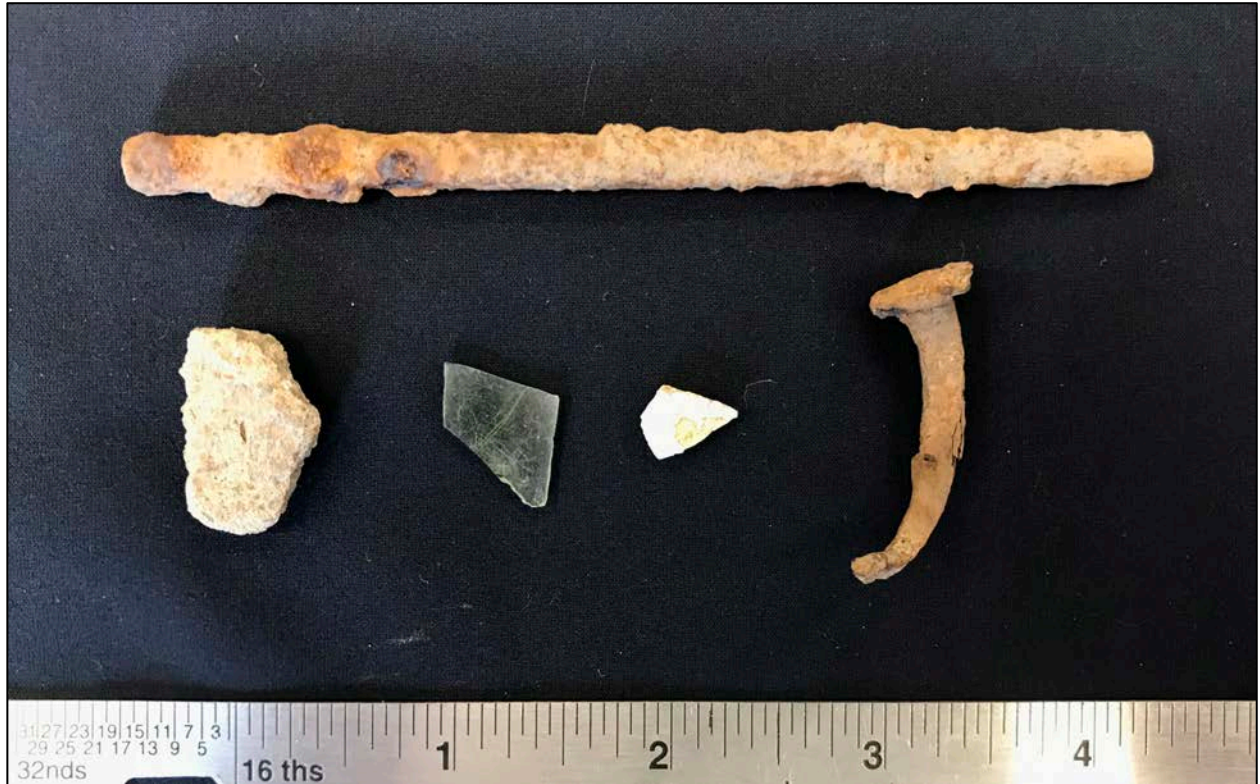
Figure 8: Artifacts from Level 2; iron rod at top; from left to right – mortar, curved glass, pearlware sherd, wrought nail.

The soil to the north of Feature 1 was Level 2, a very dark grayish brown sandy loam (Munsell 10YR3/2). It extended throughout the entirety of the northern half of Unit 1. Artifacts retrieved included brick and mortar fragments, 2 hand-wrought iron nails, a fragment of iron rod, some curved glass, and pearlware. Photos of a sample of the materials recovered from Level 2 are depicted in Figure 8.

Wrought nails typically date to before 1800, although they continued to be used in limited quantities into the early 19th C. Pearlware, as developed by Josiah Wedgwood, was introduced in 1779, although earlier variants were developed by other potters at least as early as 1775. The ware was common in North America until around 1820. The presence of pearlware and wrought nails seems to indicate late 18th or early 19th C. activity.

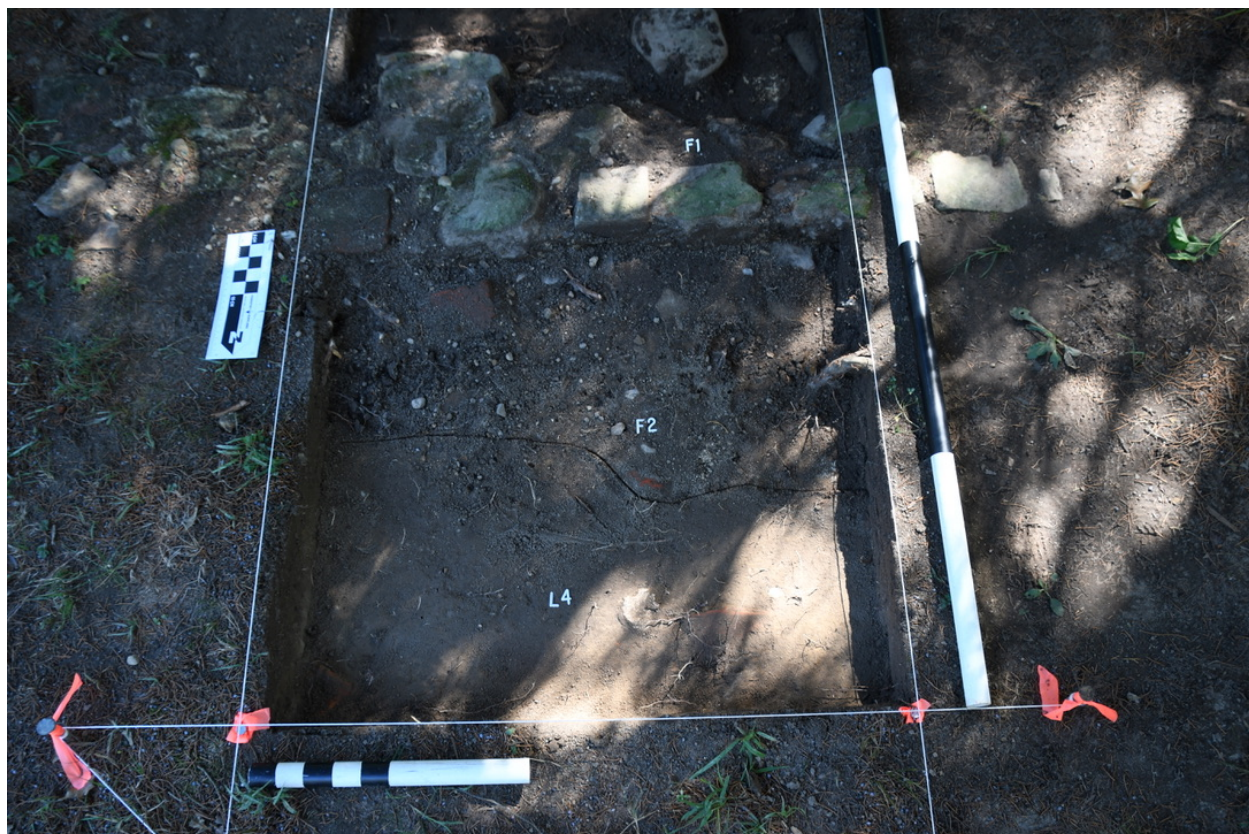
Figure 10: Photo showing the north half of Unit 1, with Level 4 and Feature 2 exposed in the north half of the unit; looking south (note level and feature numbers in the photo).

Below Level 2 in the north half of the unit, two different deposits were discerned (Figures 9-10). Up against the wall (Feature 1) was a dark grayish brown silty loam (10YR4/2) full of mortar rubble, brick fragments, and gravel. Abutting it in the north was a very dark grayish brown sandy loam (10YR3/2) – this layer was somewhat more compact and contained none of the gravel seen to the south. This northern level was designated as Level 4. The gravelly deposit between Level 2 and the wall Feature 1 seemed most likely to be a builder's trench excavated for the installation of the wall. It therefore was designated as Feature 2, Level A.

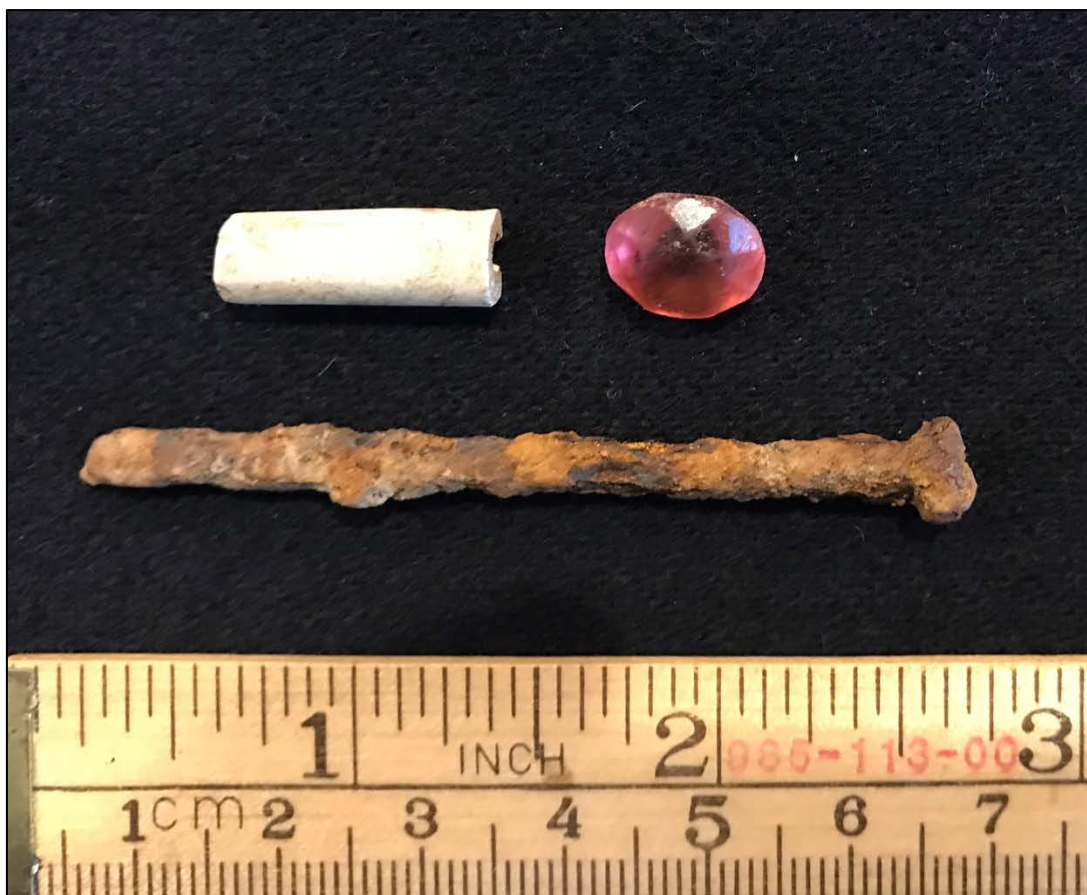
Figure 13: Artifacts from Feature 2 Level B (unit 1)

The uppermost deposit in the builder's trench (shown as F. 2, L. A. in Figure 11) was relatively thin and underlain by a brown silty loam (10YR3/2). Level A had wrought nail in it, while the lower Level B held three identifiable artifacts: a piece of kaolin pipe stem, a cut glass "gem stone," and a cut nail (Figures 12-13).

It is not possible to confidently date the pipe stem or glass piece, but cut nails can be roughly dated. Fabricated by machine rather than hand-forging, these nails are later in date than wrought nails, reflecting a shift toward industrialization. Their production started in the 1790s with a cut shank and hand-hammered head, followed in the 1820s by heads that were machine-formed. This nail has a machine-formed

head and obviously was deposited at the time that the builder's trench was backfilled, at the time of construction, suggesting a 19th C. date for Feature 1.

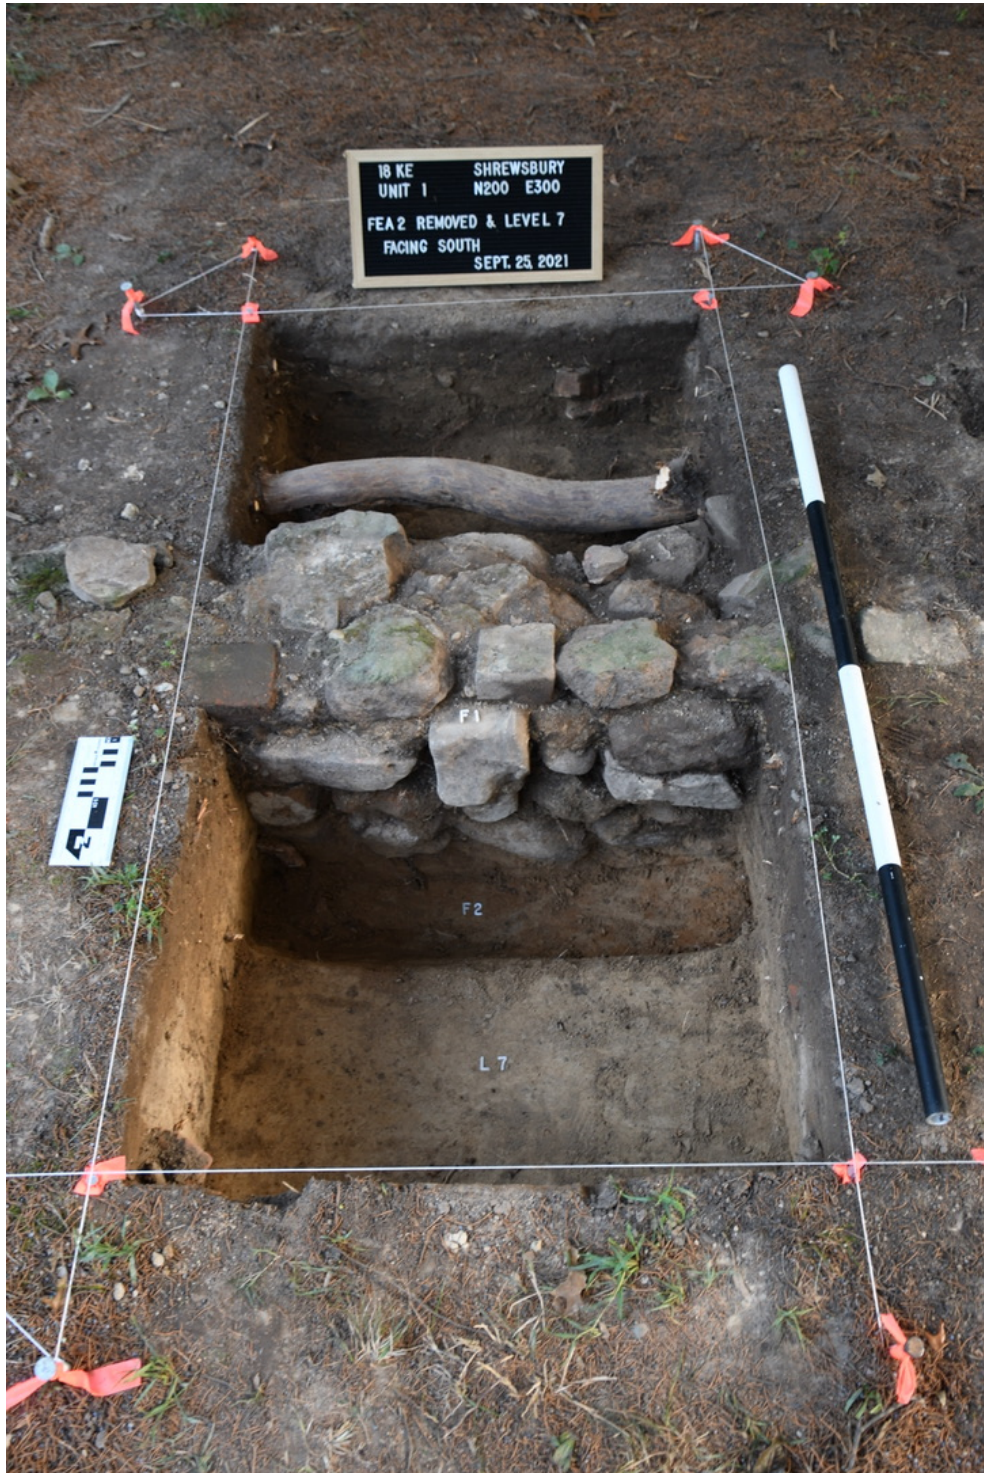
Figure 14: Unit 1 with the Feature 2 builder's trench removed and Level 7; looking south.

Upon the complete removal of the builder's trench, Feature 2, the entirety of the wall or foundation Feature 1 was visible. It extended to a depth of 1.40 ft (0.43 m) below grade (Figures 14-15).

Once the builder's trench was removed, excavation continued to the north, removing the levels into which that trench originally had been dug. These were Level 4, noted previously, and a layer beneath it, Level 7, which appeared to be undisturbed subsoil. No artifacts were found in either level, lending support to the interpretation that these are natural soil levels. Excavation of Level 7 was halted at 1.0 ft (0.30 m) below surface. The unit at this stage of excavation is shown in Figures 14-15.

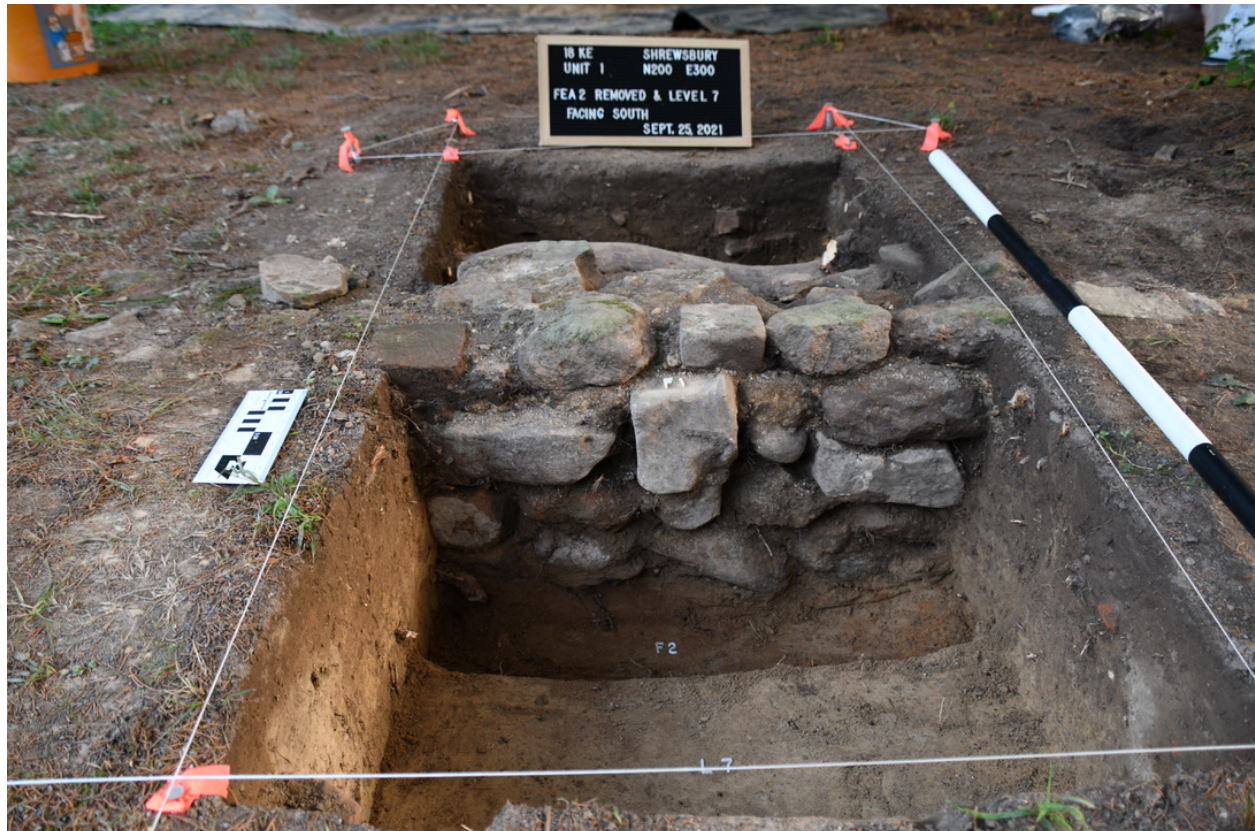
Figure 15: Unit 1 with the Feature 2 builder's trench removed and Level 7; looking south.

Excavation makes it clear that the wall that was the target of this investigation was not a surficial or ephemeral feature, but rather a substantial foundation that was intentionally installed (Figures 15, 19, 20). Comprised primarily of stone laid in mortar, partial bricks (usually half a brick) were incorporated into the upper levels. This opens the possibility that upper courses of brick are now missing. The foundation was laid into a builder's trench that was dug at least 1.3 ft (39.6 cm) below grade at the time that it was constructed. At the bottom, the foundation was 1.4 ft (42.7 cm) in width, extending to a maximum width of 1.6 ft (48.8 cm), wider than what was visible from the surface. This suggests that a substantial wall could have been on top of the foundation. Its size makes it less likely that it merely demarcated a family burial plot or was a church yard wall.

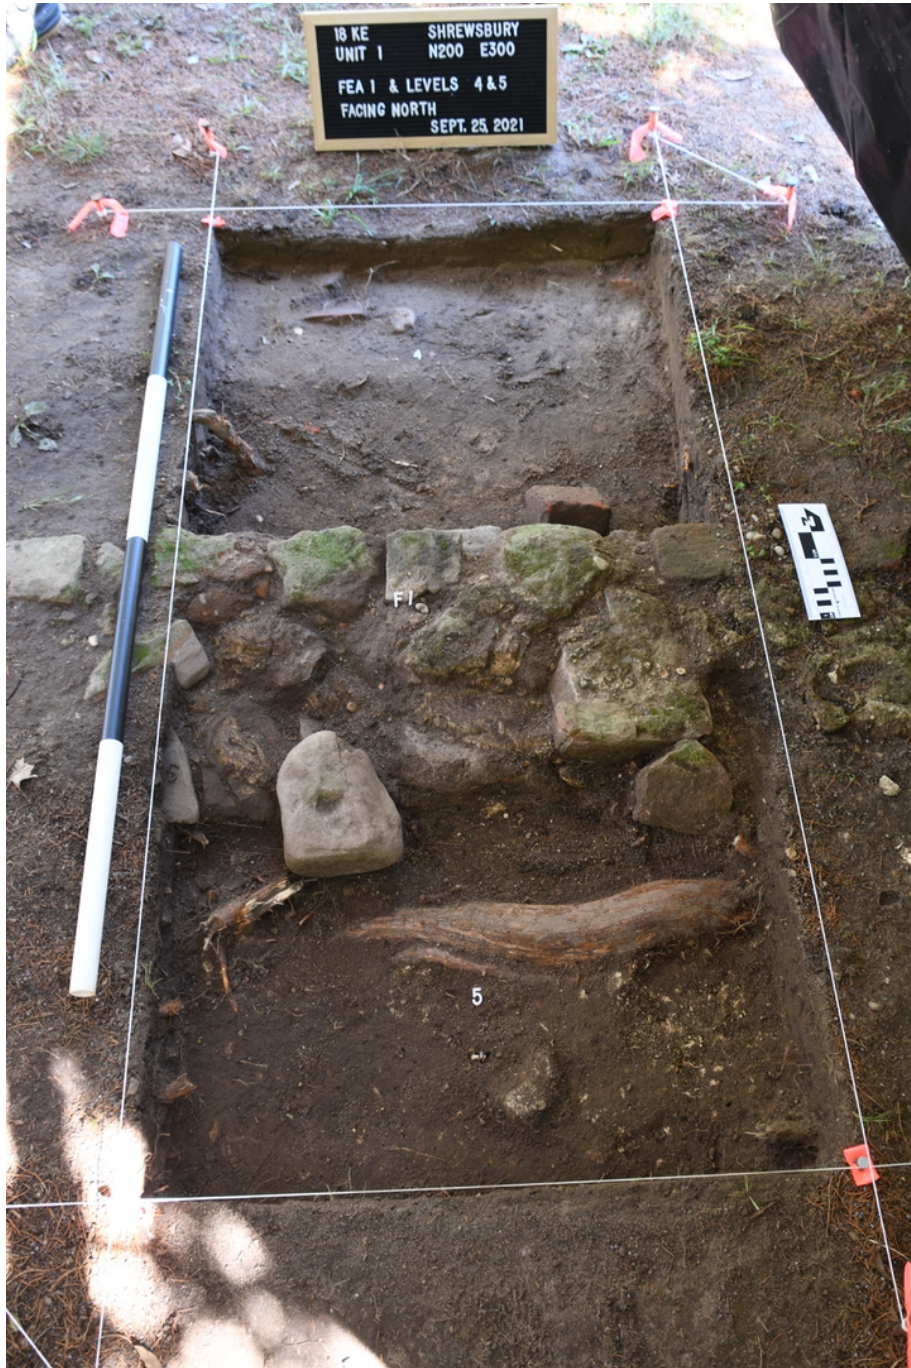
Figure 16: Level 5 exposed in Unit 1; looking north.

Below Level 3 was Level 5 (Figure 16), a sandy loam that included much heavier amounts of mortar fragments, as well as brick bits, some gravel, and portions of kaolin pipe stems. Its removal (at a thickness of roughly 0.15-0.20 ft, or 4.6-6.12 cm) revealed a soil that was similar, but without the dense amounts of mortar debris. This new stratum, Level 6, was excavated to a depth of roughly 0.90 ft (0.27 m) below surface. Level 6 was a very dark grayish brown silty loam (10YR3/2) with mottled spots of brown (10YR5/3). It included a much smaller number of small brick fragments, half of a brick, 2 pipe stem fragments, and another small fragment of kaolin (Figures 17-18). Located near the top of the stratum, these may have moved down in the soil profile due to root activity or other bioturbation. The level also was heavily dissected by

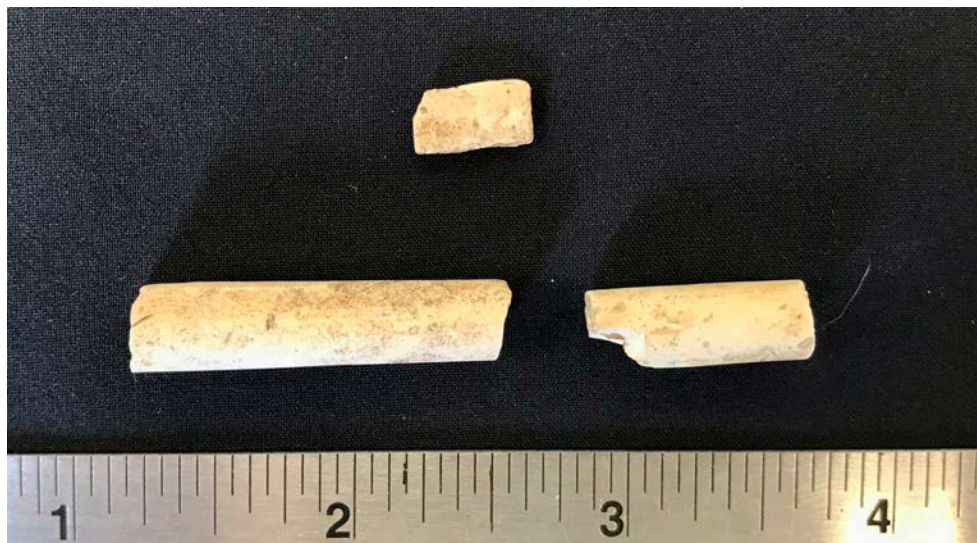
Figure 17: Kaolin pipe stem fragments (bottom) and a small fragment of kaolin (top) from Level 6.

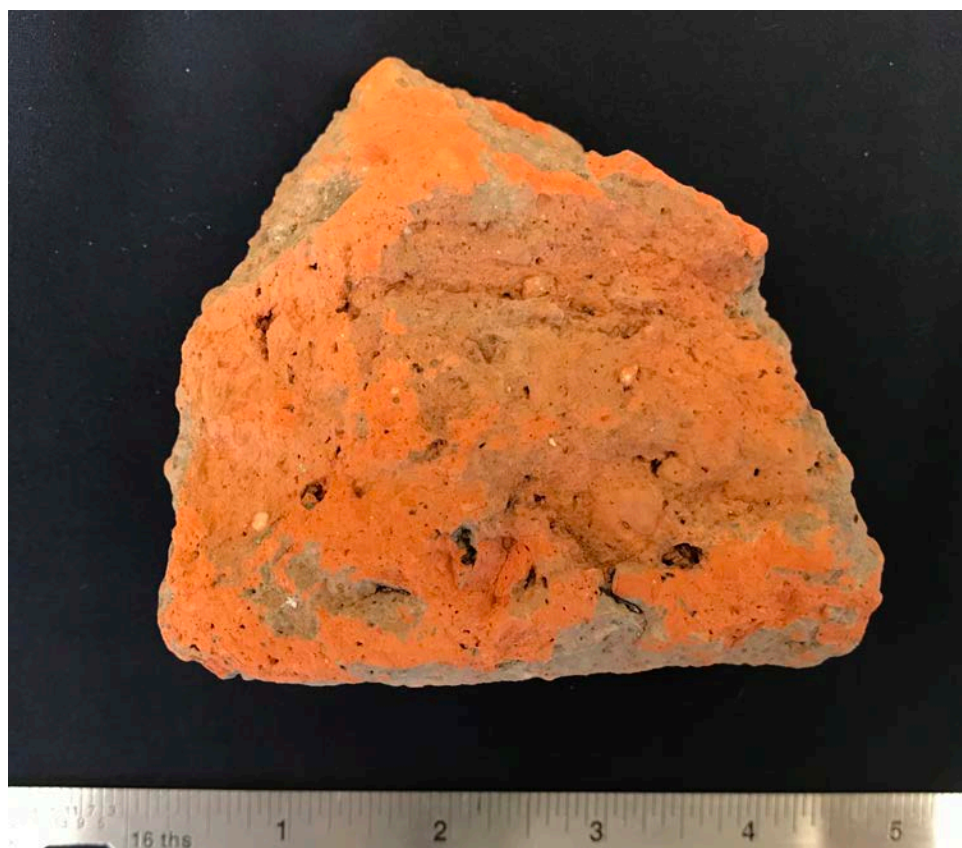
Figure 18: Brick fragment from Level 6.

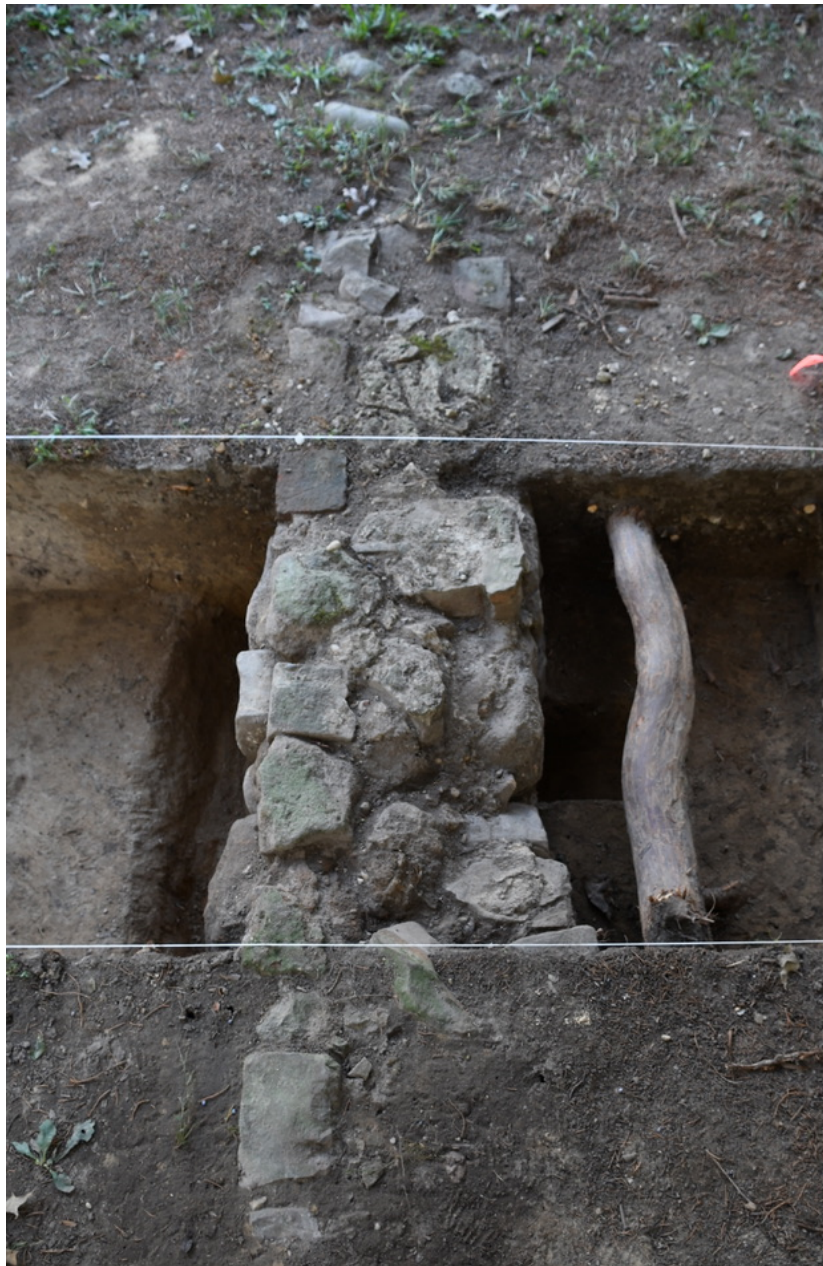
Figure 20: Top of Feature 1 wall foundation; looking east.

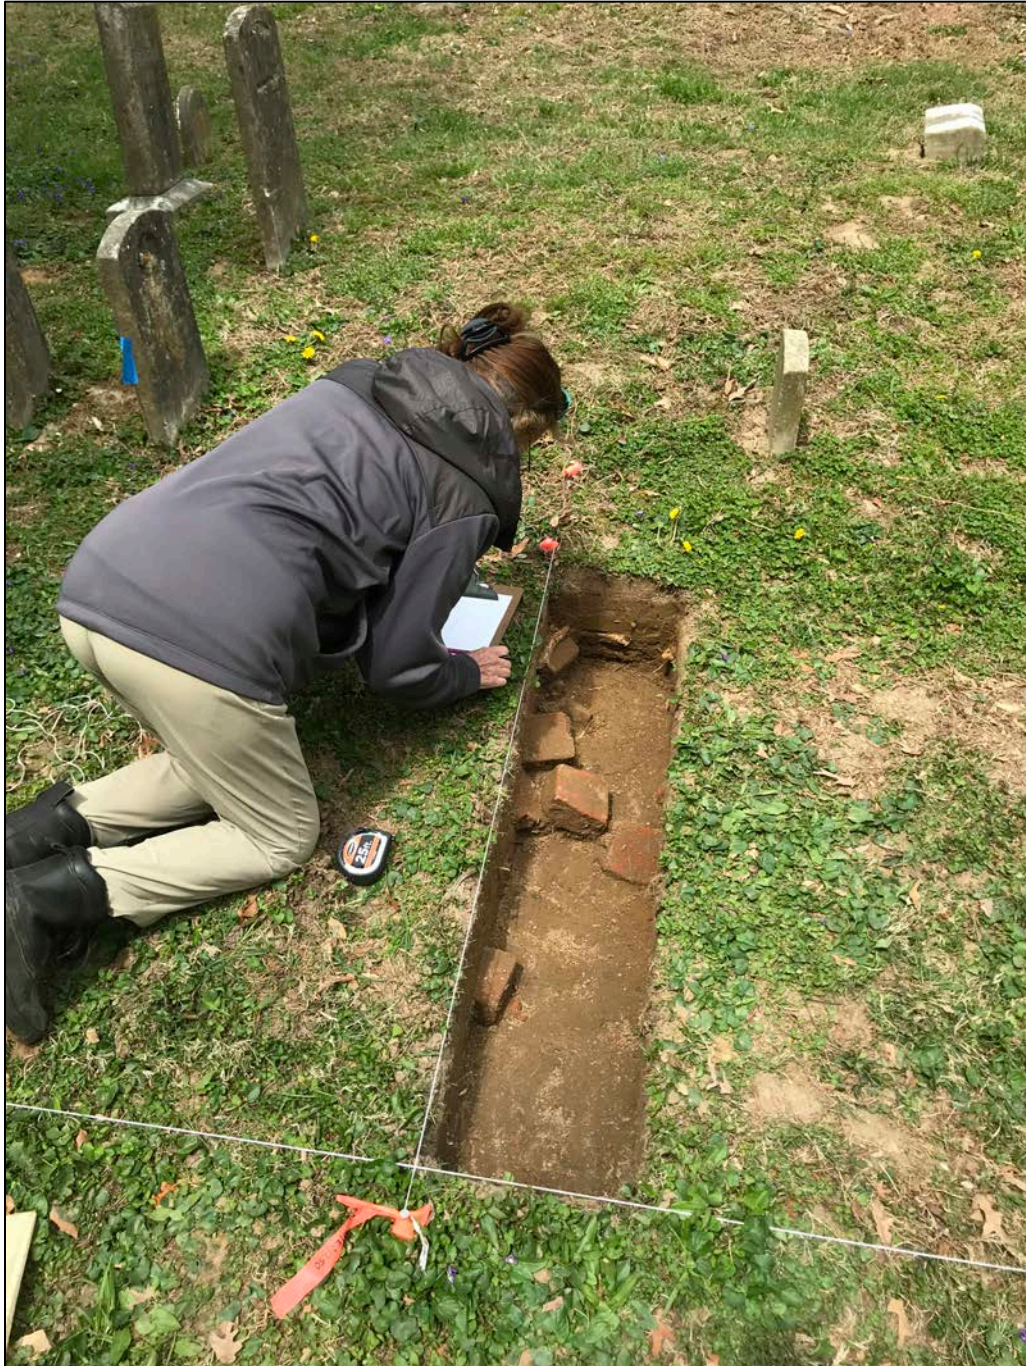
Figure 1: Excavation of Unit 2, showing disarticulated bricks being exposed, looking north.

The source of the underground obstructions was found to be several disarticulated bricks. These bricks can be seen during excavation in Figure 1. No evidence of any wall or foundation was encountered, nor were any soil disturbances indicative of an earlier wall that had been dismantled seen.

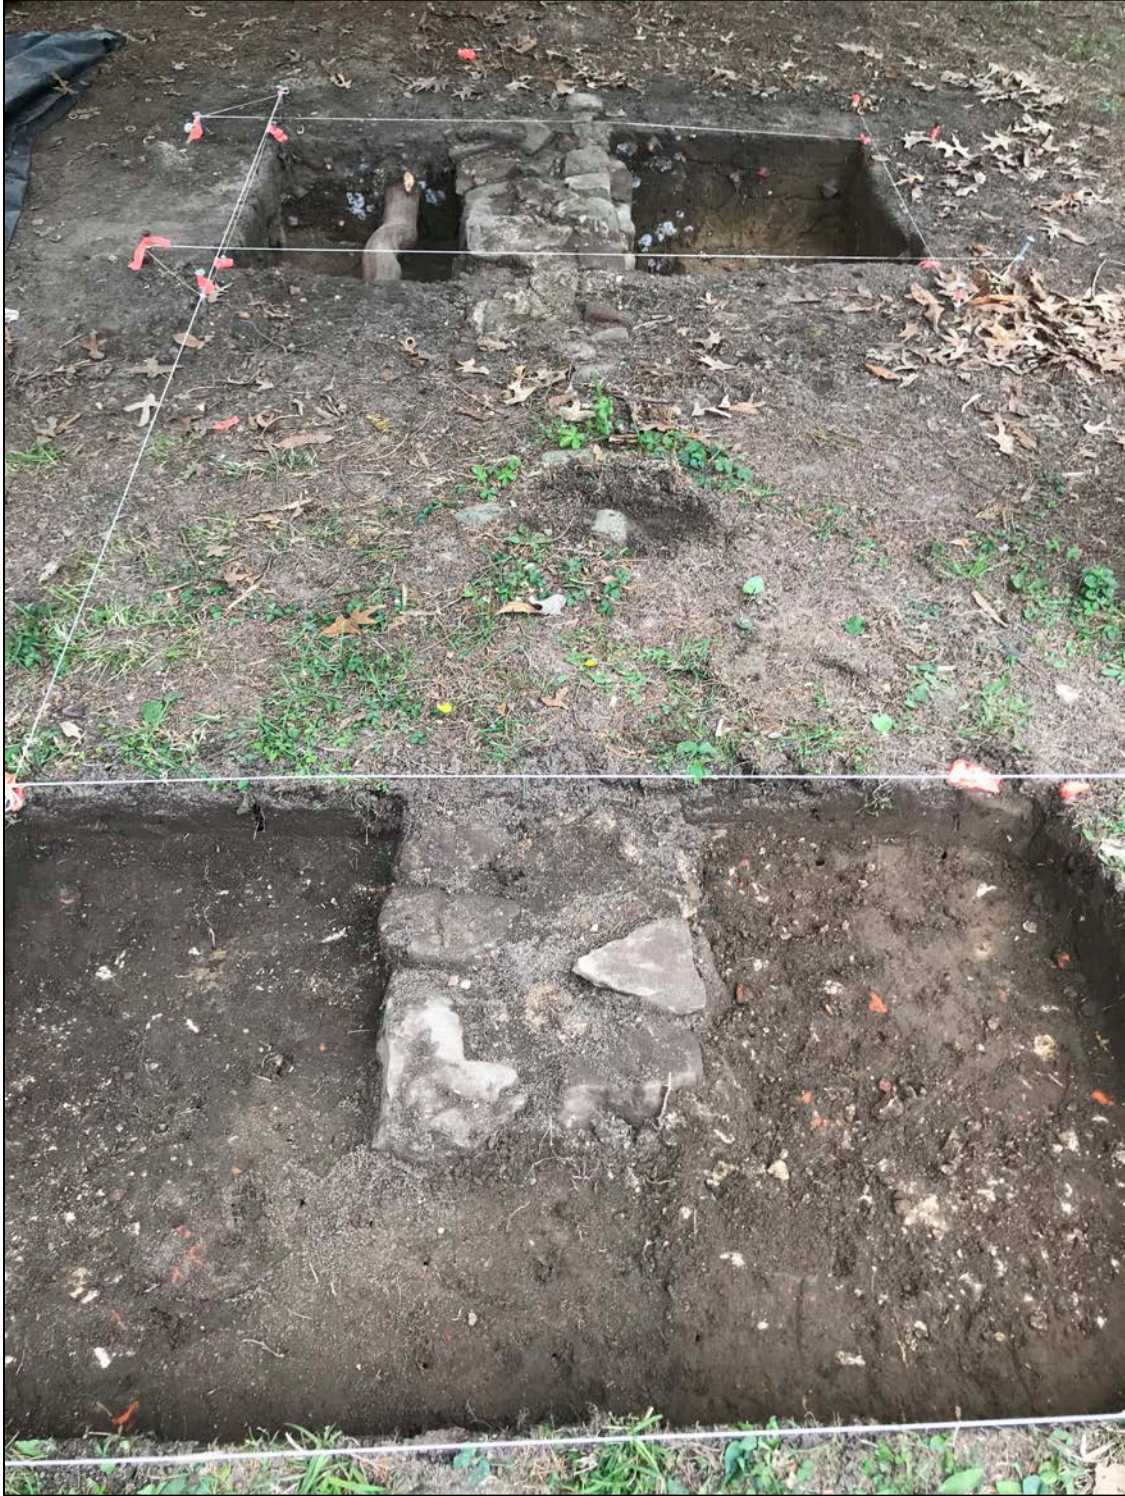
Figure 3: Units 1 (background) and 3 (foreground), looking west.

The relative positions of Units 1 and 3 are shown in Figures 2 and 3. As depicted in the plan view of Unit 3, an extension of the foundation uncovered in Unit 1 was also exposed in Unit 3. However, the wall seemed to end abruptly in the middle of the unit (see also Figure 4). There is no evidence that it turned a corner and ran to the north or south. It was not immediately clear whether this was the original terminus of the wall, but subsequent excavation revealed that the wall did indeed originally extend farther to the east, but that the foundation had been dug up and removed at some point. In other words, the abrupt end to the feature is a function of later activity, and this demolition or "robbing" probably is also the source of the rubble encountered to the east in Unit 2.

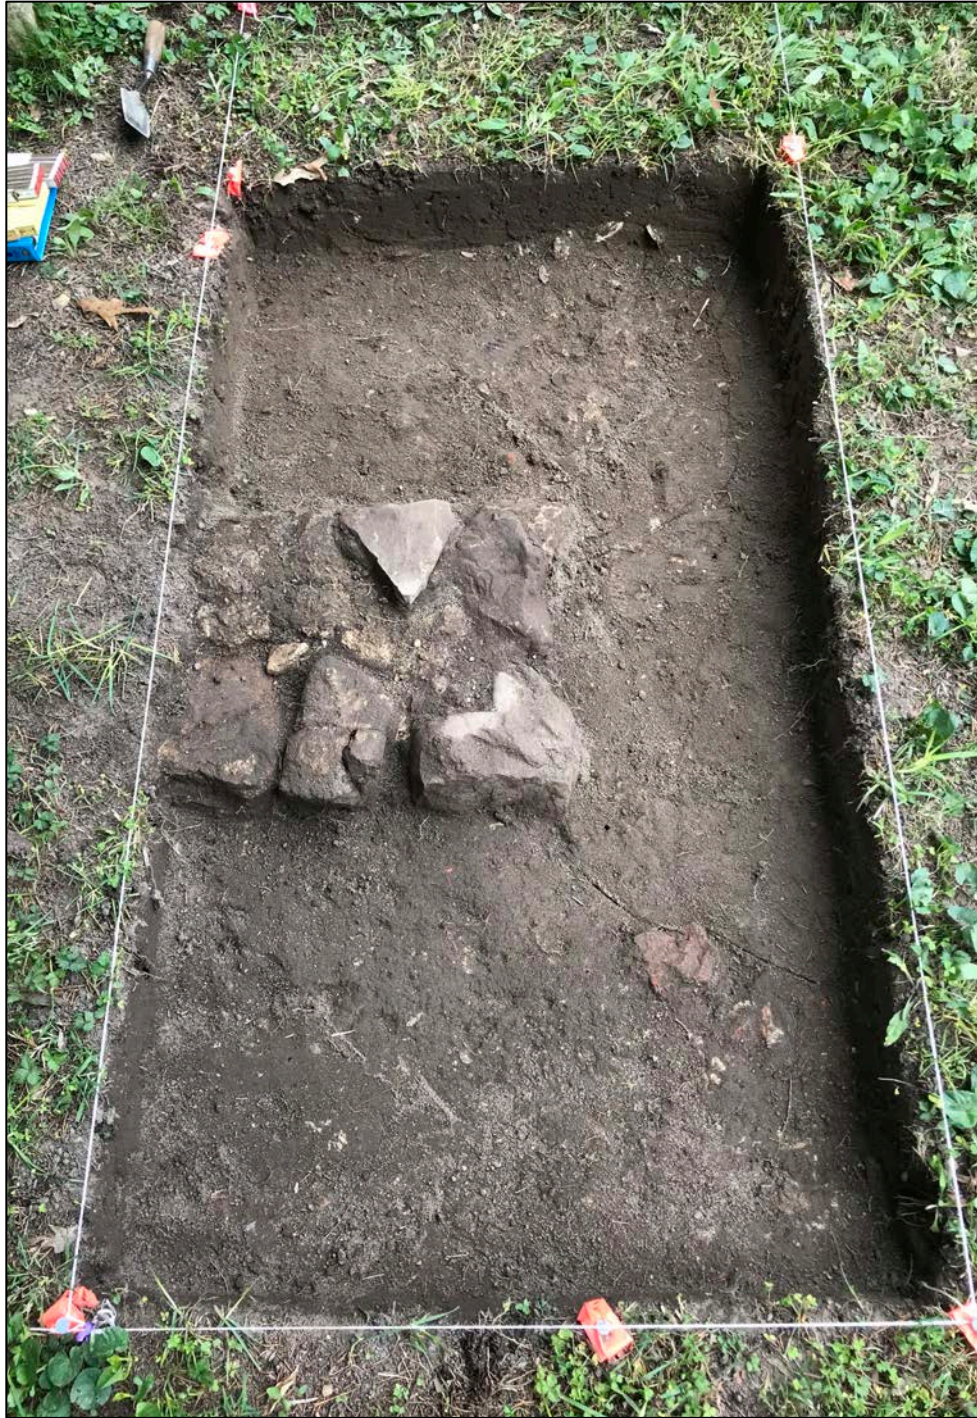
Figure 4: Unit 3 looking north, showing eastern extension of the foundation during excavation.

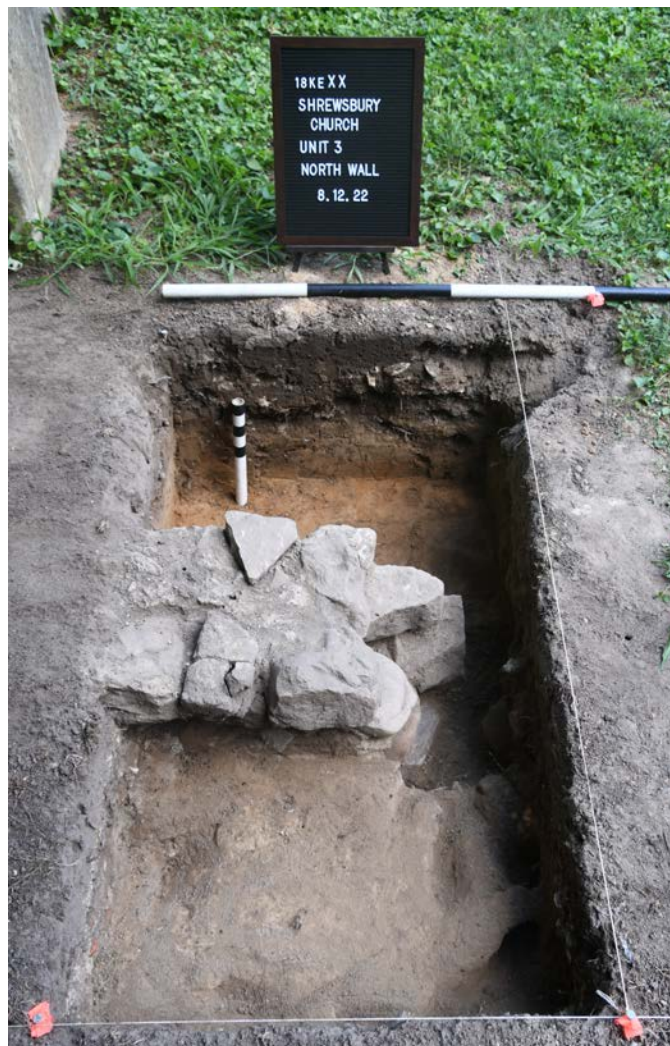
Figure 8: Unit 3 at completion of excavation, looking north.

(see Figures 7 & 8). As the north wall of the unit was being scraped clean for photography, soil spalled or flaked off of the wall, suggesting that it is disturbed. This may well be disturbed soil from the adjacent burial site.
