**ARCHAEOLOGICAL INVESTIGATIONS
AT SHREWSBURY CHURCH, 2021-2022**

**Interim Report 1 - 5 April 2022
Interim Report 2 – 31 August 2022**

**John L. Seidel, Ph.D.
Elizabeth A. Seidel**

Re: Interim Letter Report - Investigations of Foundation Remains on Church Grounds

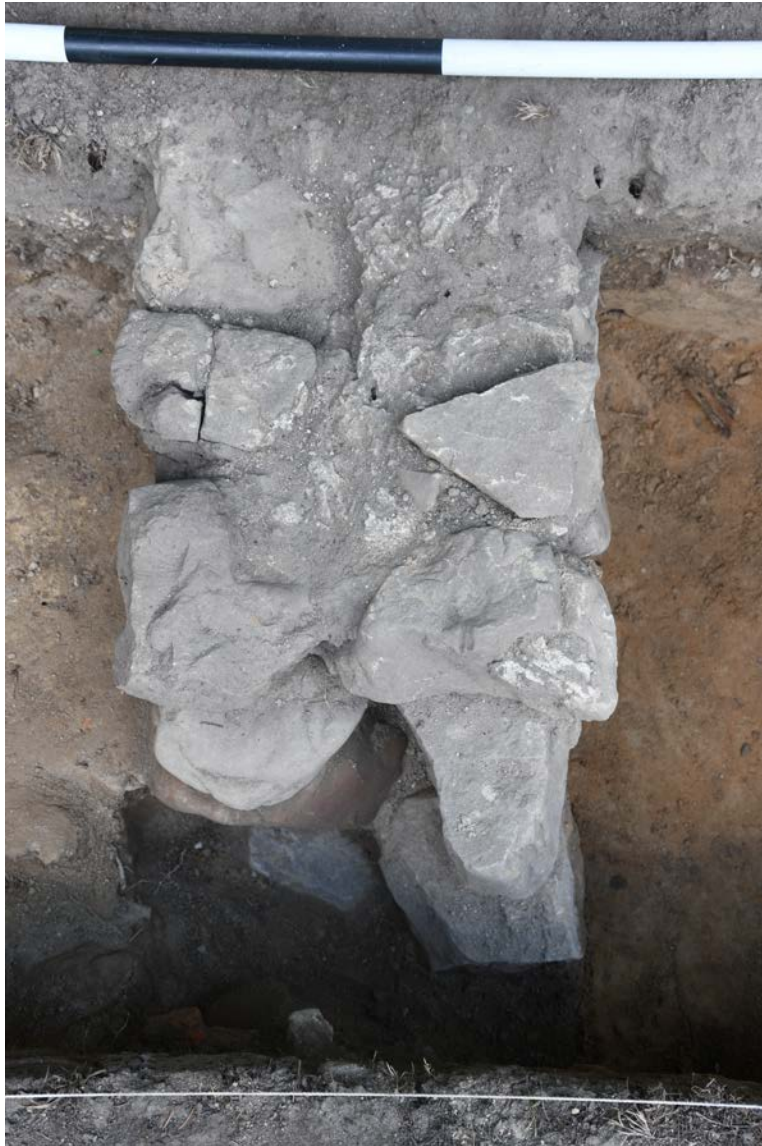
Figure 9: Unit 1 at completion of excavation , showing Feature 1 (top) and the area of the robber trench (bottom). West is at the top of the image.

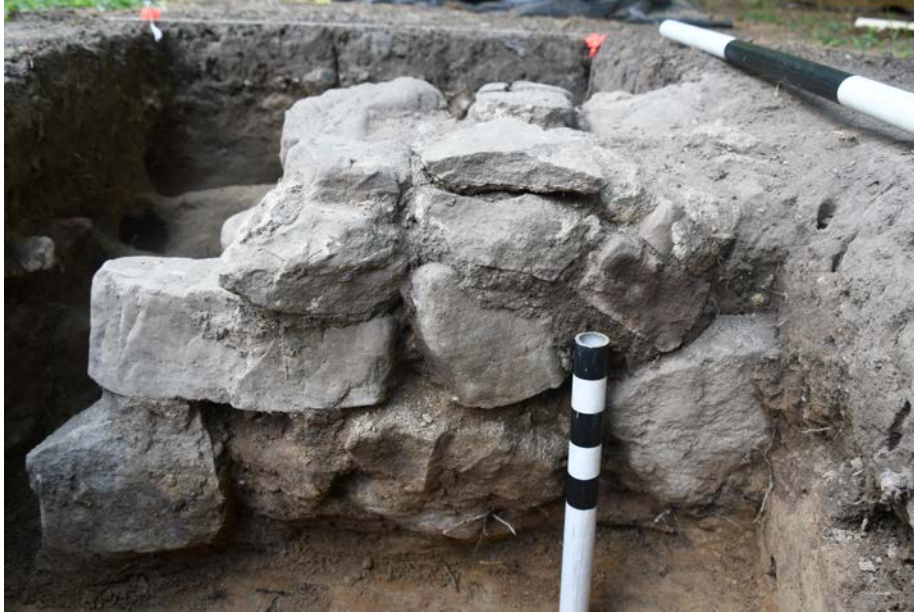
Figure 10: Unit 3, Feature 1 elevation, looking south. The soil at the bottom of the image is undisturbed and extends under the stones.

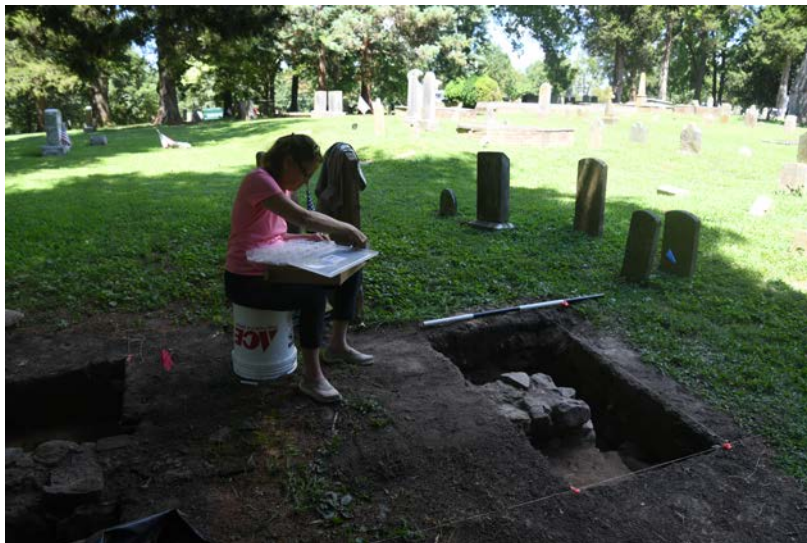
Figure 10: Unit 3 looking NE, with nearby marked graves in the background.

Following this reasoning, we considered extending the excavation another several feet to the north, but quickly ruled this out due to the proximity of marked grave sites. These can be seen in Figures 10 and 11.

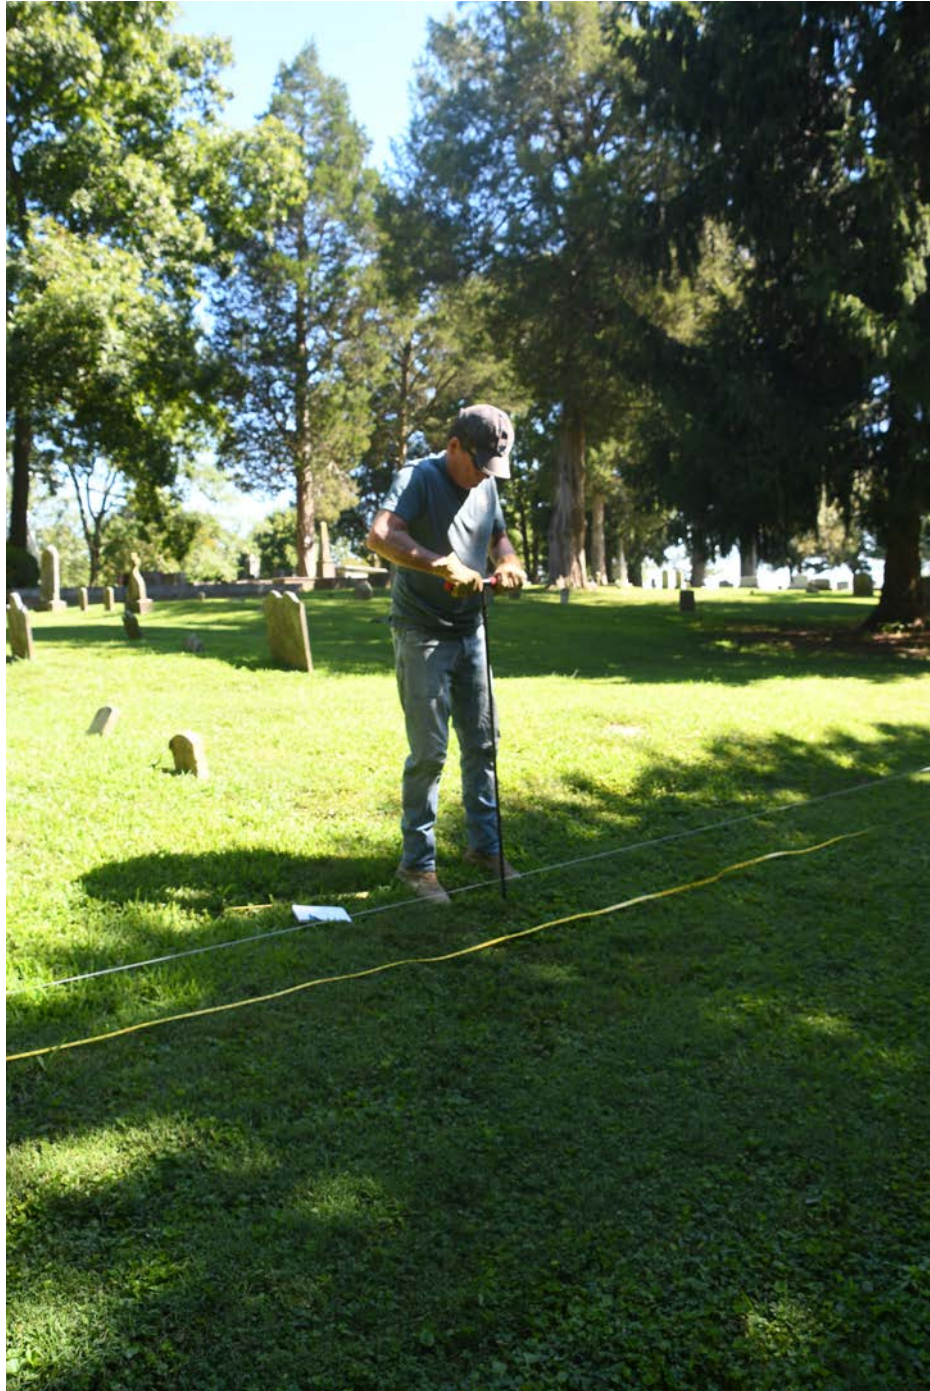
Figure 12: Probing to the east of the foundation uncovered in nits 1 & 3.

An easterly line of probes was laid out, extending 60 feet beyond the east edge of Unit 1 (by contrast, the previous probing only extended 20 feet to the east). The probe consists of a steel rod with a “t-handle” and sharp point. Pushed into the ground, the user can not only detect solid obstructions like walls and measure their depth, but also assess to some degree the nature of the soil (Figure 12).
