# VIRTUS

## PRECISION TUBE

### 422 Alloy

High performance  
alloy addresses  
formicary corrosion

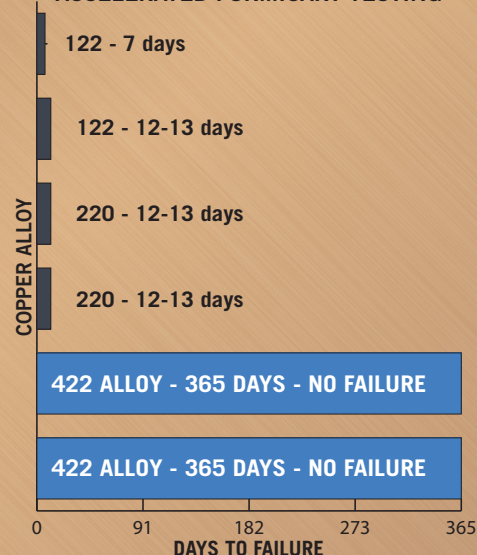
### 122 ALLOY

122 Alloy sample 125x magnification. Mounted after 7 days with failure, of accelerated formicary corrosion testing.

Formicary ("Ants Nest") corrosion has a unique morphology that appears as a wandering pit (see 122 alloy photomicrograph below). Pits are not observable to the un-aided eye. This type of corrosion only occurs in copper based alloys and in the presence of organic acids, moisture, and oxygen.
