The Journal of the Roof Consultants Institute

December 2005 • Vol. XXIII • No. 11 • \$10.00

# THE ENVIRONMENTAL BENEFITS OF A TEXAS GARDEN ROOF

By Karl A. Schaack, PE, RRC

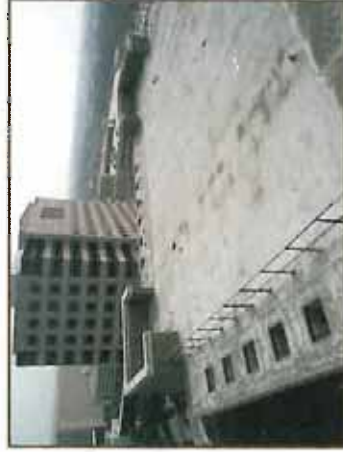
Overview of roof area prior to replacement.

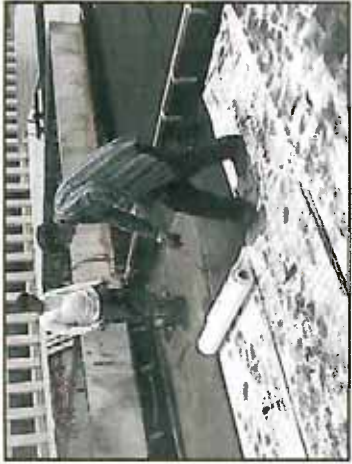
Test Plot - Quad 1.

The system provided by American Hydrotech, called “Monolithic Membrane 6125-FR,” consisted of a hot-applied rubberized asphalt reinforced with a polyester fabric. The rubberized asphalt was melted in a kettle and applied in a heated liquid form directly on top of the deck in an initial application of approximately 90-mil thickness. Polyester reinforcing fabric was embedded in the asphalt. A second layer of hot rubberized asphalt was then applied on top of the fabric at approximately 125 mils, with a resulting total membrane thickness of 215 mils. A prefabricated sheet of modified bitumen was embedded into the top layer of hot asphalt to serve as a protection mat. A 40-mil, high-density polyethylene sheet was then installed over the protection mat to serve as a root barrier. Polypropylene fiber moisture retention mat was installed on top of the root barrier. Prefabricated drain board was installed on top of the moisture retention mat. A geotextile, non-woven polypropylene filter fabric was then installed over the drain board. “Engineered soil,” consisting of expanded lightweight aggregate, sand, and compost, was placed over the filter fabric.

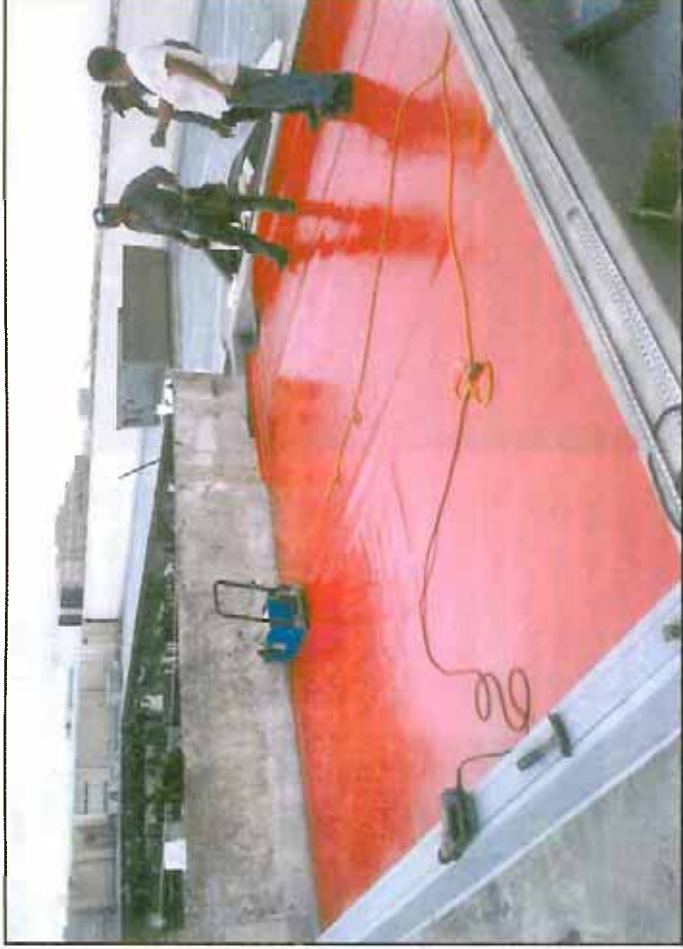
Test Plot - Quad 2.

thick. The membrane was loose-laid over the concrete deck and secured along the perimeters with a metal termination bar anchored into the concrete deck. Adjacent sheets were overlapped, and the overlapped portions were thermally fused via hot-air welding. The chemical composition of the membrane inhibits root growth, thus eliminating the need for additional root barrier mediums. Pre-fabricated drain board, consisting of a dimpled polymeric core with a filter fabric laminated to the core, was placed over the membrane. General landscaping soil was installed over the drainage board.

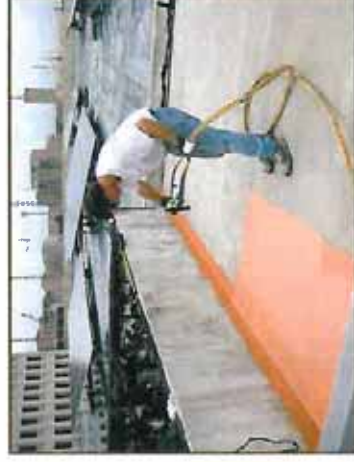
Test Plot - Quad 3.

The system provided by Grace is called “Procor Deck System 3R,” which consists of a cold-vulcanized, fluid-applied synthetic rubber membrane with a polyester reinforcing fabric. The fluid-applied waterproofing membrane consists of two parts that were site-mixed and cold-applied, using conventional spray equipment, directly on top of the concrete deck in an initial application of approximately 60-mil thickness. Reinforcing fabric was embedded in the initial application of the material, and then a second layer of liquid-applied material was spray-applied at approximately 60 mils, with a resulting membrane thickness of 120 mils. Prefabricated drainage board, consisting of a dimpled polymeric core with a filter fabric laminated to the core, was then placed on

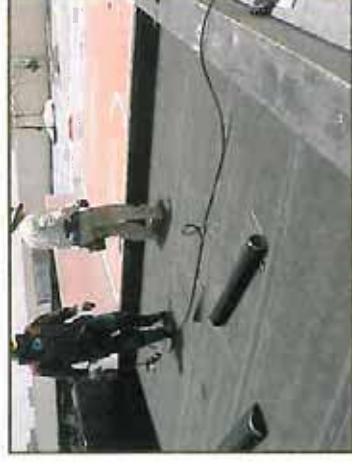
Test Plot - Quad 4.

brane is composed of a smooth-surfaced, modified bitumen, fiberglass-reinforced base ply, 110 mils thick, which was fully adhered to the concrete deck by torch-application methods; and a smooth-surfaced, modified bitumen, polyester-reinforced top ply, 160 mils thick, which was fully-adhered to the base ply via torch-application methods, with a resulting membrane thickness of 270 mils. The top surface of the top ply consists of a polymeric film that inhibits root growth. Prefabricated drain board was then placed on top of the membrane sheet. The drain board is manufactured with dimpled polymeric core with cross flow holes and nonwoven fabrics laminated to both sides of the core and the perforations in the core allow drainage. The fabric laminated to the top surface of the core has a "root barrier" embodied into the fabric that stops the initial root growth. "Engineered soil," consisting of an expanded lightweight aggregate (shale), coarse sand, pine bark humus, and compost was then placed on top of the drain board.

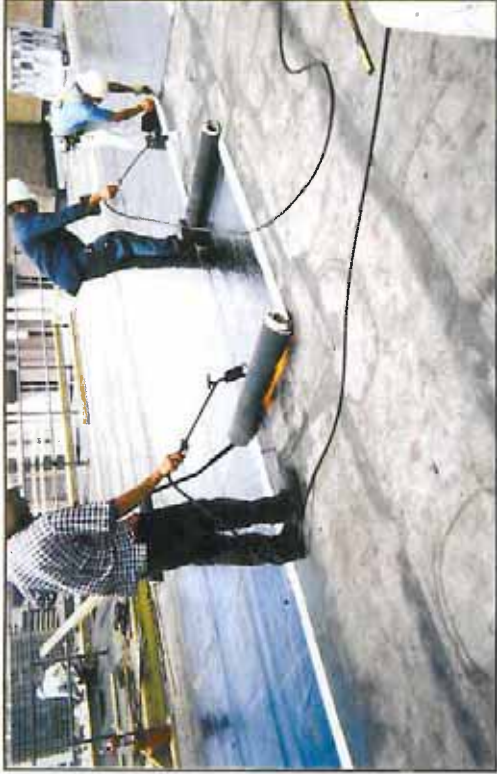
*Installation of membrane.*

The existing materials on the eastern portion of the main level were removed, and the new membrane and flashings were installed across the entire roof prior to the installation of any of the garden accessory components. The installation process was completed in the latter part of July 2003. A flood test was performed on the membrane after completion of the installation. The water for the flood-test was maintained over the membrane for 48 hours with no evidence of infiltration into the building interior. After successful completion of the flood test, the prefabricated drain panel was installed over the entire area. Adjacent panels were interlocked by nesting the perforations, and the filter fabric was overlapped by four inches.

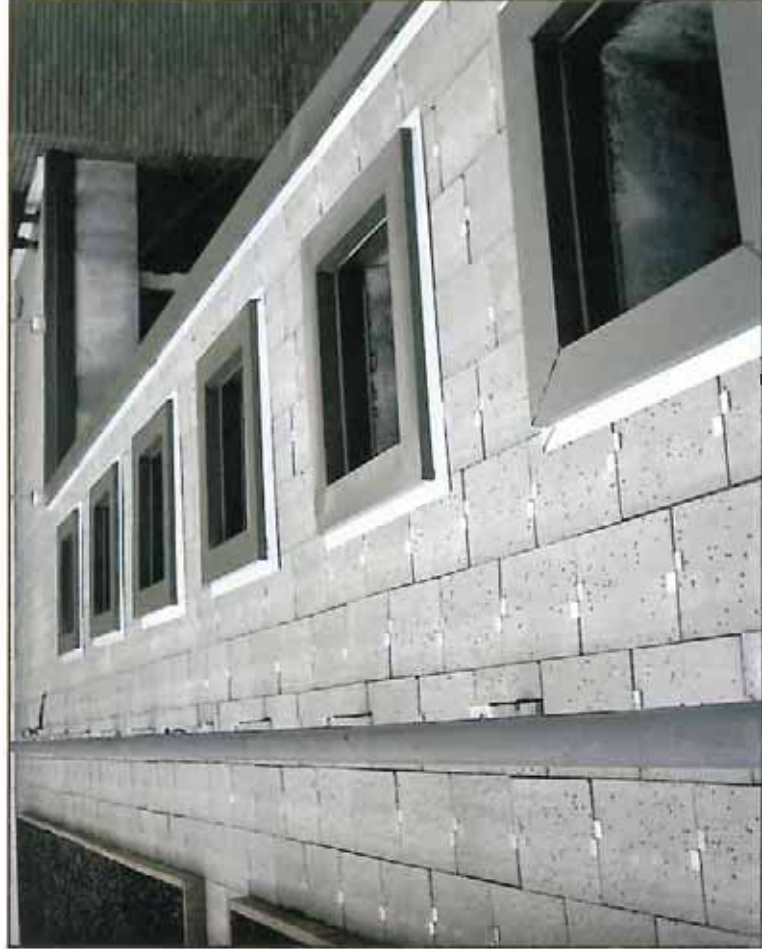
*Typical perimeter paver condition.*

The paver system consisted of interlocking concrete pavers, "Ballast Paver" by Westile. A sheet metal tab was placed between adjacent pavers to interlock the adjoining abutting sides (longitudinal side) of the pavers. The pavers were installed along the perimeter of the roof, extending inward from the edge to a distance of approximately six feet. This boundary provided several functions, including the following: provided a walking surface around the planned planting areas; provided protection along the perimeters against wind erosion/scour of the soil and fire; and pro-

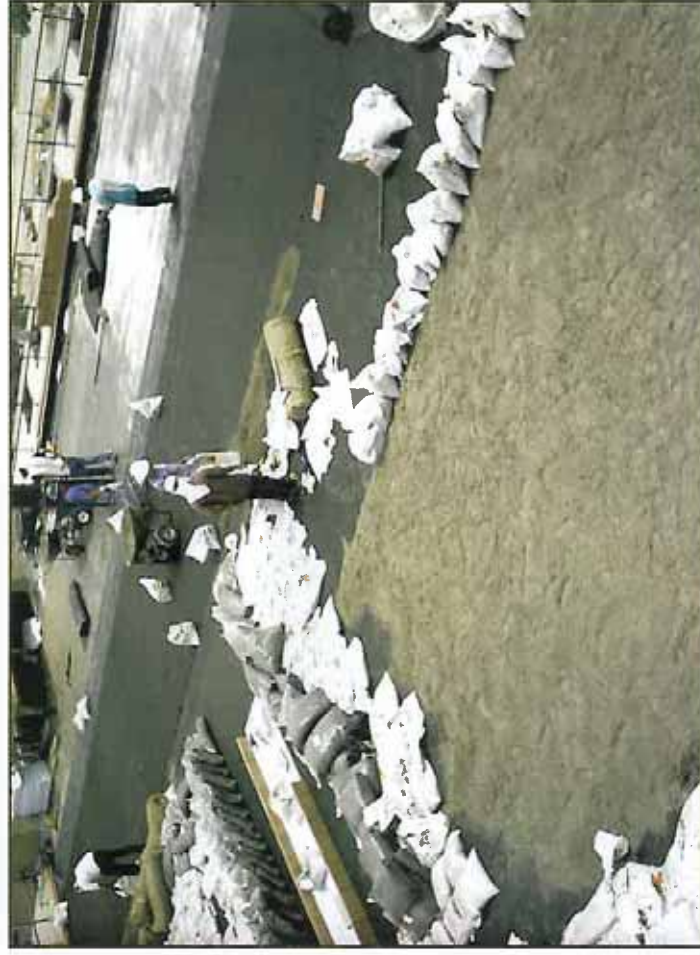
Placement of soil.

The roofing contractor found and utilized a local resource for the engineered soil. The “engineered” growing medium (soil) was pre-mixed and bagged by the LETCO Group L.P. of Houston, Texas. The soil was packaged in 4,000 40-pound bags delivered on 68 pallets to the site and raised to the roof via a hoist by the contractor. The constituents of the soil provided by LETCO were as follows: 1) an expanded shale, “Tru-Gro” supplied by TXI in Streetman, Texas; 2) coarse sand complying with specifications of the United States Golf Association; 3) compost based on horse manure blended with aged pine bark

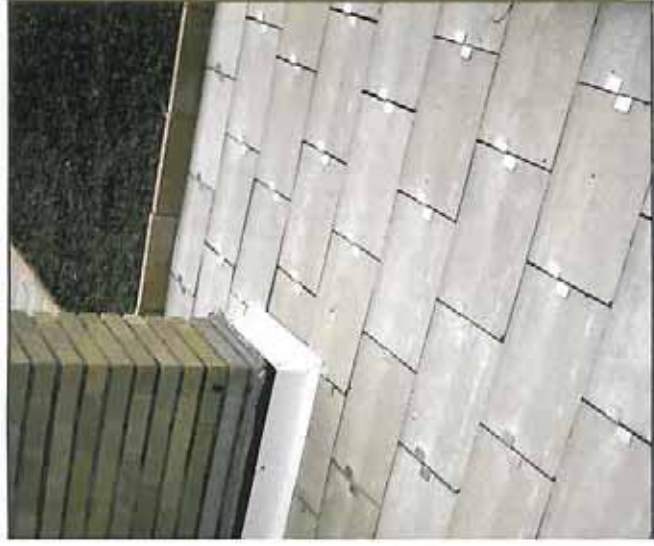
Typical wall flashing.

The sheet metal fabrications located at the low-profile roof edge and the counter-flashing assemblies along the parapet walls were extended over the top surface of the adjacent pavers to provide additional wind-uplift resistance. Concrete pavers were installed over a filter fabric that was installed over two inches of extruded polystyrene insulation board placed over the prefabricated drain panel. The board had ribs or channels on the top surface and drainage channels along the edges on the bottom surface of the board, "Ribbed," Roof-

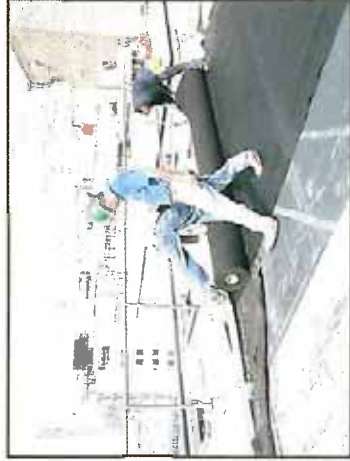
*Installation of drain board.*

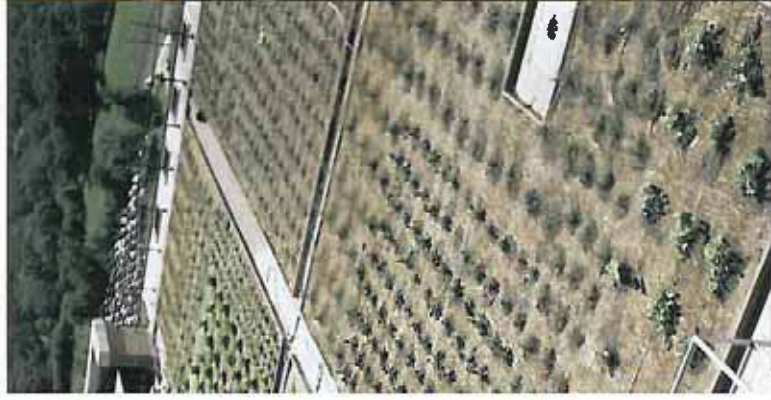
Completed roof in 2003.

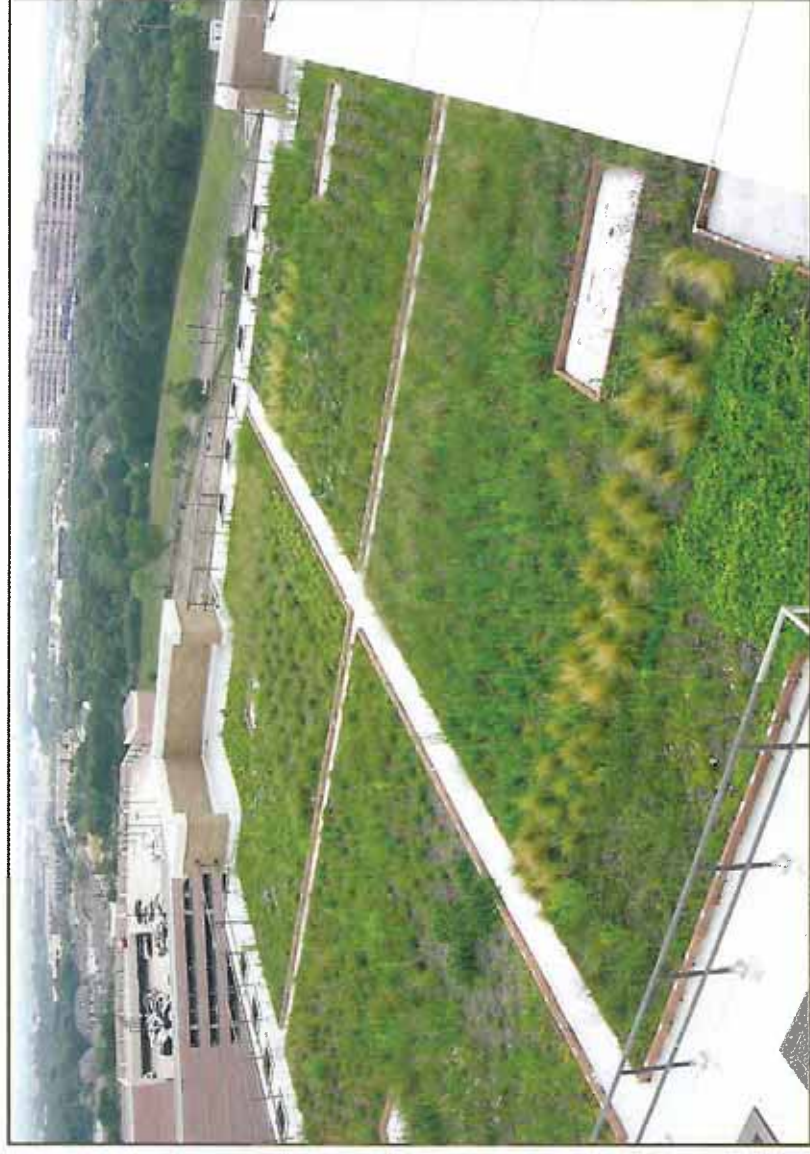
Overview of roof in 2005.
