International Roofing Expo

March 8, 2023 -- Dallas, TX

NRCA update on roofing technical issues

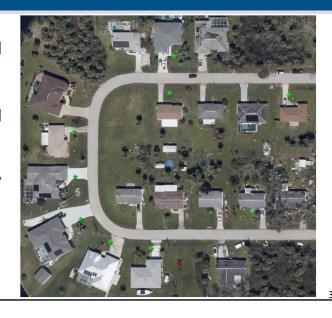
Hurricane Ian – Roof Covering Performance Data Collected

- Data on roof age was collected in clusters throughout the impacted areas
- Roof age determined by parcel data and analysis of permit data for selected areas
 - ★ Roof coverings less than 7 years old

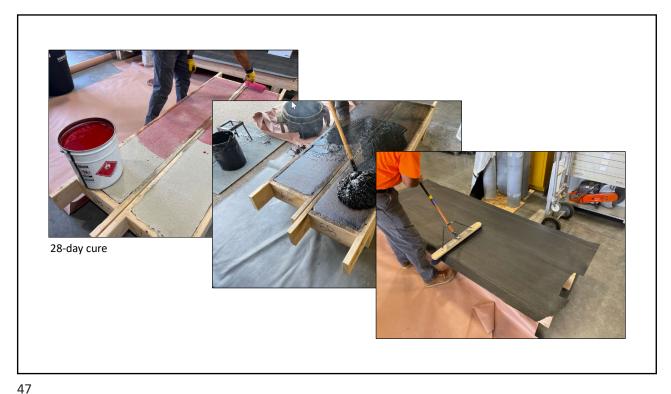
What we tested...

Vapor retarder adhesion testing

- 2-ply asphalt BUR membrane
- Manufacturer A-SA vapor retarder
- Manufacturer B-SA vapor retarder
- Manufacturer C-SA vapor retarder
- Manufacturer D-SA vapor retarder

Sample conditioning After vapor retarder application

- Conditioned for 60-days
- One set of each at standard laboratory conditions
- Other set of each at a 30 F temperature differential
 - -The temperature differential creates an upward vapor pressure drive

Sample	Tested pull resistance		Differ	ence
	Lab. conditions 60-day conditioning (Average of 5 specimens)	Vapor drive 60-day conditioning (Average of 5 specimens)	Differential	Percent differential
2-ply built-up membrane	1,421 psf	833 psf	-588 psf	-41%

- Results vary
- For 4 of 5 samples, vapor drive conditioning resulted in lower values, but Manufacture 3-SA VR is higher
- All results greater than 90 psf (i.e., FM 1-90)
