Epitaph of a Cracking Hardband[©]

"All cracked up.... & Buried in the Mud"

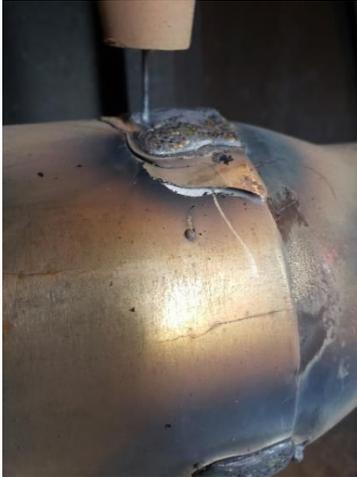
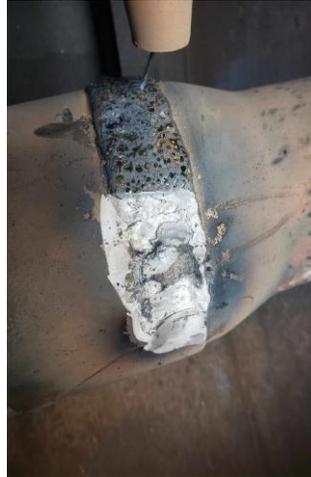
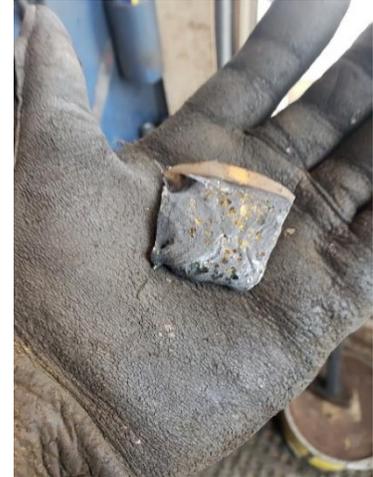
As shown in the above photos the “delamination” of the current hardband from the previous hardband verifies that the previous hardband is not a “true” non-cracking hardband wire. The most likely culprit is an unbalanced and/or unstable chemistry from the previous hardband that begins to show its true properties after a 2nd or 3rd application.

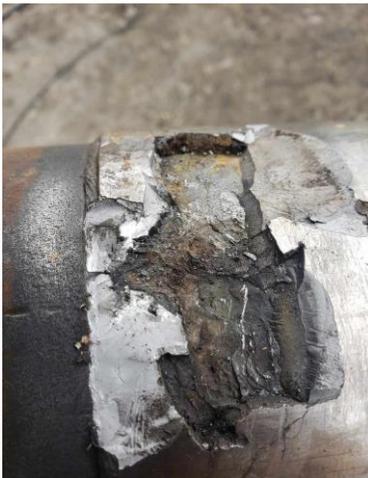
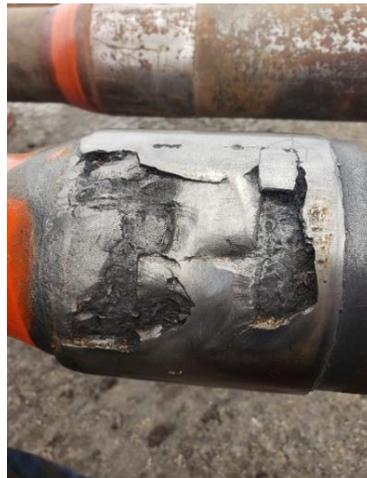
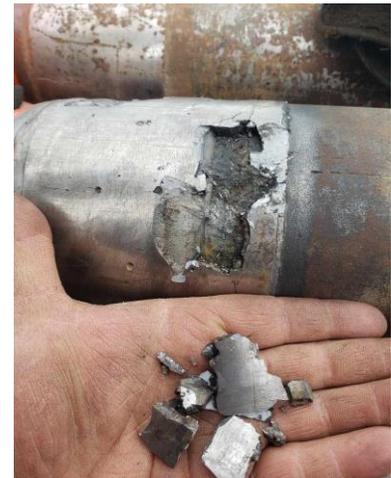
Upon further investigation of the above, it was noted that the under-bead delamination was not only limited to the current hardband application. The delamination was presenting itself all the way down to the parent material of the heavy weight tool joint and potentially into the tool joint itself.

As the delaminated (or spalled) fragments of hardband have to go someplace, they are captured in the drilling mud and screens, and brought to the surface. The problem is that depending on the size of these pieces of hardband alloy, there are multiple issues that can arise as this debris works its way to the surface. These fragments have a hardness of ~60RC, if they get stuck in between the tube/TJ and the casing, they can put gouges into either and cause major damage. The spalled hardband can also cause major damage specific components to the BOP, etc. Even fishing for loose pieces is expensive rig time.

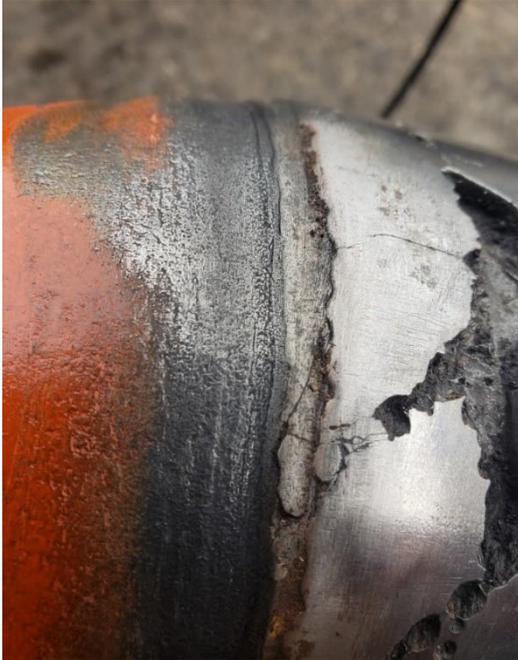
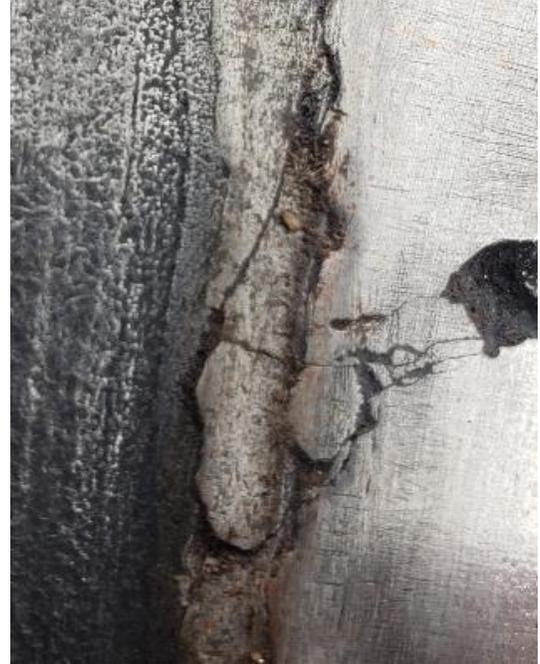
The below pictures show that the cracking of the hardband goes all the way to below the first pass of the original hardband when it was applied to the heavyweight pipe.

The above pictures show that not only can the delamination (spalling) develop between the second and/or third layer, **BUT** the migration of the cracks can propagate into the initial layer of Hardbanding alloy.... and possibly even into the tool joint itself. When delamination (spalling) happens, the stated “casing friendly” hardband wire has just become a milling tool, due to the sharp edges of the delaminated fragments of hardbanding. In addition, the debris from the spalling hardband will most likely get caught in the screens or they will have to be fished out.
