The Journal of the Roof Consultants Institute

THE ENVIRONMENTAL BENEFITS OF A TEXAS GARDEN ROOF

By Karl A. Schaack, PE, RRC

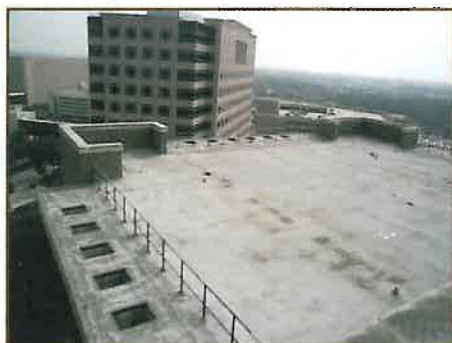
Overview of roof area prior to replacement.

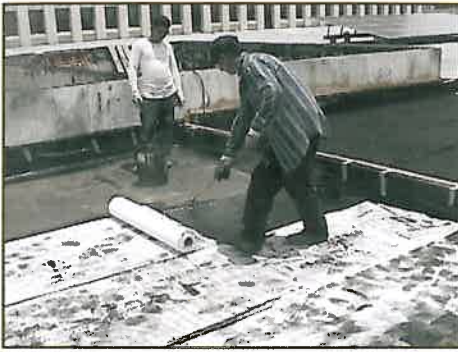
Test Plot - Quad 1.

The system provided by American Hydrotech, called “Monolithic Membrane 6125-FR,” consisted of a hot-applied rubberized asphalt reinforced with a polyester fabric. The rubberized asphalt was melted in a kettle and applied in a heated liquid form directly on top of the deck in an initial application of approximately 90-mil thickness. Polyester reinforcing fabric was embedded in the asphalt. A second layer of hot rubberized asphalt was then applied on top of the fabric at approximately 125 mils, with a resulting total membrane thickness of 215 mils. A prefabricated sheet of modified bitumen was embedded into the top layer of hot asphalt to serve as a protection mat. A 40-mil, high-density polyethylene sheet was then installed over the protection mat to serve as a root barrier. Polypropylene fiber moisture retention mat was installed on top of the root barrier. Prefabricated drain board was installed on top of the moisture retention mat. A geotextile, non-woven polypropylene filter fabric was then installed over the drain board. “Engineered soil,” consisting of expanded lightweight aggregate, sand, and compost, was placed over the filter fabric.

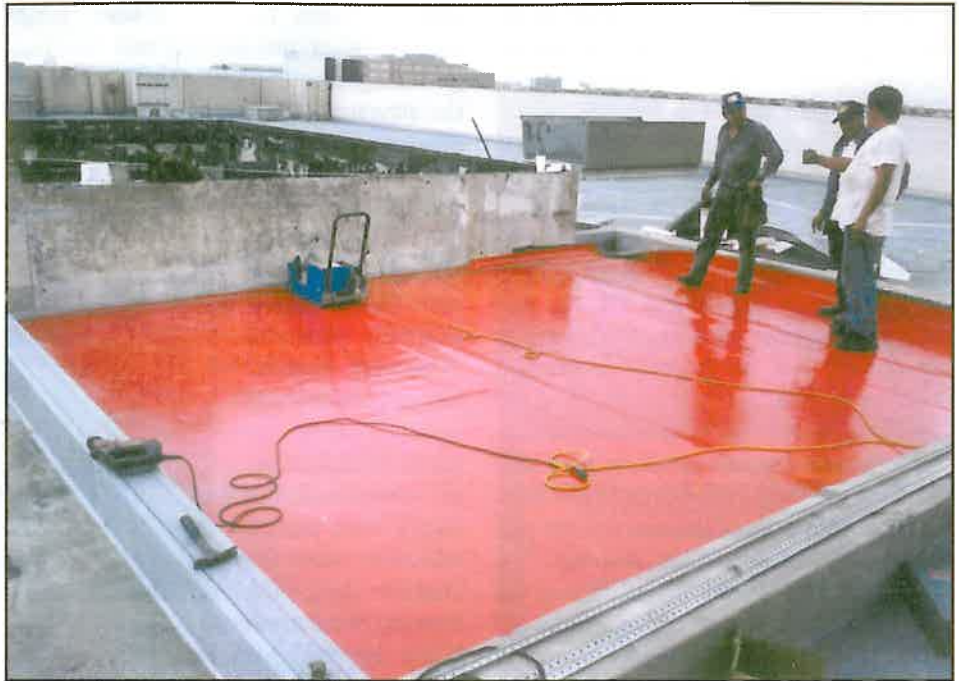
Test Plot - Quad 2.

thick. The membrane was loose-laid over the concrete deck and secured along the perimeters with a metal termination bar anchored into the concrete deck. Adjacent sheets were overlapped, and the overlapped portions were thermally fused via hot-air welding. The chemical composition of the membrane inhibits root growth, thus eliminating the need for additional root barrier mediums. Pre-fabricated drain board, consisting of a dimpled polymeric core with a filter fabric laminated to the core, was placed over the membrane. General landscaping soil was installed over the drainage board.

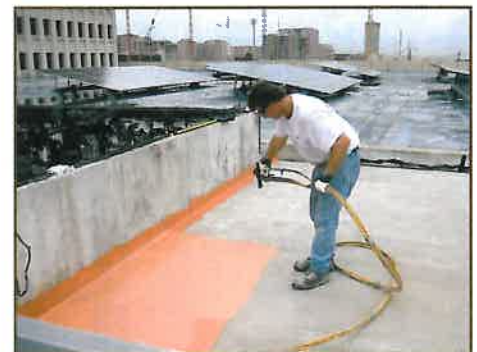
Test Plot - Quad 3.

The system provided by Grace is called “Procor Deck System 3R,” which consists of a cold-vulcanized, fluid-applied synthetic rubber membrane with a polyester reinforcing fabric. The fluid-applied waterproofing membrane consists of two parts that were site-mixed and cold-applied, using conventional spray equipment, directly on top of the concrete deck in an initial application of approximately 60-mil thickness. Reinforcing fabric was embedded in the initial application of the material, and then a second layer of liquid-applied material was spray-applied at approximately 60 mils, with a resulting membrane thickness of 120 mils. Prefabricated drainage board, consisting of a dimpled polymeric core with a filter fabric laminated to the core, was then placed on

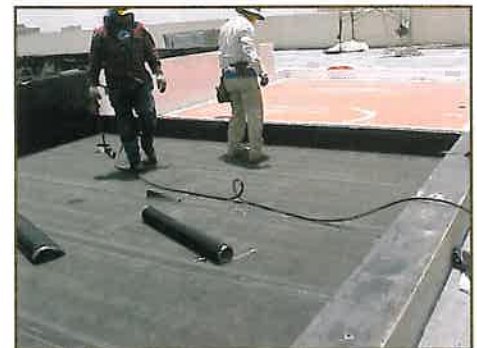
Test Plot - Quad 4.

brane is composed of a smooth-surfaced, modified bitumen, fiberglass-reinforced base ply, 110 mils thick, which was fully-adhered to the concrete deck by torch-application methods; and a smooth-surfaced, modified bitumen, polyester-reinforced top ply, 160 mils thick, which was fully-adhered to the base ply via torch-application methods, with a resulting membrane thickness of 270 mils. The top surface of the top ply consists of a polymeric film that inhibits root growth. Prefabricated drain board was then placed on top of the membrane sheet. The drain board is manufactured with dimpled polymeric core with cross flow holes and nonwoven fabrics laminated to both sides of the core and the perforations in the core allow drainage. The fabric laminated to the top surface of the core has a "root barrier" embodied into the fabric that stops the initial root growth. "Engineered soil," consisting of an expanded lightweight aggregate (shale), coarse sand, pine bark humus, and compost was then placed on top of the drain board.

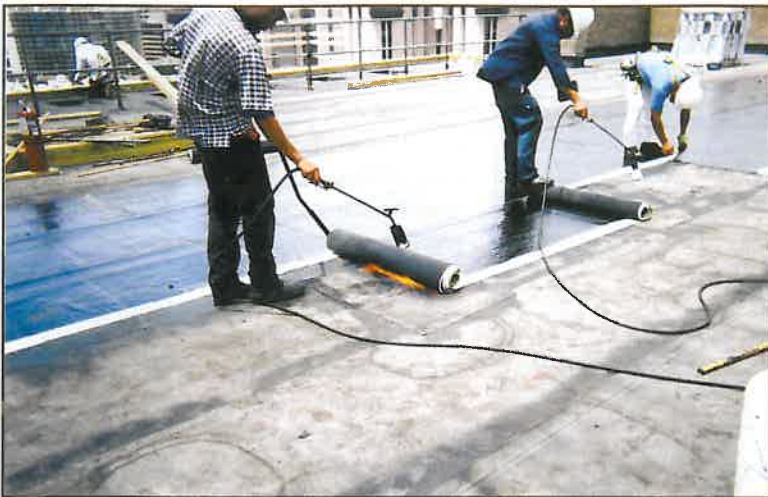
Installation of membrane.

The existing materials on the eastern portion of the main level were removed, and the new membrane and flashings were installed across the entire roof prior to the installation of any of the garden accessory components. The installation process was completed in the latter part of July 2003. A flood test was performed on the membrane after completion of the installation. The water for the flood-test was maintained over the membrane for 48 hours with no evidence of infiltration into the building interior. After successful completion of the flood test, the prefabricated drain panel was installed over the entire area. Adjacent panels were interlocked by nesting the perforations, and the filter fabric was overlapped by four inches.

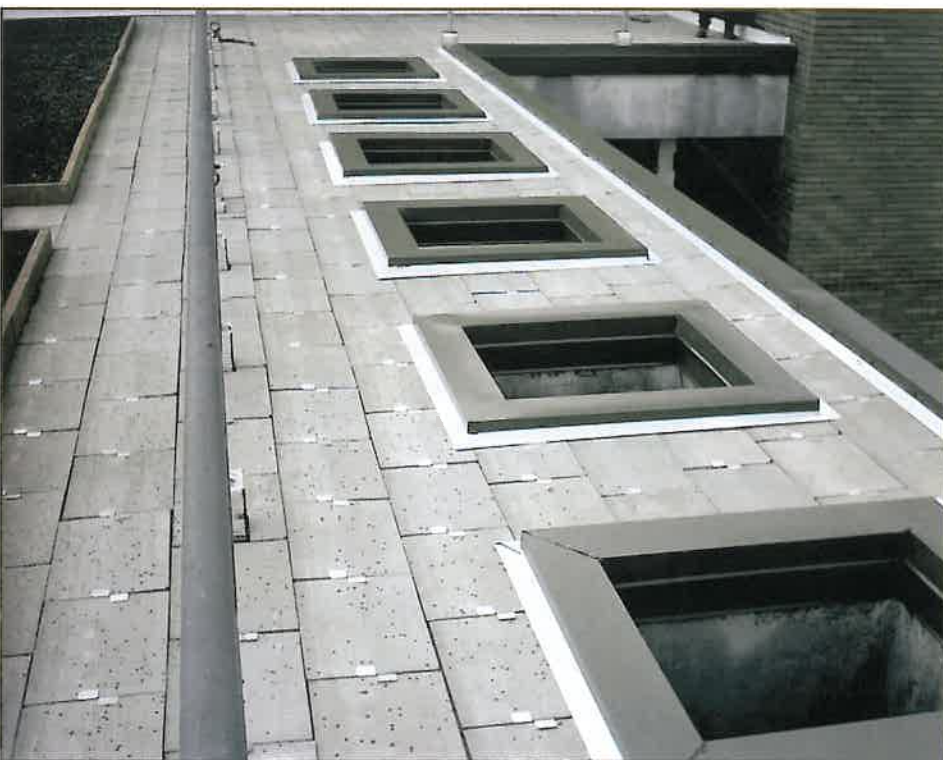
Typical perimeter paver condition.

The paver system consisted of interlocking concrete pavers, "Ballast Paver" by Westile. A sheet metal tab was placed between adjacent pavers to interlock the adjoining abutting sides (longitudinal side) of the pavers. The pavers were installed along the perimeter of the roof, extending inward from the edge to a distance of approximately six feet. This boundary provided several functions, including the following: provided a walking surface around the planned planting areas; provided protection along the perimeters against wind erosion/scour of the soil and fire; and pro-

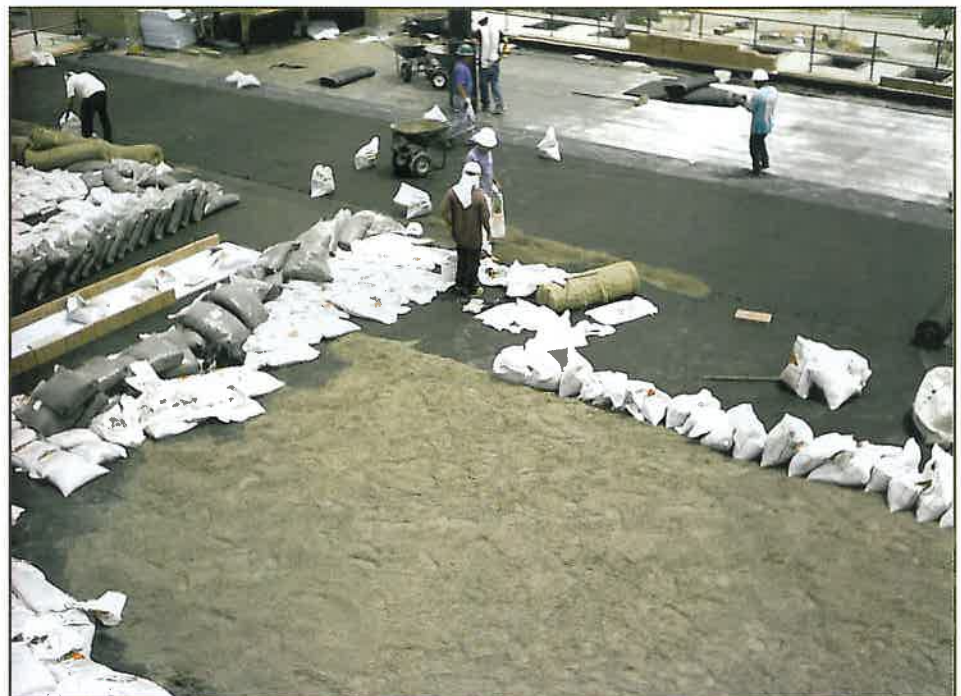
Placement of soil.

The roofing contractor found and utilized a local resource for the engineered soil. The "engineered" growing medium (soil) was pre-mixed and bagged by the LETCO Group L.P. of Houston, Texas. The soil was packaged in 4,000 40-pound bags delivered on 68 pallets to the site and raised to the roof via a hoist by the contractor. The constituents of the soil provided by LETCO were as follows: 1) an expanded shale, "Tru-Gro" supplied by TXI in Streetman, Texas; 2) coarse sand complying with specifications of the United States Golf Association; 3) compost based on horse manure blended with aged pine bark

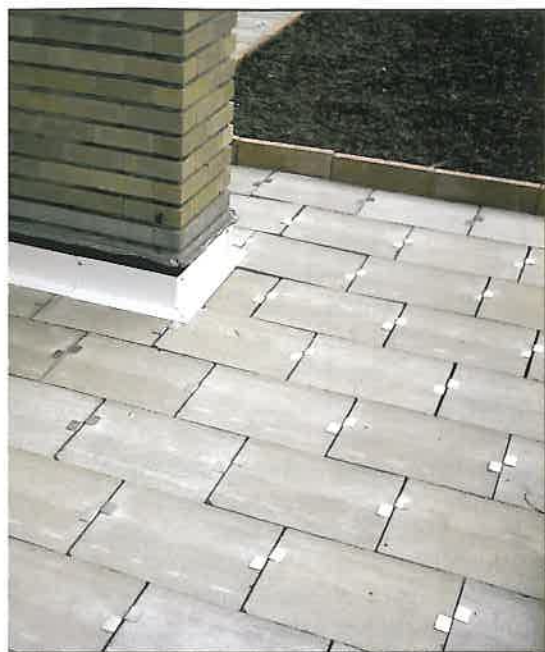
Typical wall flashing.

The sheet metal fabrications located at the low-profile roof edge and the counter-flashing assemblies along the parapet walls were extended over the top surface of the adjacent pavers to provide additional wind-uplift resistance. Concrete pavers were installed over a filter fabric that was installed over two inches of extruded polystyrene insulation board placed over the prefabricated drain panel. The board had ribs or channels on the top surface and drainage channels along the edges on the bottom surface of the board, "Ribbed," Roof-

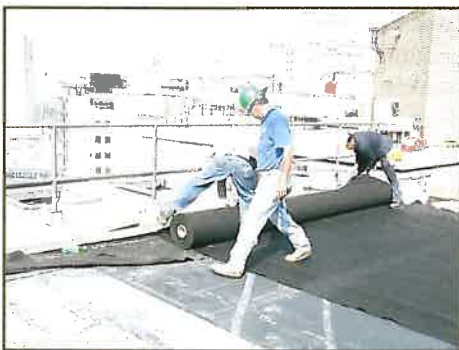
Installation of drain board.

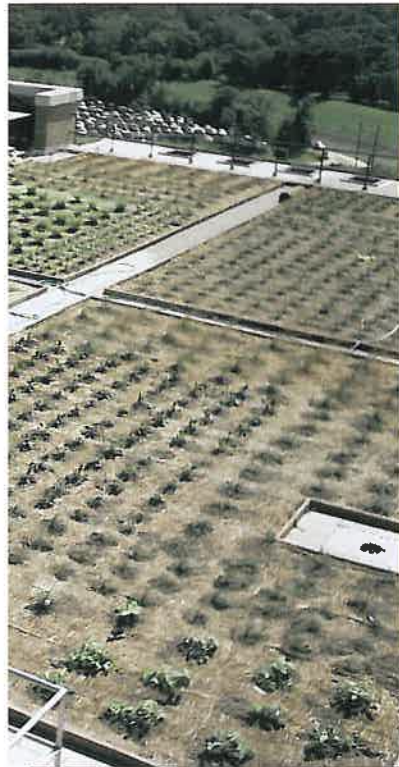
Completed roof in 2003.

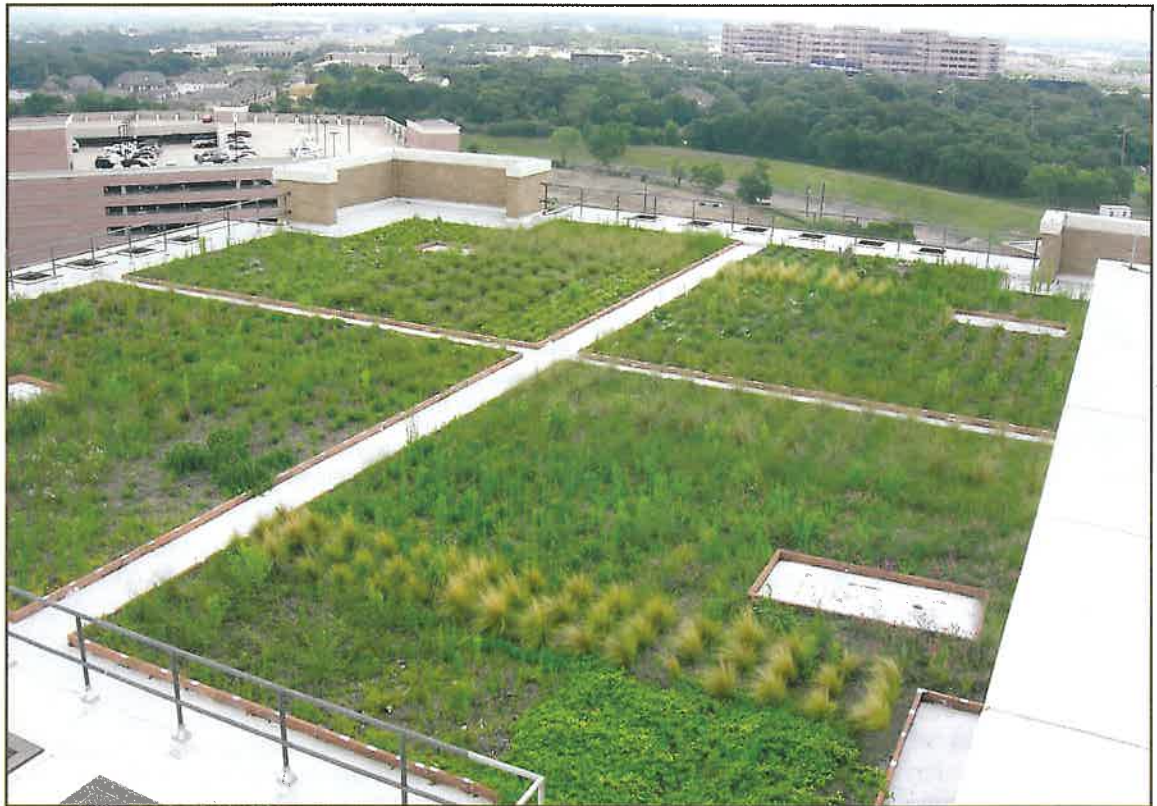
Overview of roof in 2005.
