Condon Elementary School

Structural Data Gaps Evaluation of Existing Building

Gary Livermore, PE, Architect
Livermore Architecture & Engineering

February 8, 2024
Project Number: 223083.00

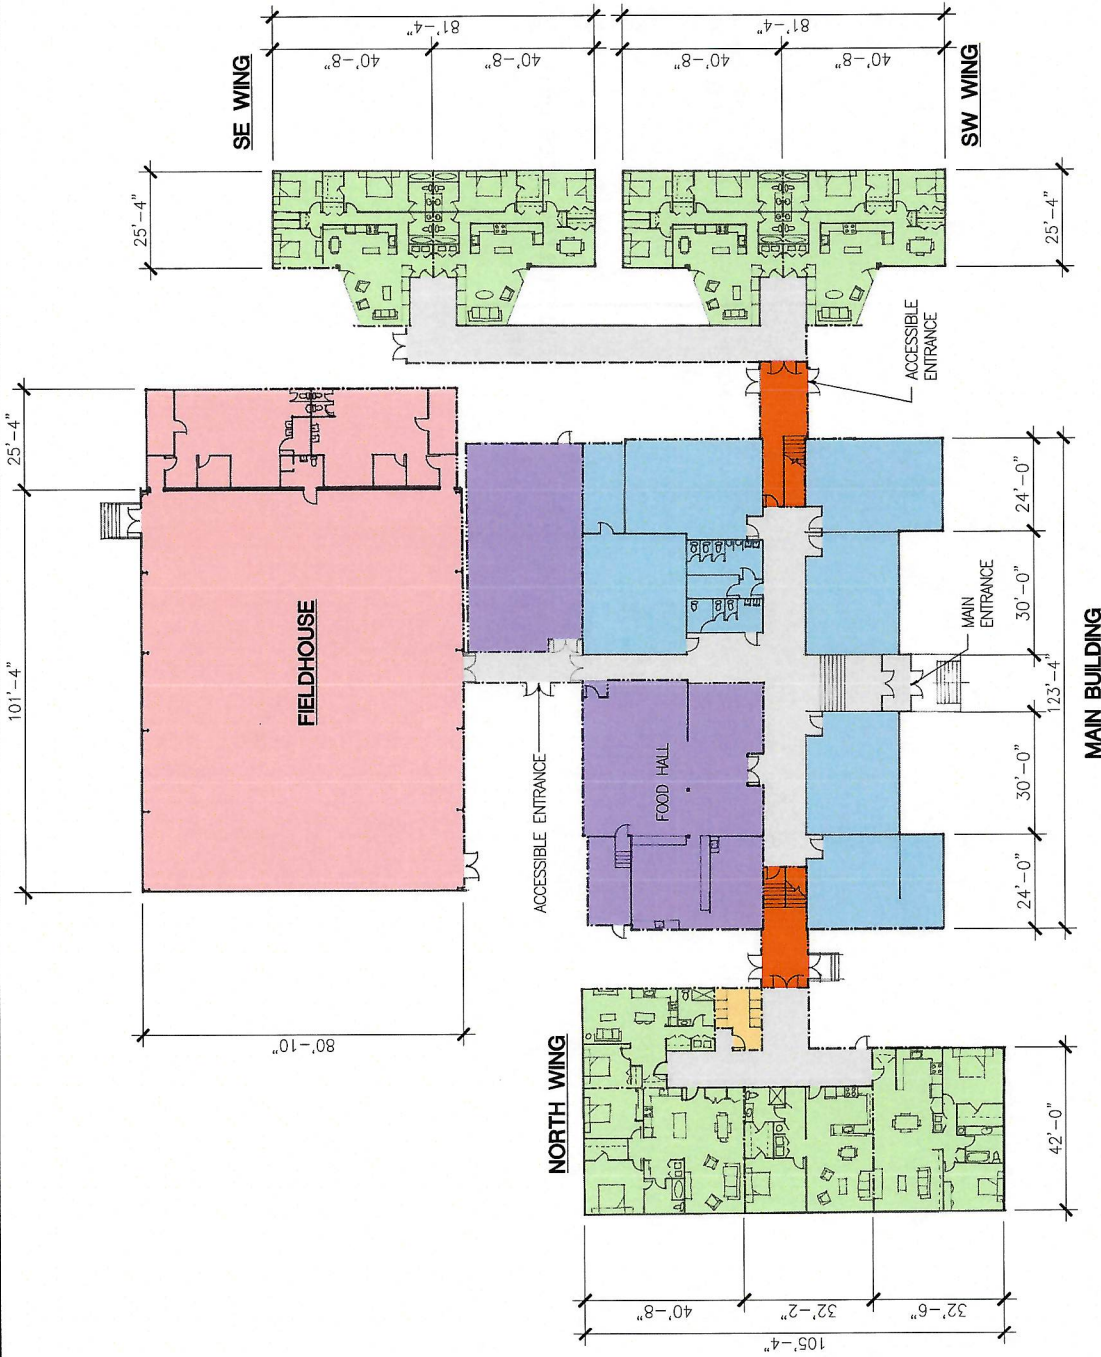
1ST FLOOR ARCHITECTURAL CONCEPT PLAN

MAIN BUILDING:	9,890 SF (1ST FLOOR)
	9,890 SF (2ND FLOOR)
	19,780 SF (TOTAL AREA)
NORTH WING:	5,455 SF
SE WING:	3,430 SF
SW WING:	3,040 SF
LIBRARY:	2,005 SF
FIELDHOUSE:	10,170 SF
TOTAL FOOTPRINT:	33,985 SF
GROSS AREA:	44,040 SF

The foundation and framing plans at the back of this report show the general areas of the building as well as existing structural systems. These plans are based on floor diagrams constructed by LAE in their earlier report and on an additional review of existing site conditions. LAE's foundation and framing are all approximate and have been developed with the intent of providing reference documents for the required structural upgrades. These are not construction documents.

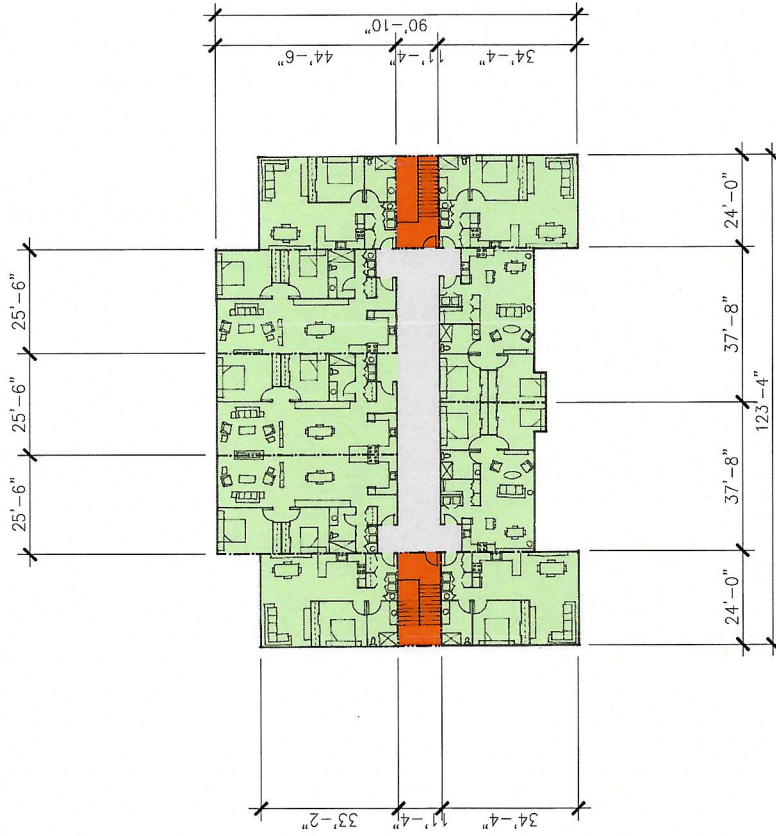
2ND FLOOR CONCEPT PLAN

OCCUPANCY GROUPS: R-2 (RESIDENTIAL)
 CONSTRUCTION TYPE: VB (MAIN BUILDING)
 FIRE SPRINKLER: REQUIRED
 AREAS:
 MAIN BUILDING: 9,890 SF (2ND FLOOR)
