The Journal of RCI

INFRARED THERMOGRAPHY IN TODAY'S ROOFING WORLD

BY KARL SCHAACK, RRC, PE

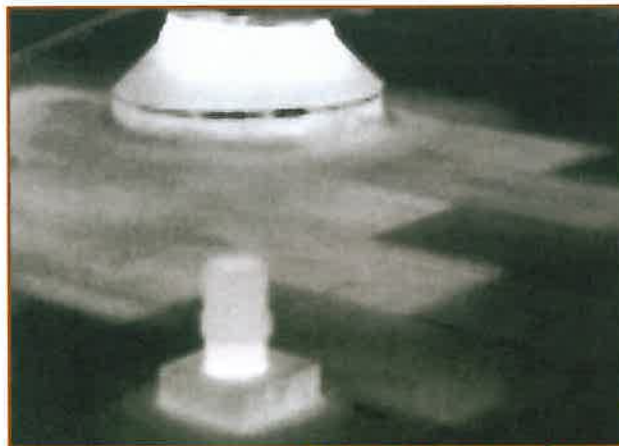
Photograph 1: Board stock anomaly of wet insulation in stair-stepped fashion.

an infrared camera, will commonly exhibit a stair-stepped or joint-staggered configuration that is used during the original installation of the subject materials (*Photo 1*).

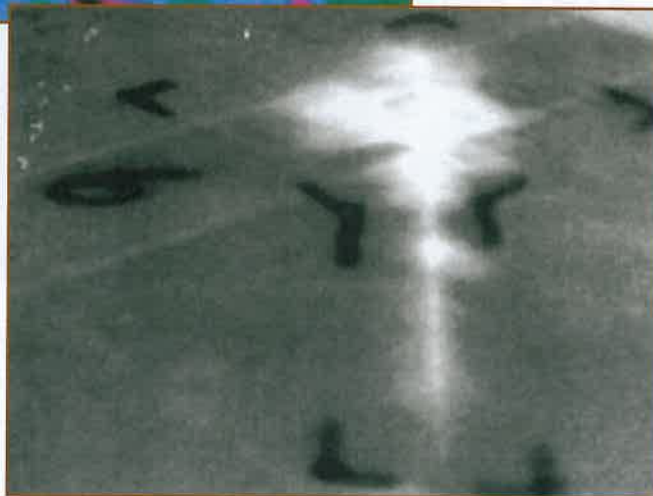
Photograph 4: View of wet insulation occurring along joint between ISO boards (gray contrast).

The board joint thermal anomaly can also occur within cellular insulation material such as cellular glass and foamed plastics. This anomaly is observed and typically occurs during the initial wetting as the moisture becomes absorbed along the cut or formed edges of these boards. This type of anomaly, when viewed through an infrared camera, typically appears as irregular-shaped brightened borders around the perimeter edges of the insulation board or joints between adjacent boards (Photos 3 and 4).

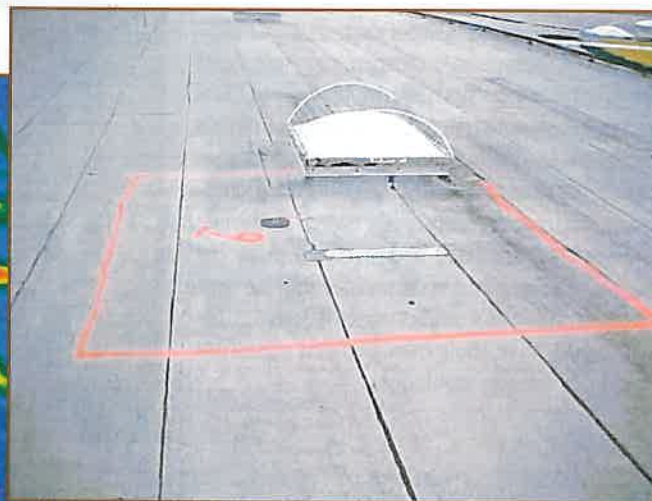
Photograph 6: View of anomaly of wet ISO under modified-bitumen membrane.

In today's roofing market, applications can be composed of a roof membrane—either single-ply or modified-bitumen—installed directly on top of ISO without the use of a cover board (Photographs 5 and 6). Single-ply membranes, as well as bituminous membranes, have also been installed directly over LWIC without incorporating any type of rigid board insulation above the surface of the LWIC. Modified-bitumen and single-ply membranes with white-colored surfacing are currently installed in more widespread applications and over various substrates that provide additional challenges for thermographers. If the roof system is applied directly over cellular insulation or LWIC, and moisture intrusion has occurred, entrapped moisture can be detected with infrared thermography (Photos 7, 8, and 9). On white-colored membranes, the images may not be as discernible compared to other darker-colored membranes. On smooth-surfaced, white, single-ply membranes, thermal anomalies may appear as ghost-like images, depending on the weather conditions during the day and survey time.

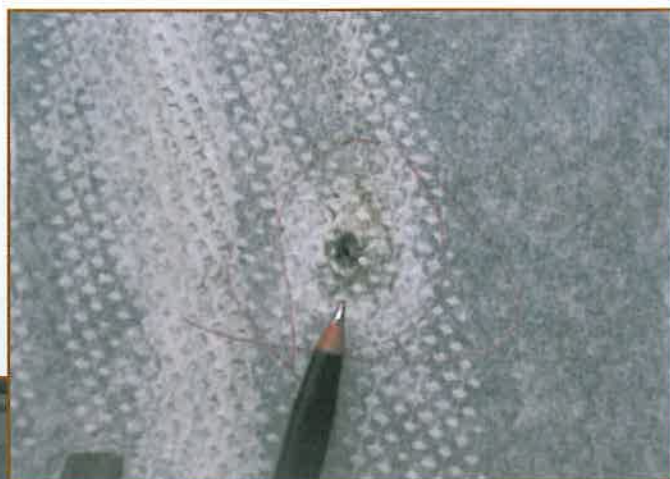
Photo 8 – View of demarcated anomaly.

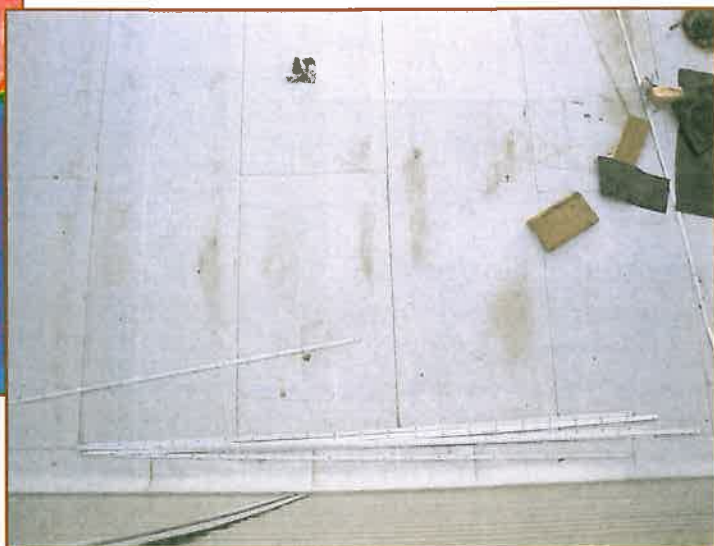
Photo 11 – View of soiled areas of white-surfaced modified-bitumen cap sheet.

With the reflectivity and physical characteristics of white roofs, the surface temperature of the roof can remain close to the ambient air temperature on the day of the inspection and not become elevated such as typically occurs with bituminous or dark-colored coverings. Therefore, the thermal loading and thermal differential between wet substrate and outside and interior air temperatures may not be as great during the warmer months. The optimum weather conditions for performing an infrared survey would be a relatively warm, sunny day followed by a rapid cool-down after sundown, resulting in a thermal difference of 20° to 30° or greater. Although most commonly used equipment is capable of detecting temperature differentials of less than 1°, the greater the difference in temperatures from daytime to survey time, the better the opportunity for finding thermal anomalies. White-colored surfacings could also have false thermal anomalies associated with isolated areas where the surface has become darkened or stained, such as is associated with ponding water (Photographs 10 and 11). Stained or darkened areas on white-colored

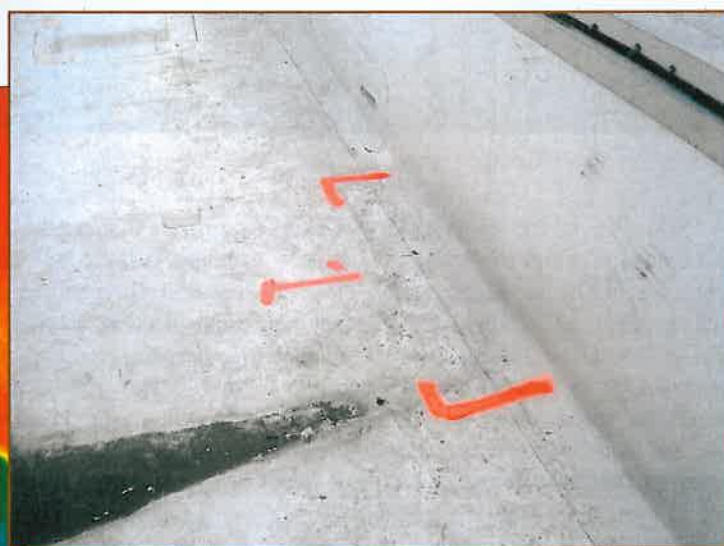
Photograph 16 – View of anomaly location of water in TPO base flashing.

insulation with a facer and taped seams can also accumulate moisture. The water may not be contained within an insulation material or the substrate, but it can be of significant quantity to form a blister or a balloon shape within the flashing material and, therefore, become detectable with infrared technology (Photos 15 and 16).

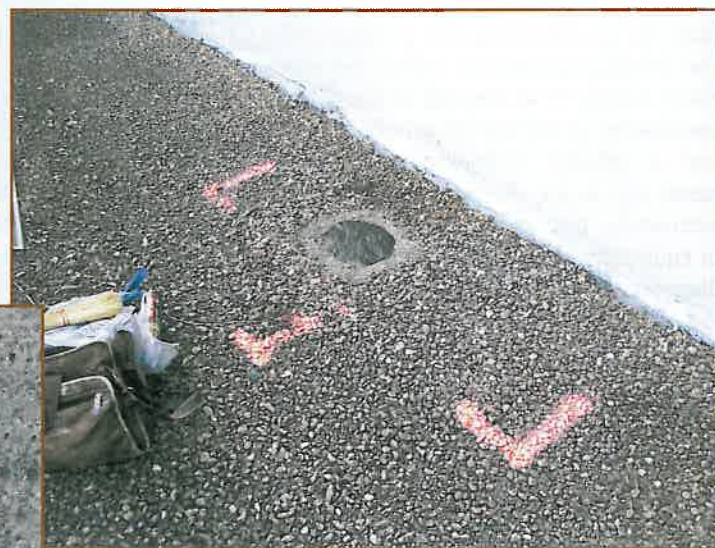
Photo 21 – View of anomaly of wet perlite under BUR.

Gravel-surfaced built-up roof coverings typically can offer the most challenging conditions for gathering accurate results from thermal imaging (Photos 20, 21, and 22). The irregular surfacing from the differing accumulations of bituminous materials or gravel typically creates numerous variations in the thermal appearance of the roof and will most likely involve significantly more time for the thermographer to differentiate between false and actual anomalies associated with wet substrate materials. Asphalt bleed-out at side and end laps or other overlapped sections of sheets, together with embedded metal flashings, provide obstacles such as "false" readings during the survey for detecting thermal anomalies in a roof with a granule-surfaced cap sheet (Photo 23). It is prudent to take additional time when viewing these areas, as they are considered to be more vulnerable to moisture intrusion or are most likely sources of moisture penetration if a breach is present.

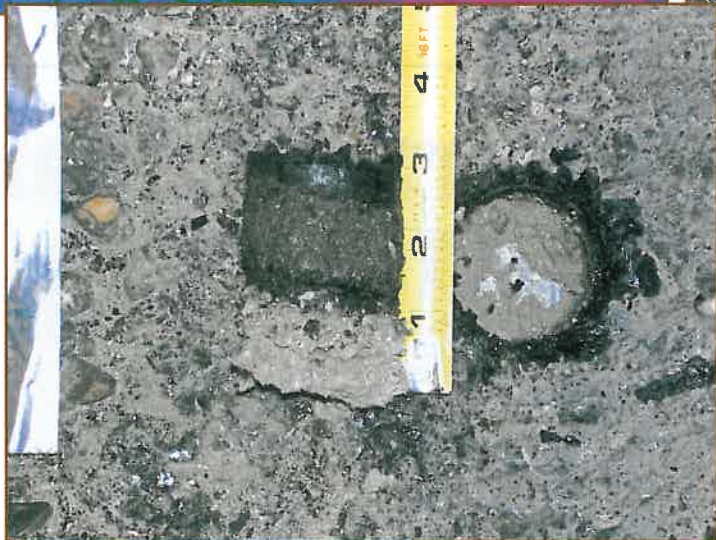
Photo 22 – Core showing wet upper layer of perlite in BUR.
