## Unknown Radio Schematic

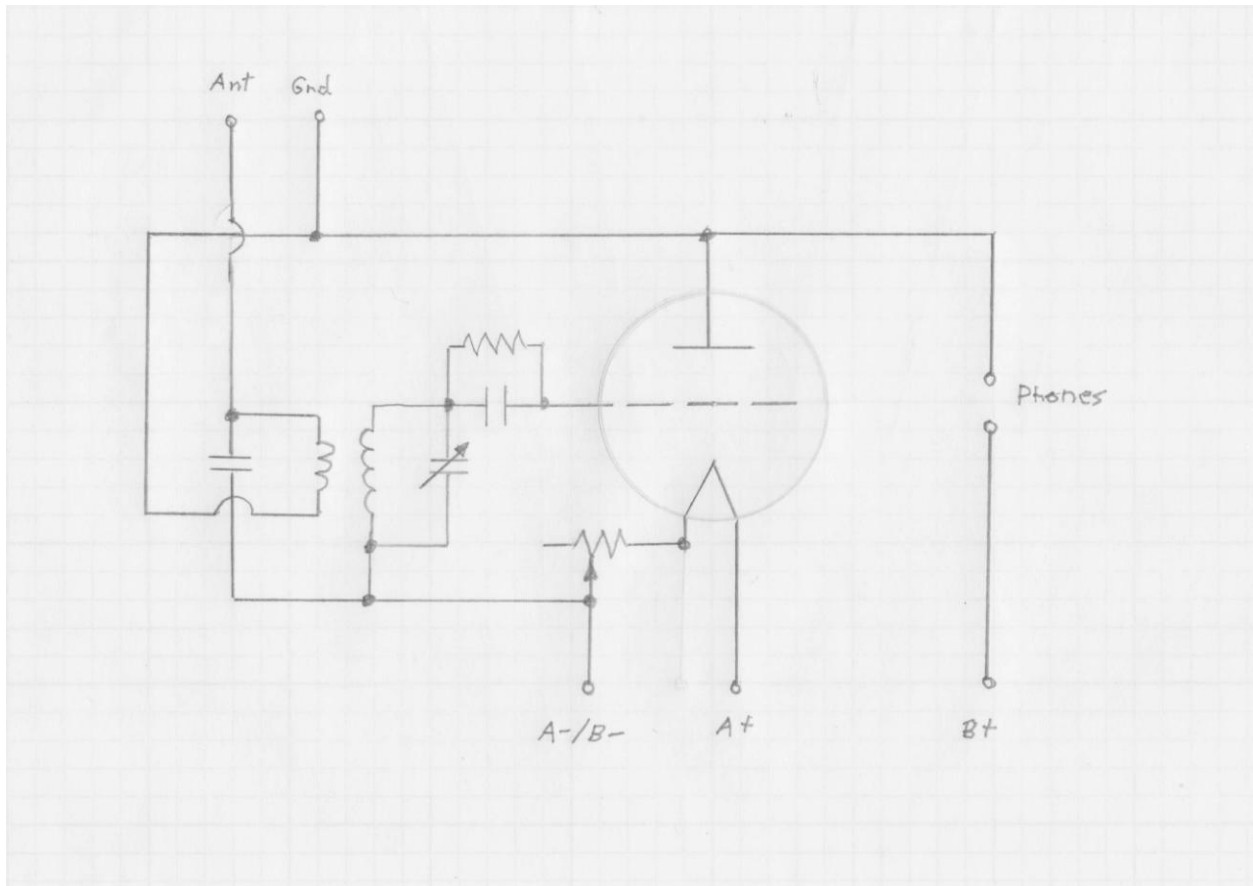
Here is the schematic of the “unknown” receiver. One thing became very obvious, when the circuit was being “traced out”, is that the UV-199 is NOT the proper tube for this design! The tube base connections are not correct for the UV-199. They are correct for the WD-12; any of the Western-Electric 231D, 239, or 264 series, or the QRS 201A. The “normal” 00, 00A, 100, 100A, 200, 200A, 300, 300A, 01, 01A, 101, 101A, 201, 201A, 301, 301A all have envelopes that will not fit the hole in the panel as well as being too tall to fit the space between the tube socket and the panel.

Another thing is that the circuit is not like any other that I have seen. Of course, there could always be a wiring error in the receiver. As presently wired, the tube plate is connected to the external ground! Since the receiver is battery operated, there is no need to connect the B- / A- to the external ground.

The receiver does appear to be regenerative and not TRF since the antenna input coil is also wired as a “tickler coil”. However, with a couple of minor changes, the receiver would become a TRF circuit.

The WD-12 would need either a sleeve or be one of the Sylvania larger base versions that were designed to fit the larger diameter tube sockets.
