SE ¼ of the SW ¼ of Section 9 in Township 2 North, Range 22 East in the Town of Somers, Kenosha County, WI.

Location of Somers Branch Project Area within Pike River Watershed

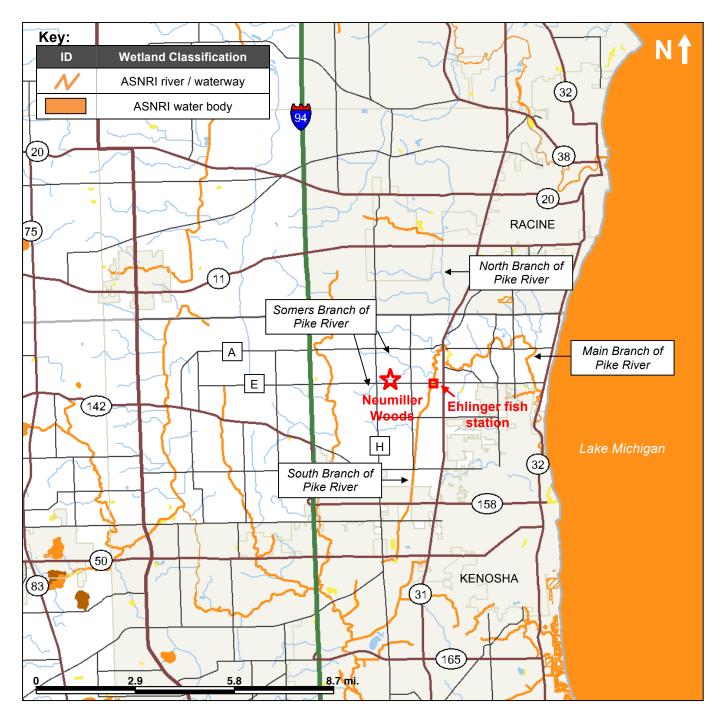
#### Figure 2:

Pike River Watershed – Areas of Special Natural Resource Interest (ASNRIs)

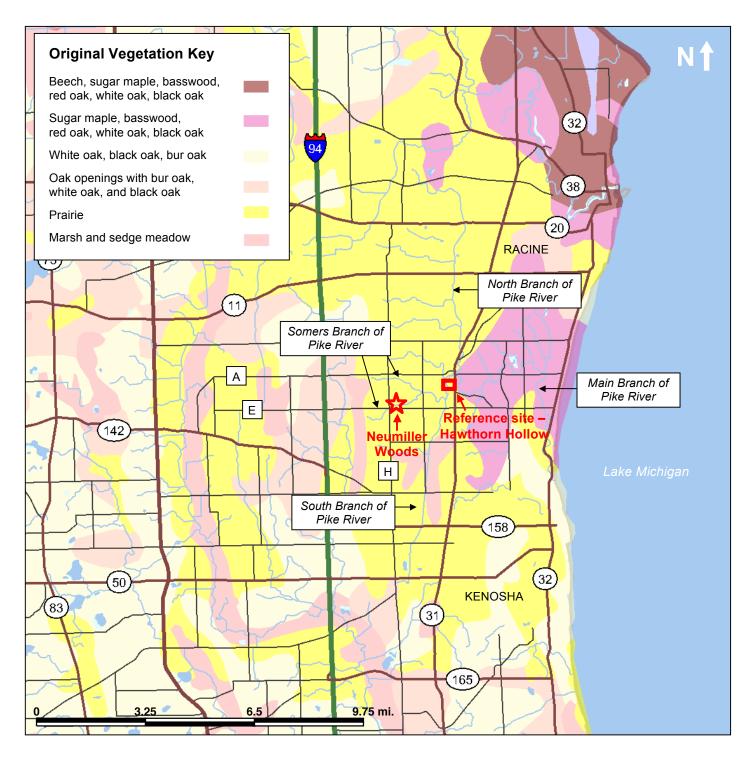
### Figure 4:

## Original Vegetation in Pike River Basin

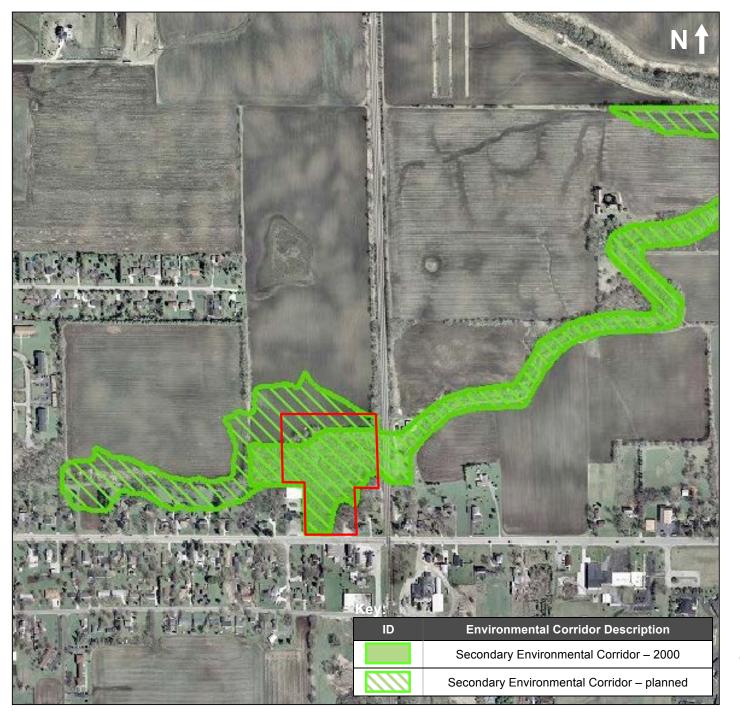
### Figure 6:

# **Local Environmental Corridors**

2010 aerial photograph

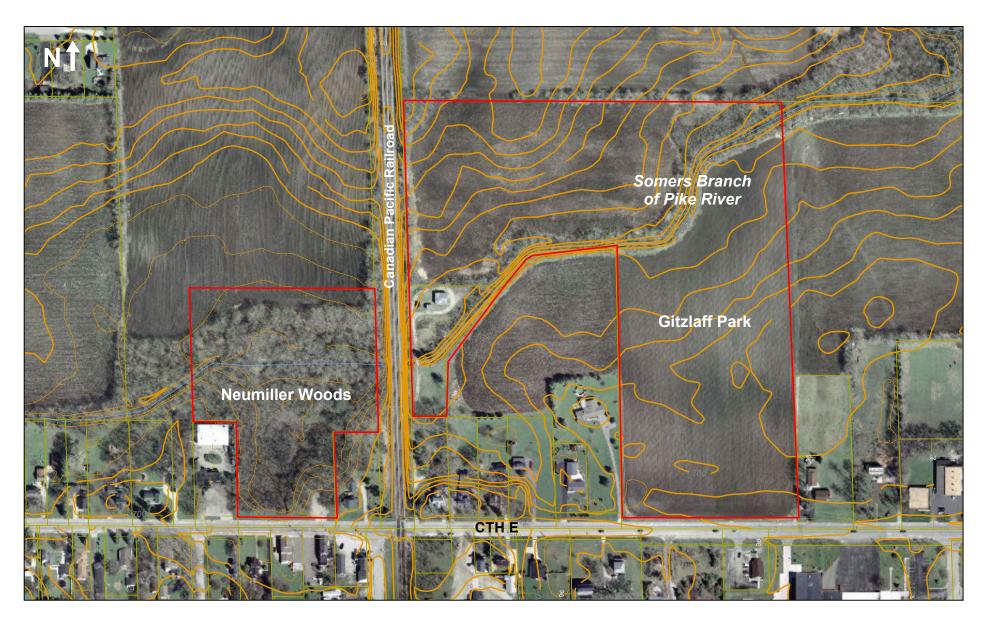
Figure 8:

Town of Somers Park Land: Neumiller Woods and Gitzlaff Park with Topographic Map SE ¼ of the SW ¼ and SW ¼ of the SE ¼ of Section 9 in Township 2 North, Range 22 East in the Town of Somers, Kenosha County, WI.

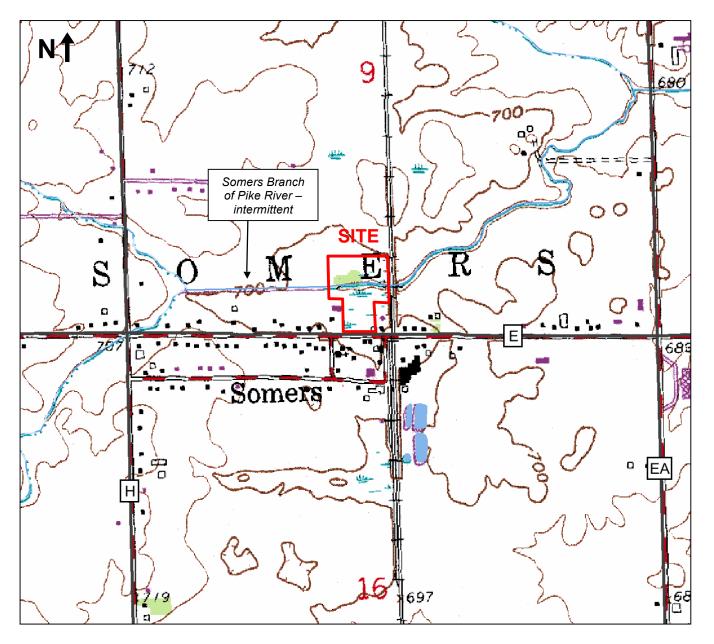
Figure 9:

Neumiller Woods USGS Topographic Map

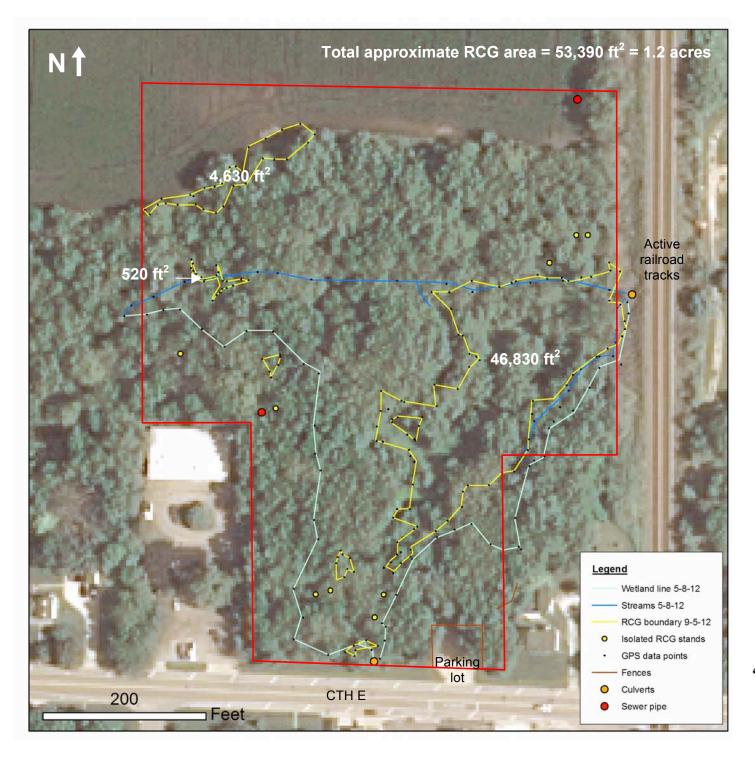
#### Figure 10:

#### Neumiller Woods – GPS Extent of Reed Canary Grass and Wetlands

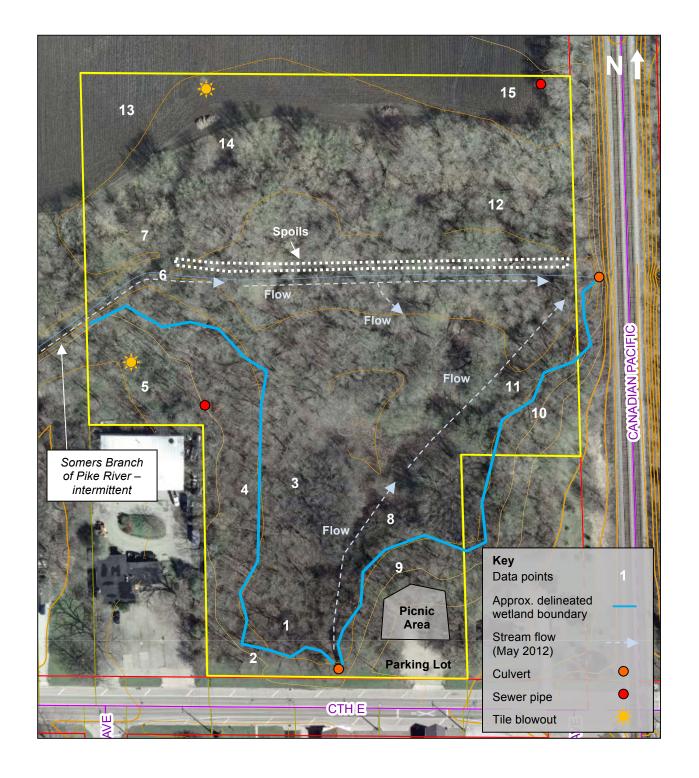
#### Figure 11:

# **Neumiller Woods Wetland Features**

2010 aerial photograph with waterway layer

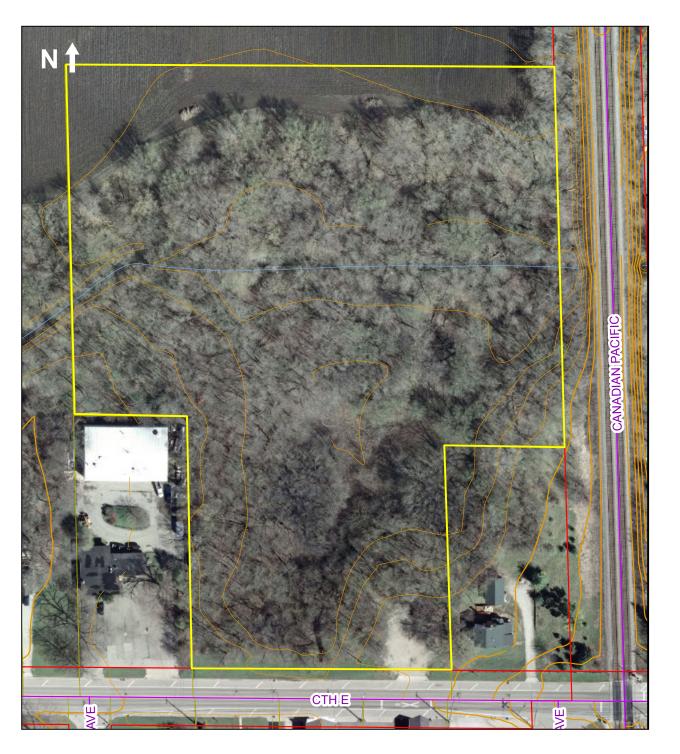
#### Figure 12:

Neumiller Woods – 2-foot Contour Topographic Map

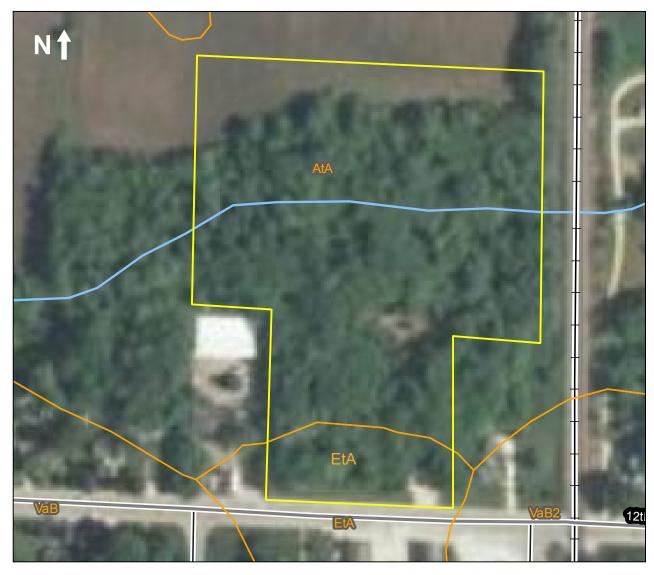
Soil	Symbol	Hydric Class
Ashkum silty clay loam, 0 to 3 percent slopes	AtA	Hydric
Elliott silty clay loam, 0 to 2 percent slopes	EtA	Upland with hydric inclusions

### Figure 13: Neumiller Woods Soils Map

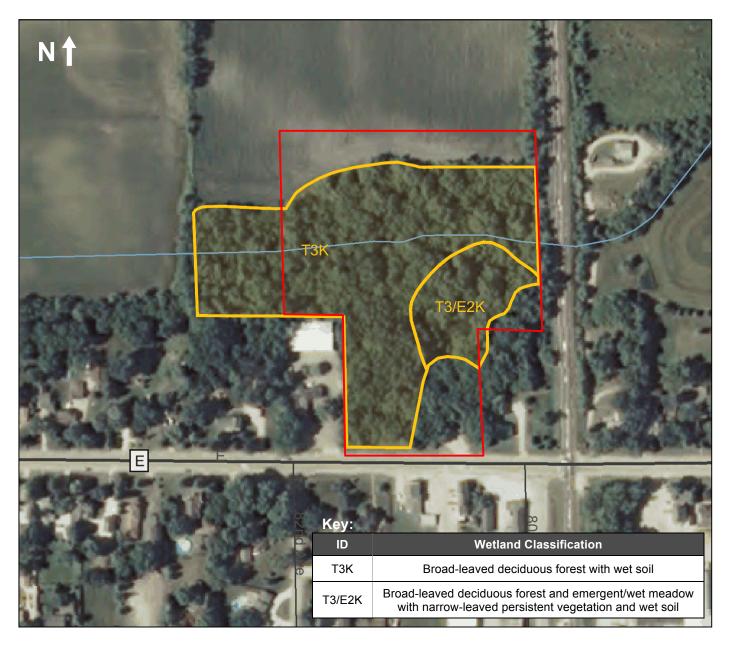
#### Figure 14:

#### Neumiller Woods Wisconsin Wetland Inventory Map

2008 aerial photograph with waterways layer

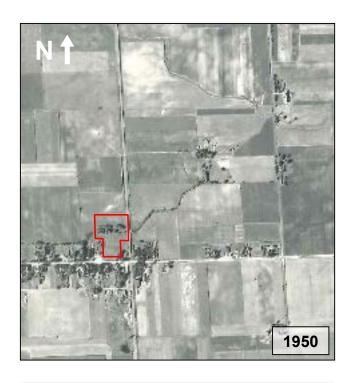
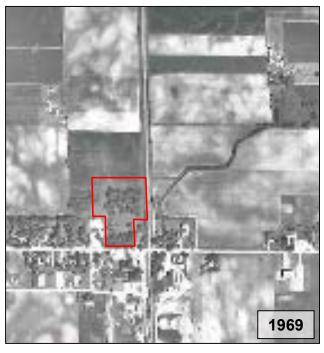
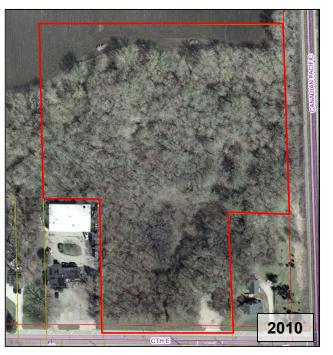
Figure 15: Neumiller Woods – Historical Aerials

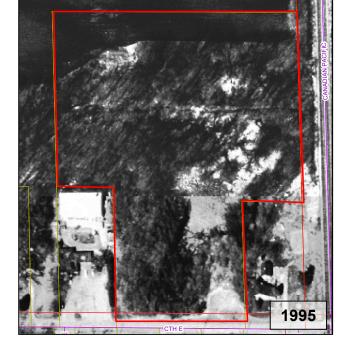
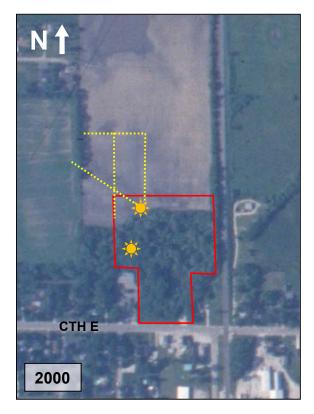
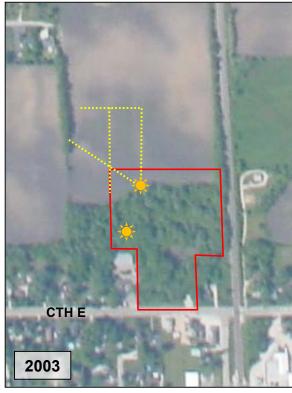
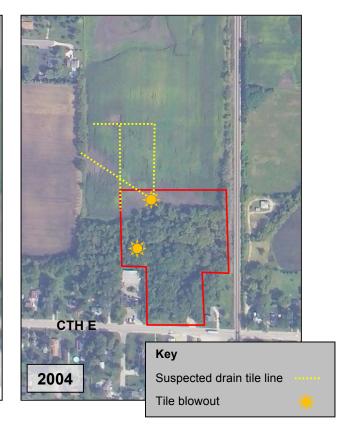
Figure 16:

Neumiller Woods – Farm Service Agency Aerials and Suspected Drain Tile Lines Image Source: Kenosha/Milwaukee/Racine FSA office
