RADHA KRISHNA TEMPLE
Owner
ALLEN TEXAS

SHEET NUMBER
S0.3

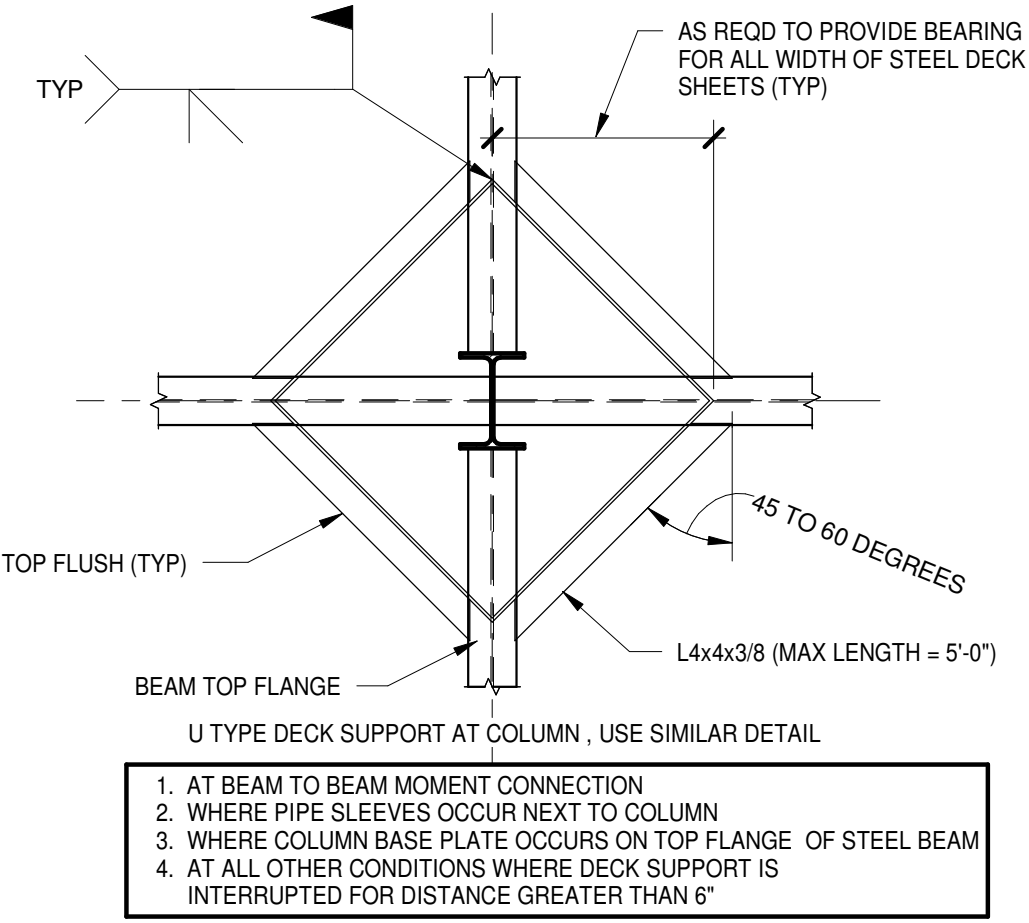
4 DECK SUPPORT SECTION
S0.3 1/2" = 1'-0"

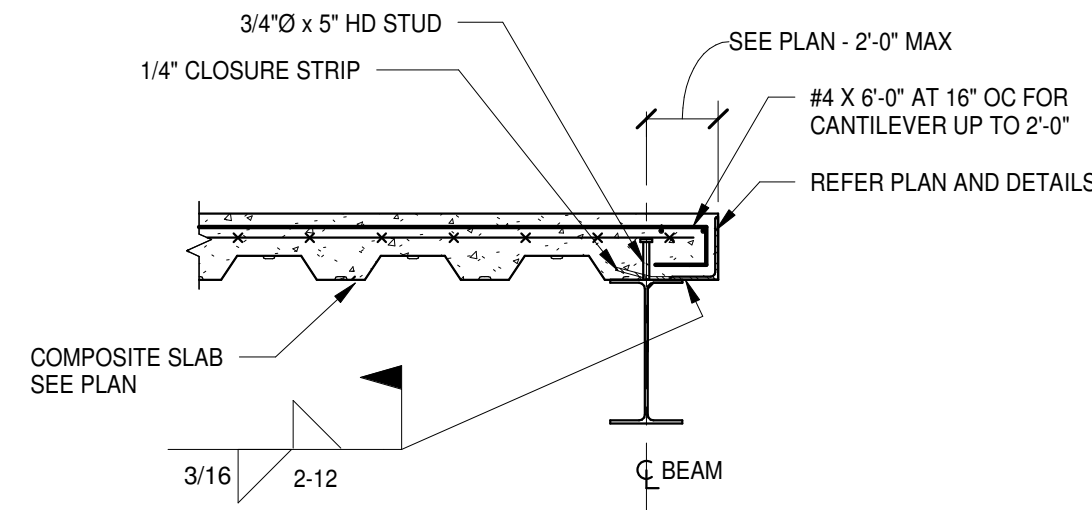
3 EDGE OF COMPOSITE DECK SECTION
S0.3 3/4" = 1'-0"

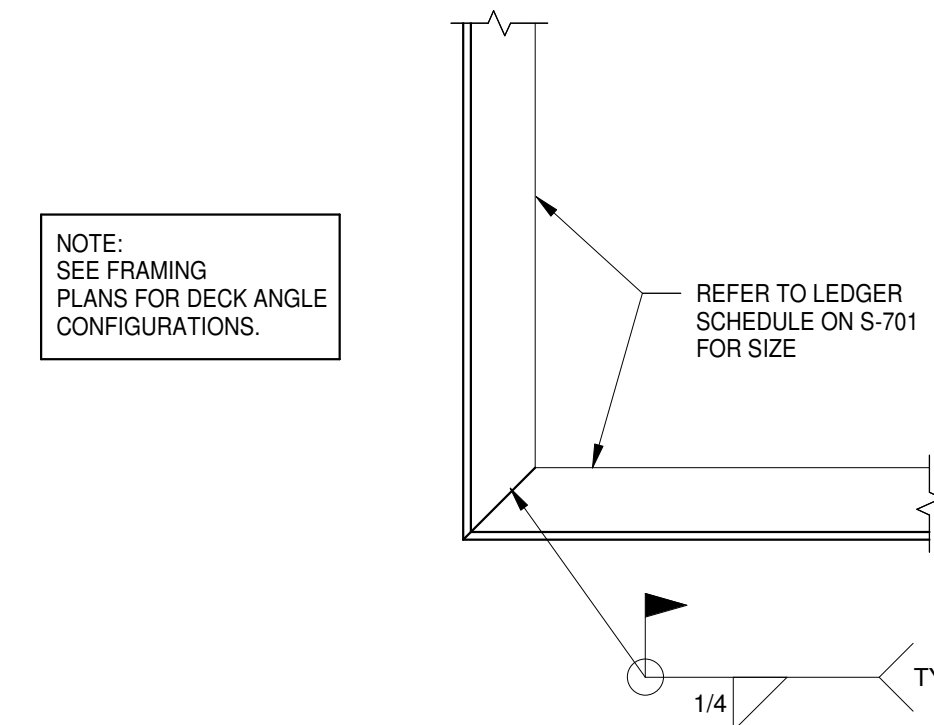
2 TYPICAL DECK ANGLE MITRED CORNER DETAIL
S0.3 3/4" = 1'-0"

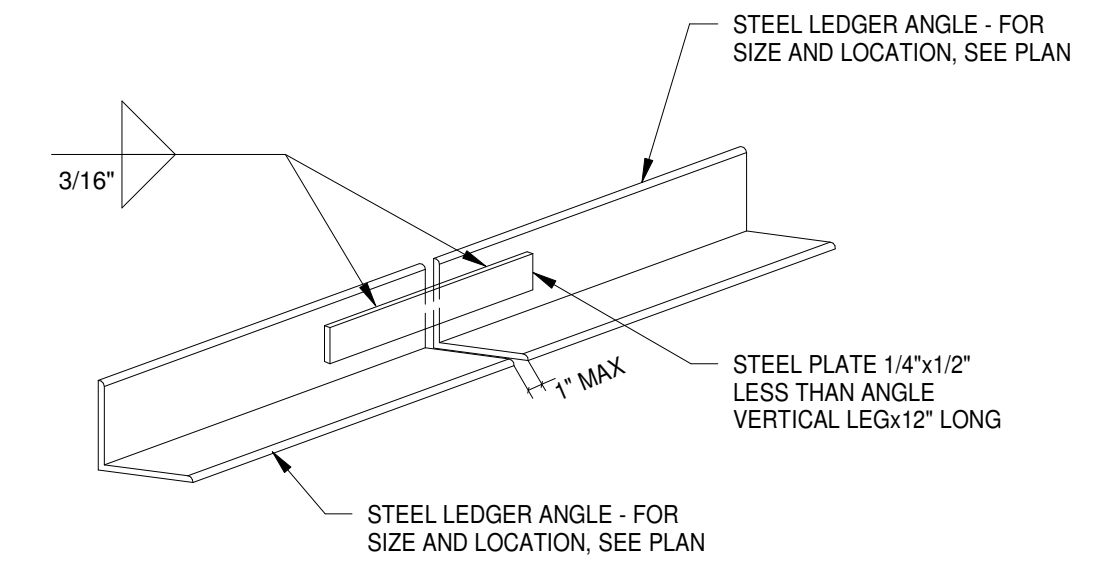
1 TYPICAL SPLICE IN CONTINUOUS STEEL LEDGER ANGLE
S0.3 3/4" = 1'-0"

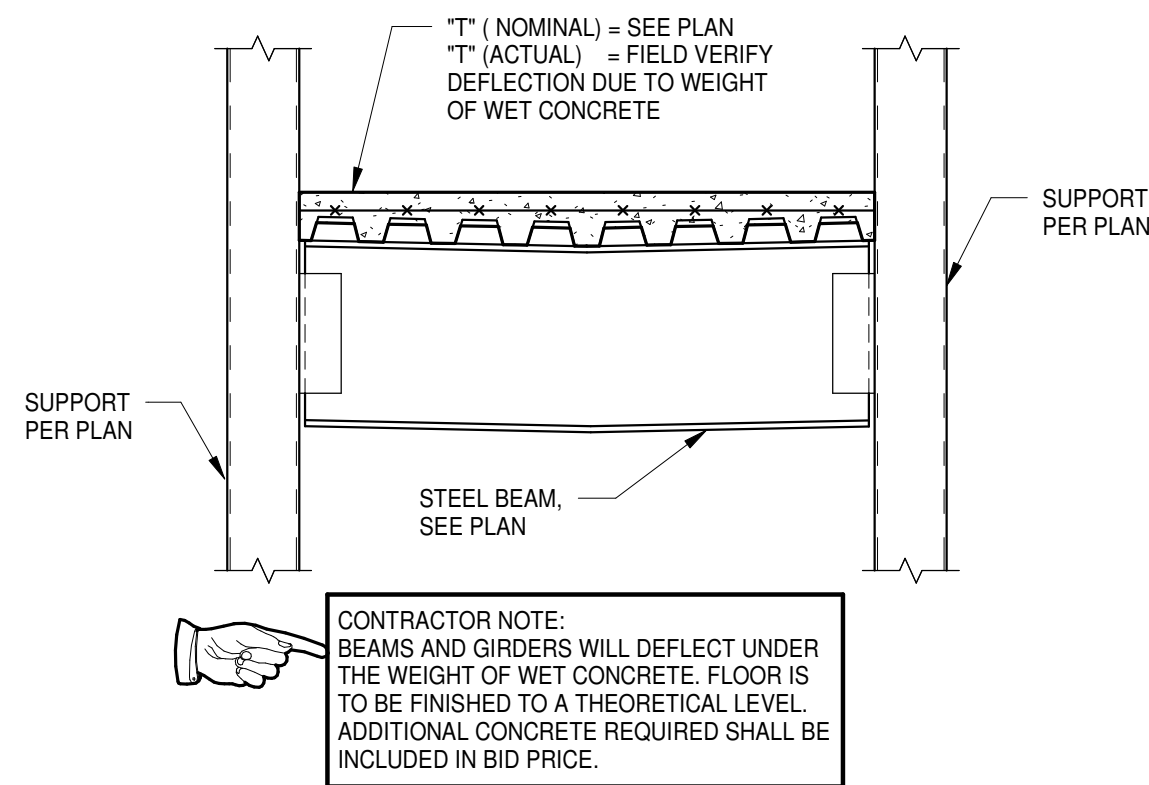
8 COMPOSITE SLAB FLOOR BEAM DEFLECTION DETAIL
S0.3 3/4" = 1'-0"

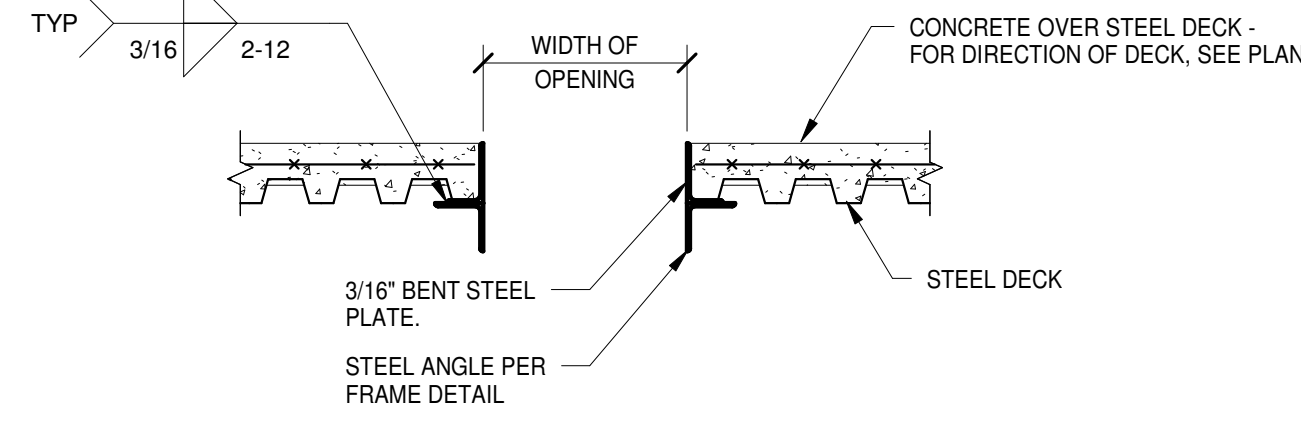
7 FRAMING AROUND OPENING IN STEEL DECK
S0.3 3/4" = 1'-0"

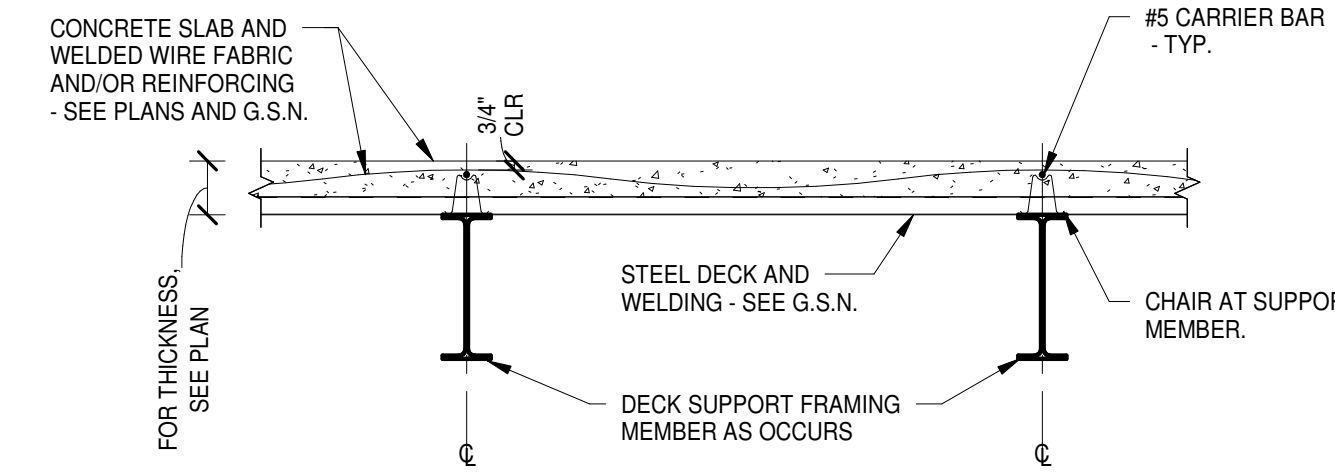
6 CONCRETE SLAB REINFORCING AT STEEL DECK
S0.3 3/4" = 1'-0"

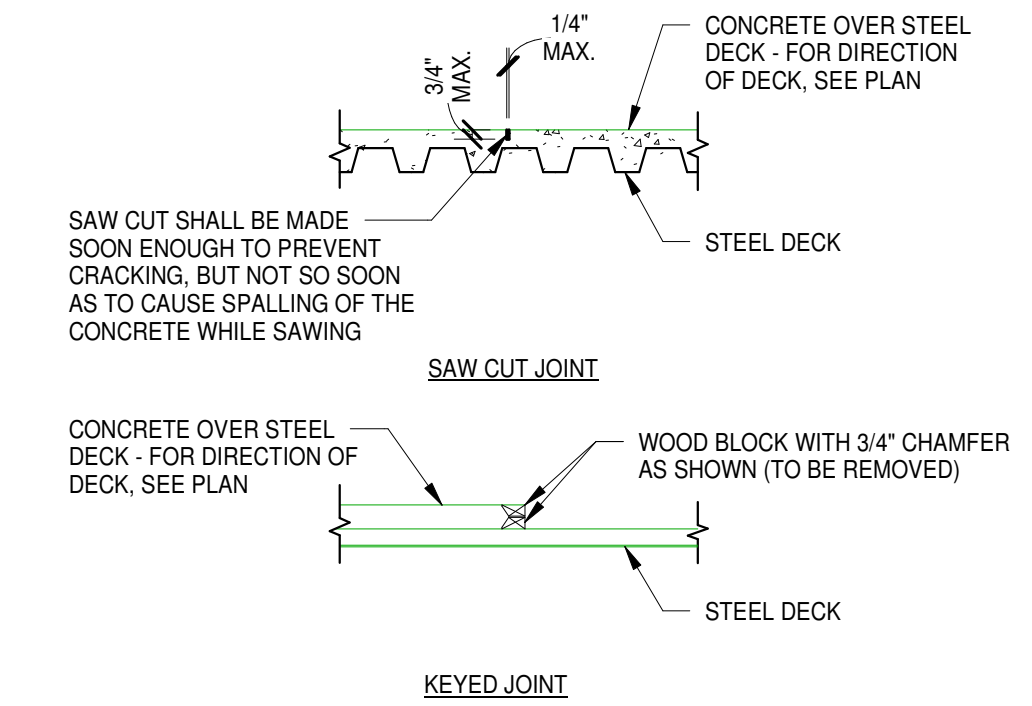
5 CONTROL JOINTS IN CONCRETE OVER STEEL DECK
S0.3 3/4" = 1'-0"

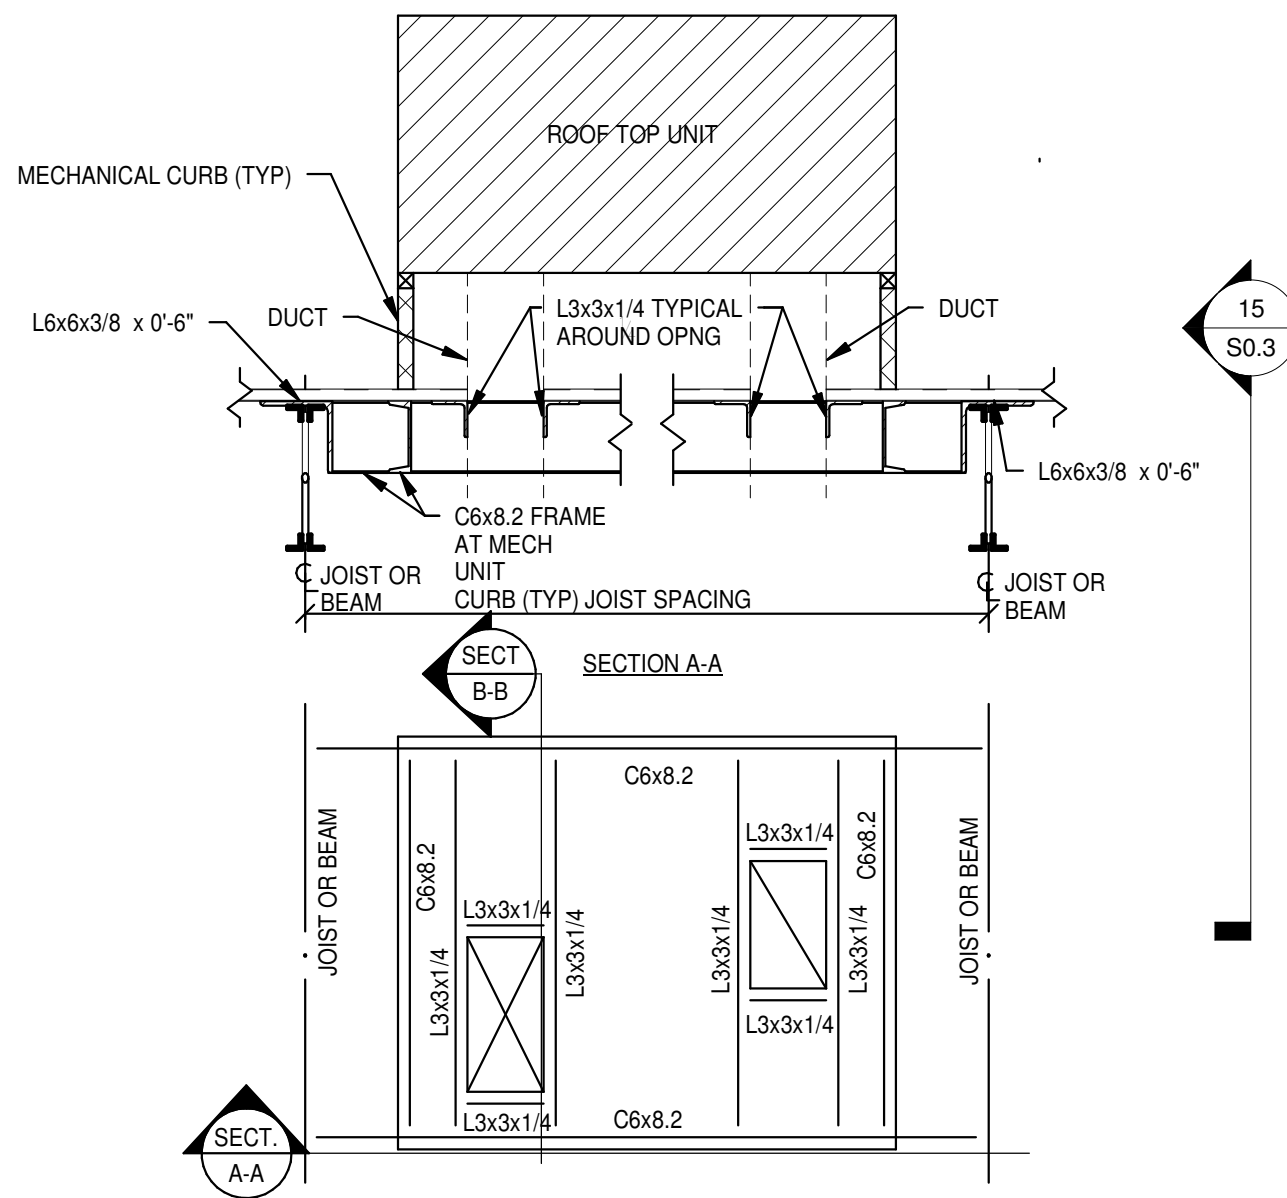
16 TYPICAL FRAMING ABOUT MECHANICAL UNIT
S0.3 3/4" = 1'-0"

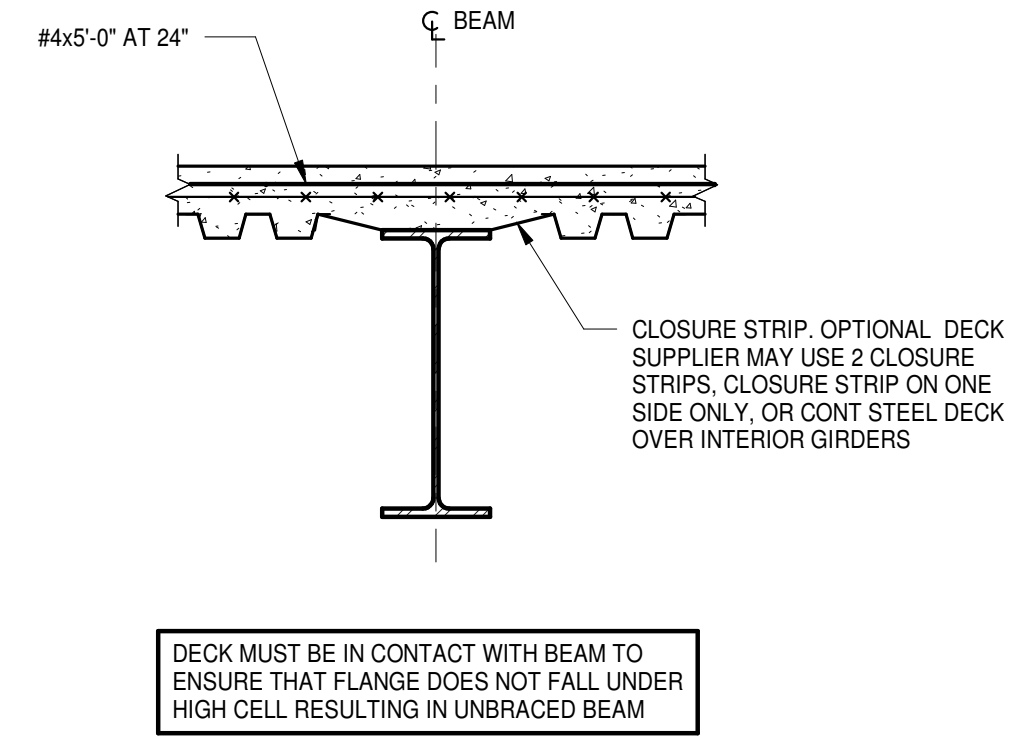
11 NON-COMPOSITE SLAB BEARING SECTION AT GIRDER
S0.3 3/4" = 1'-0"

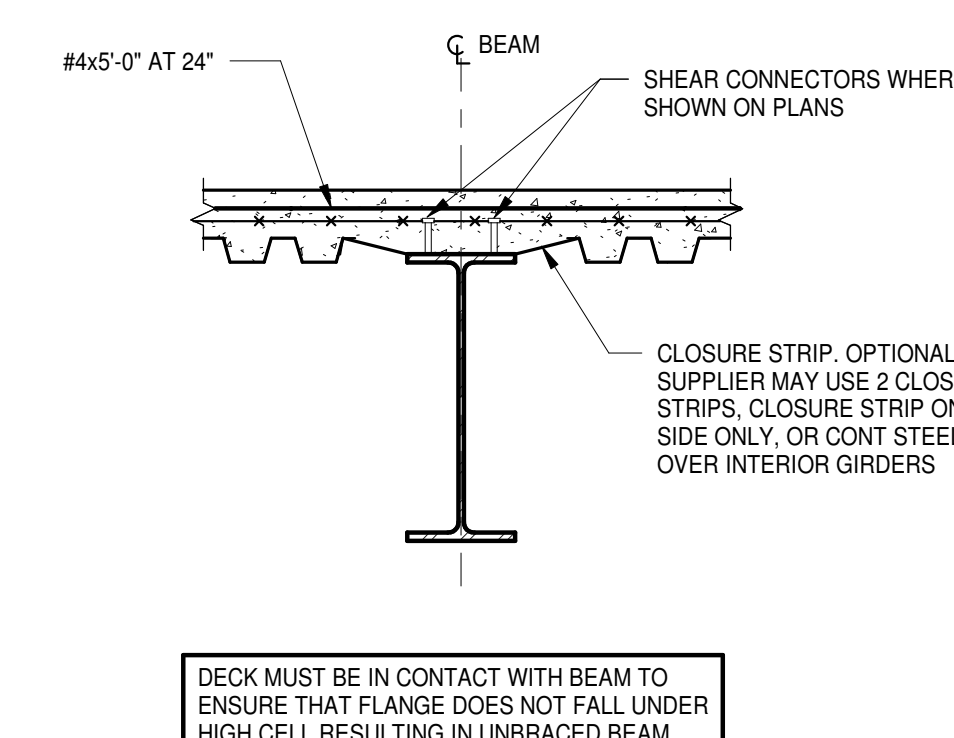
10 COMPOSITE SLAB BEARING SECTION AT GIRDER
S0.3 3/4" = 1'-0"

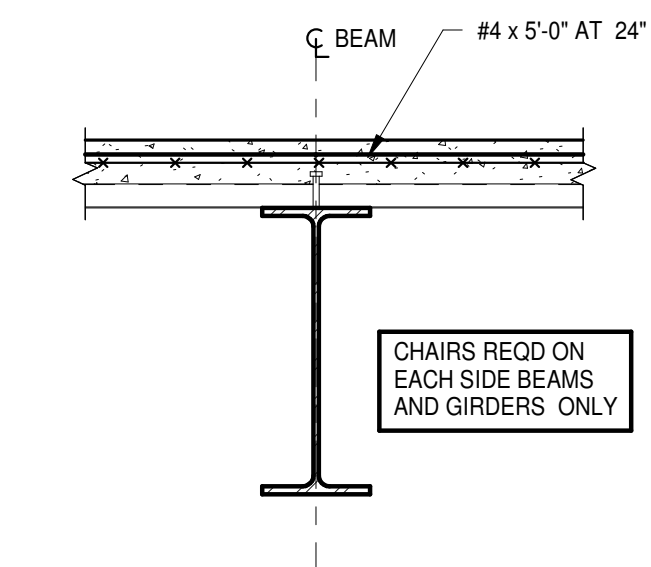
9 COMPOSITE SLAB BEARING SECTION AT STEEL BEAM GIRDERS
S0.3 3/4" = 1'-0"

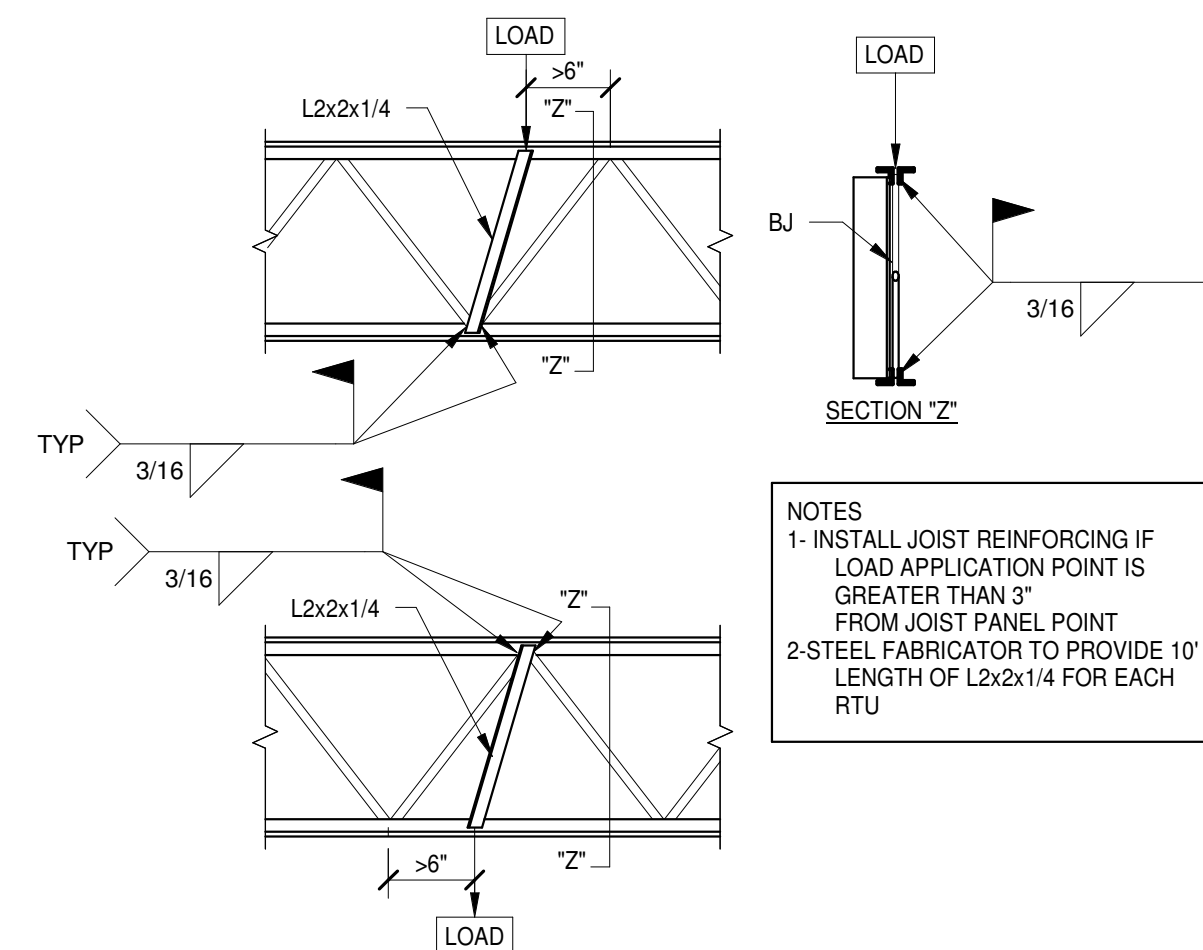
15 JOIST REINFORCING AT MECHANICAL UNITS
S0.3 3/4" = 1'-0"

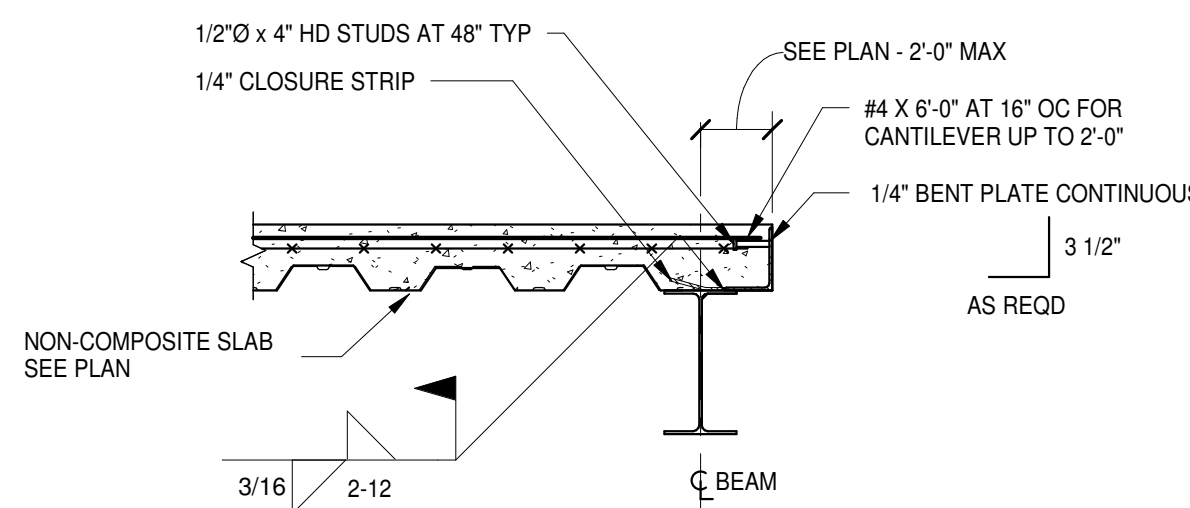
14 EDGE OF NON-COMPOSITE DECK SECTION
S0.3 3/4" = 1'-0"

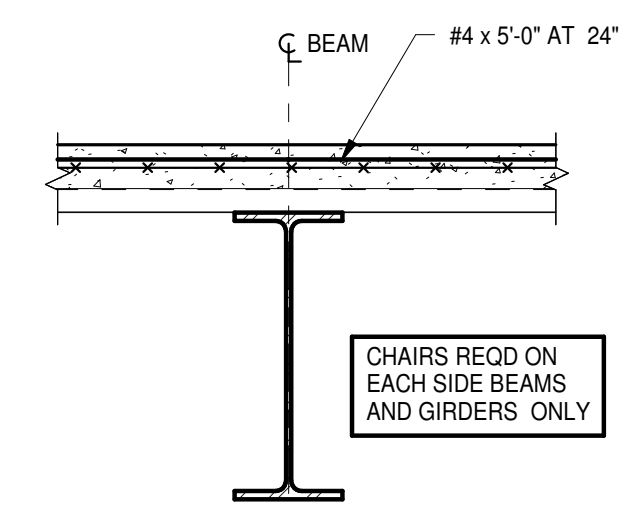
13 NON-COMPOSITE SLAB BEARING SECTION AT PURLINS
S0.3 3/4" = 1'-0"
