CMA File #1507-018AC

Date: 7/23/2015

ESTIMATE # 2116 Date Inspected: 7/11/2015

Make & Model KAWASAKI ZX1000KEFL

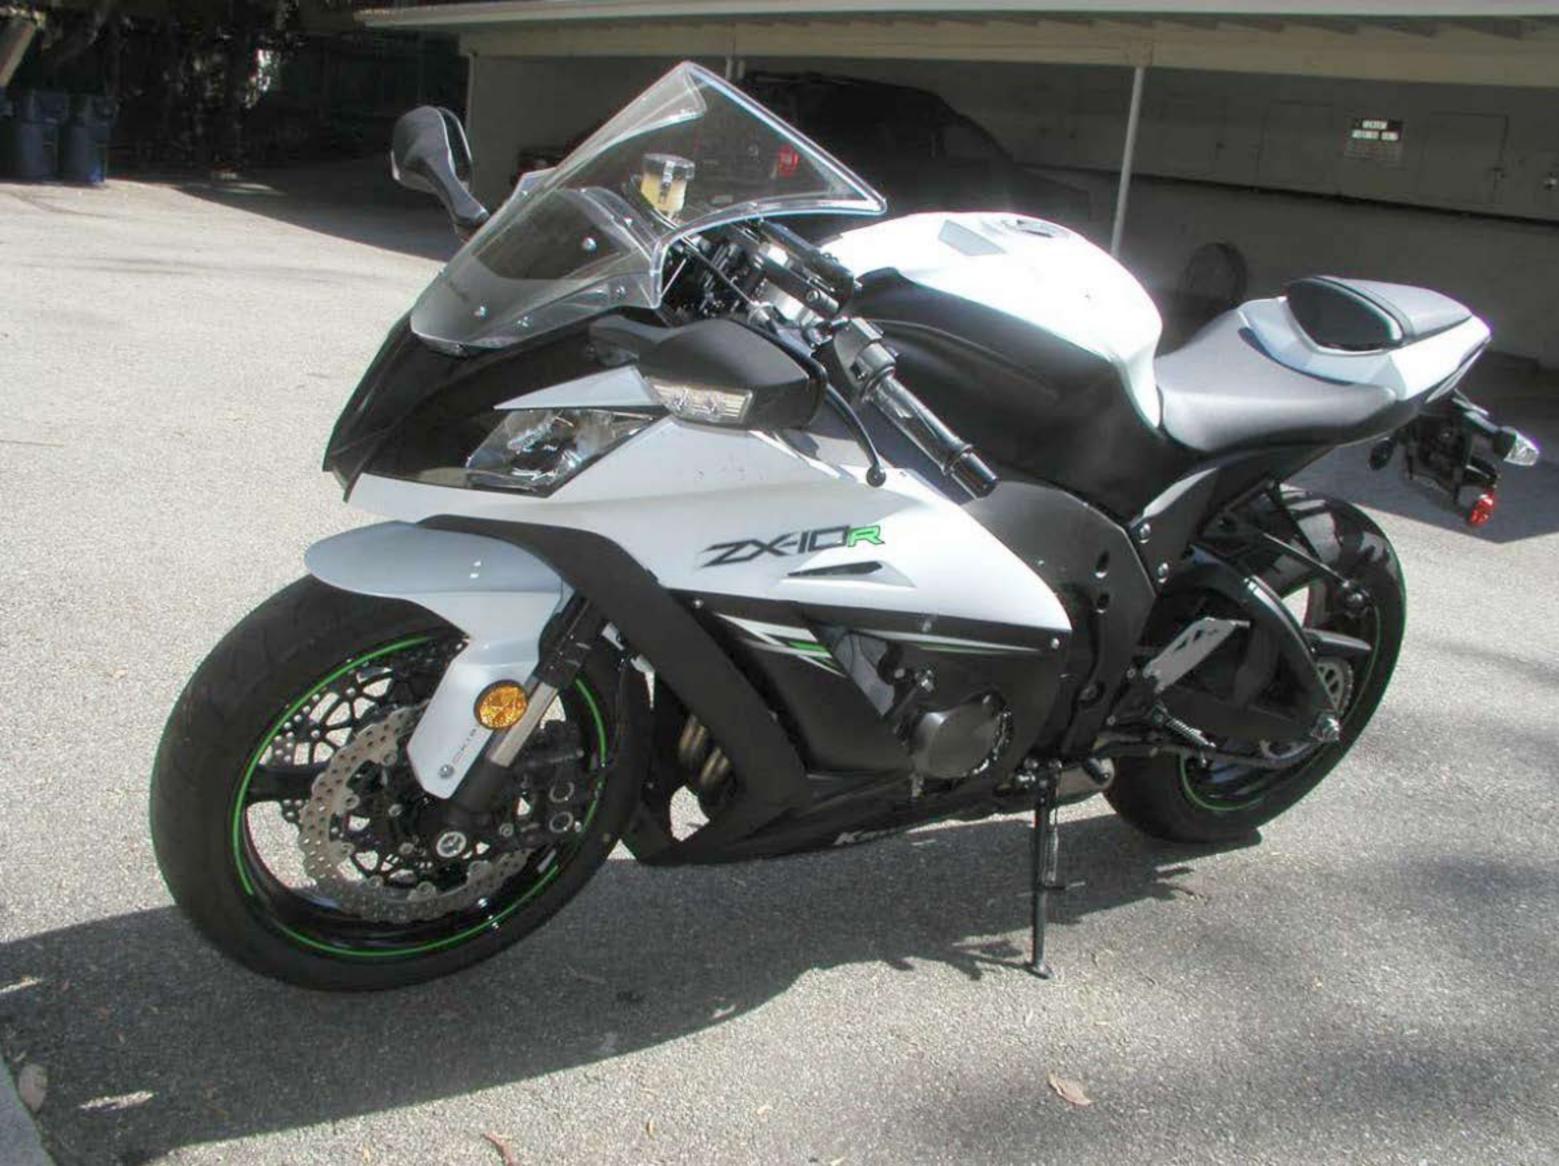
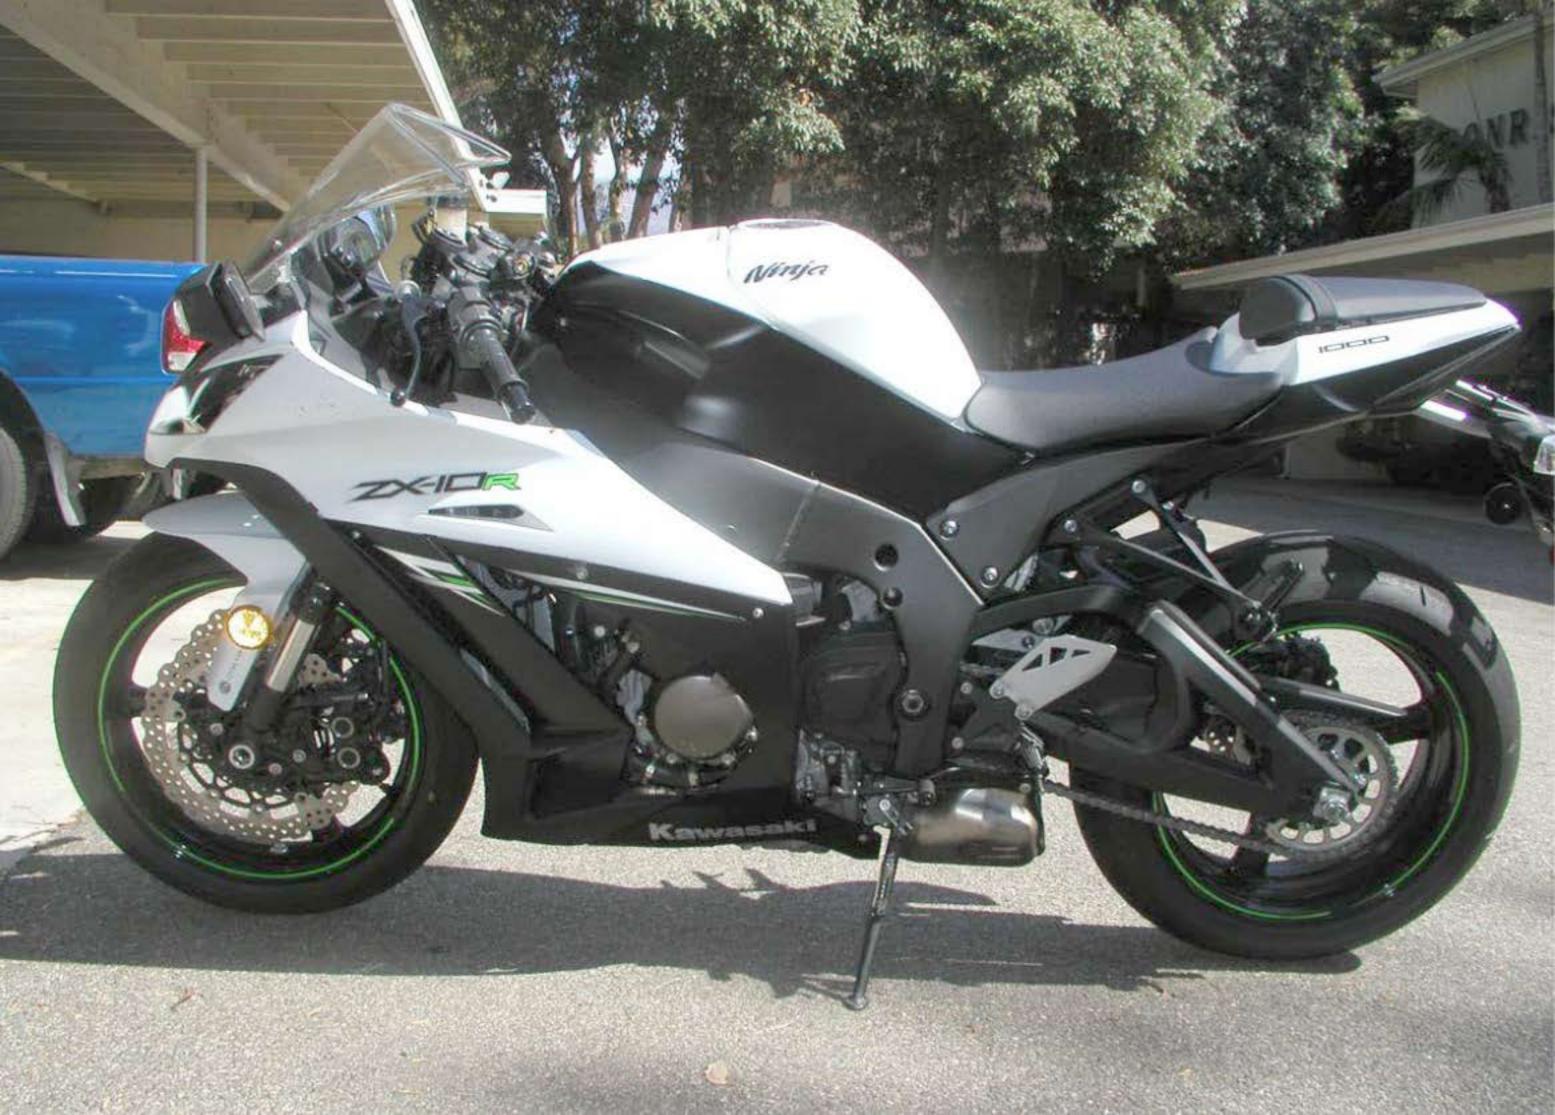
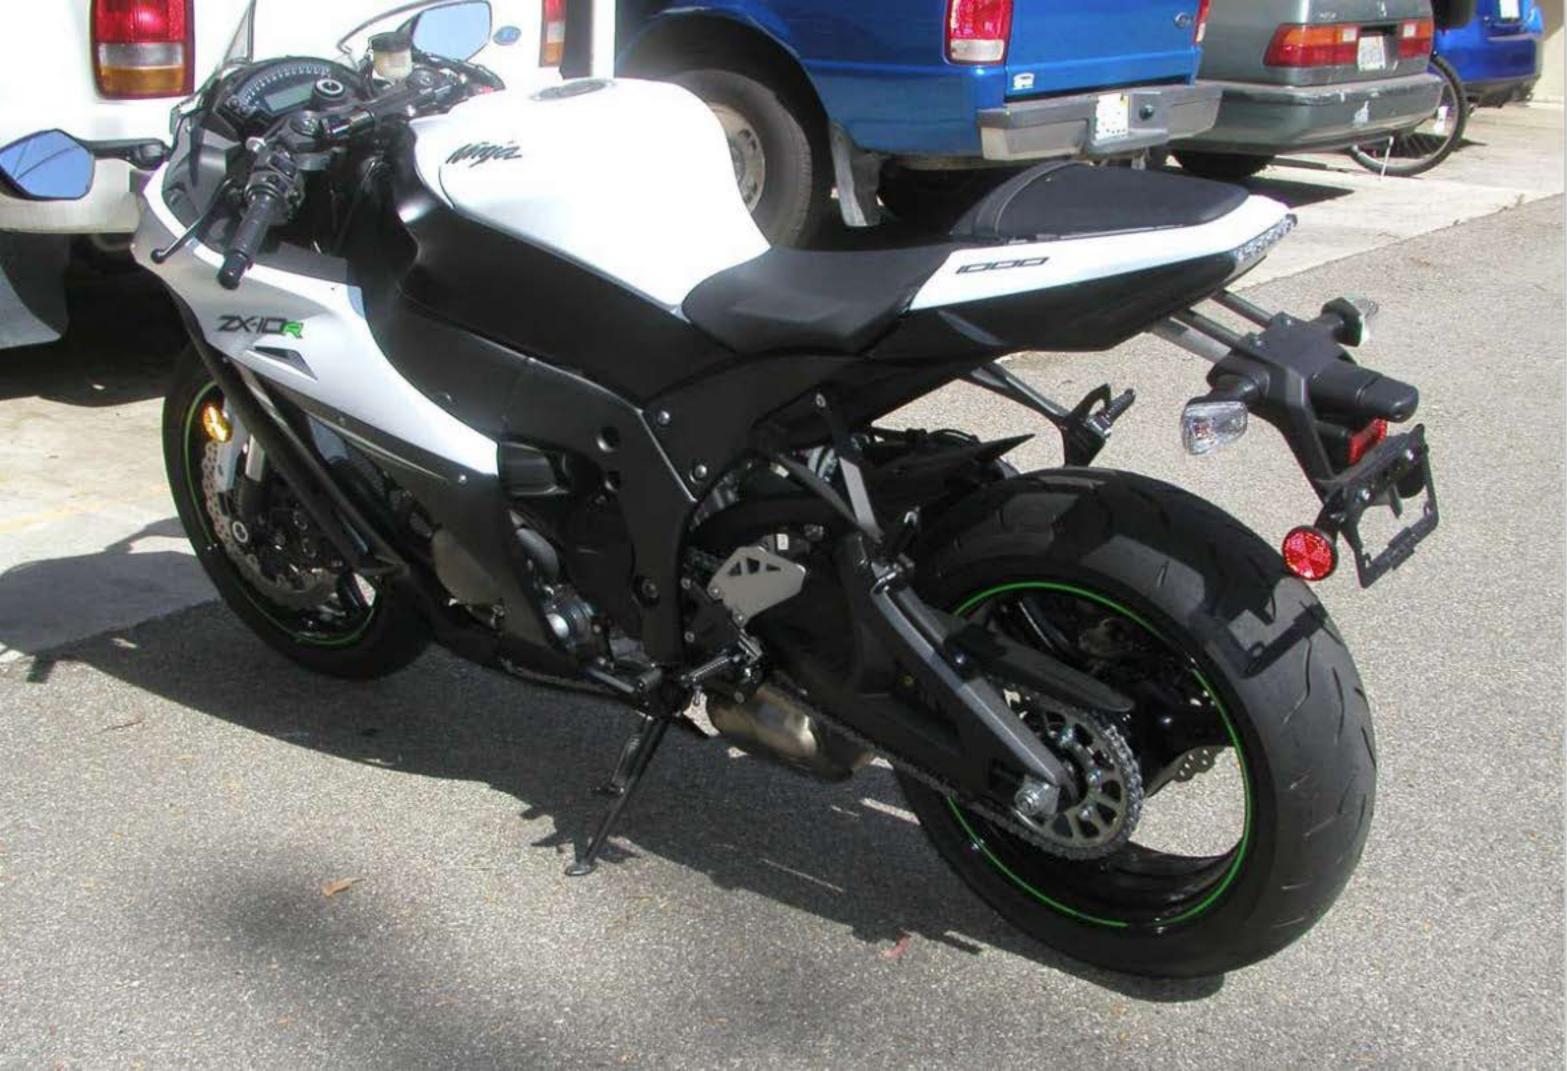
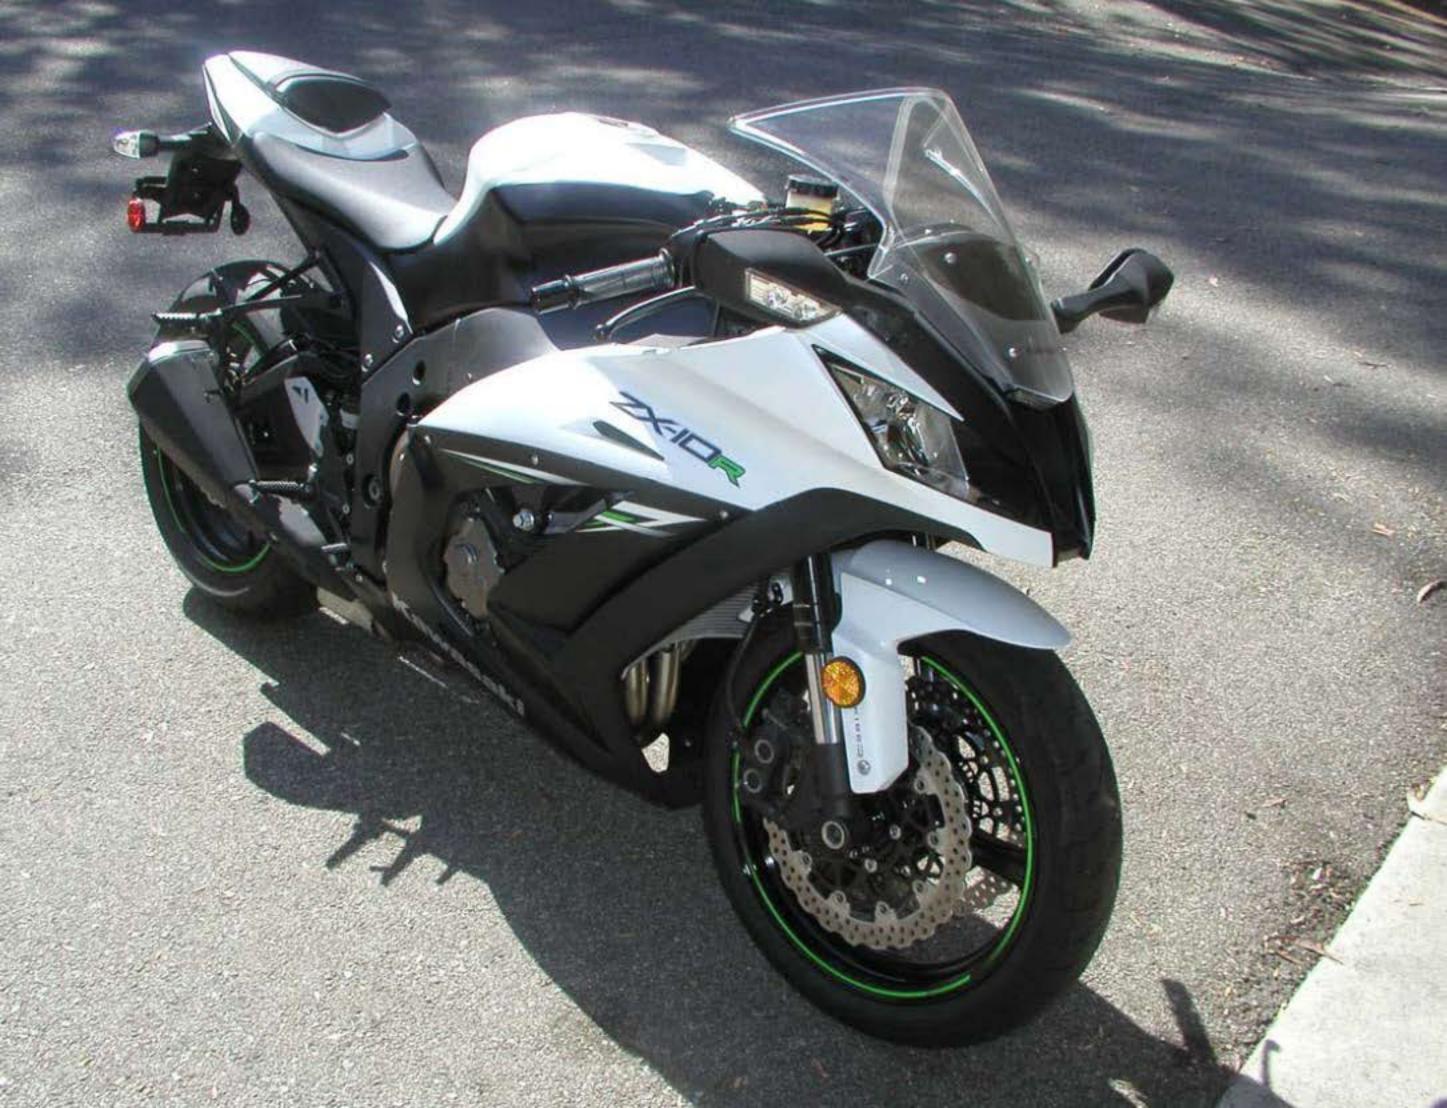
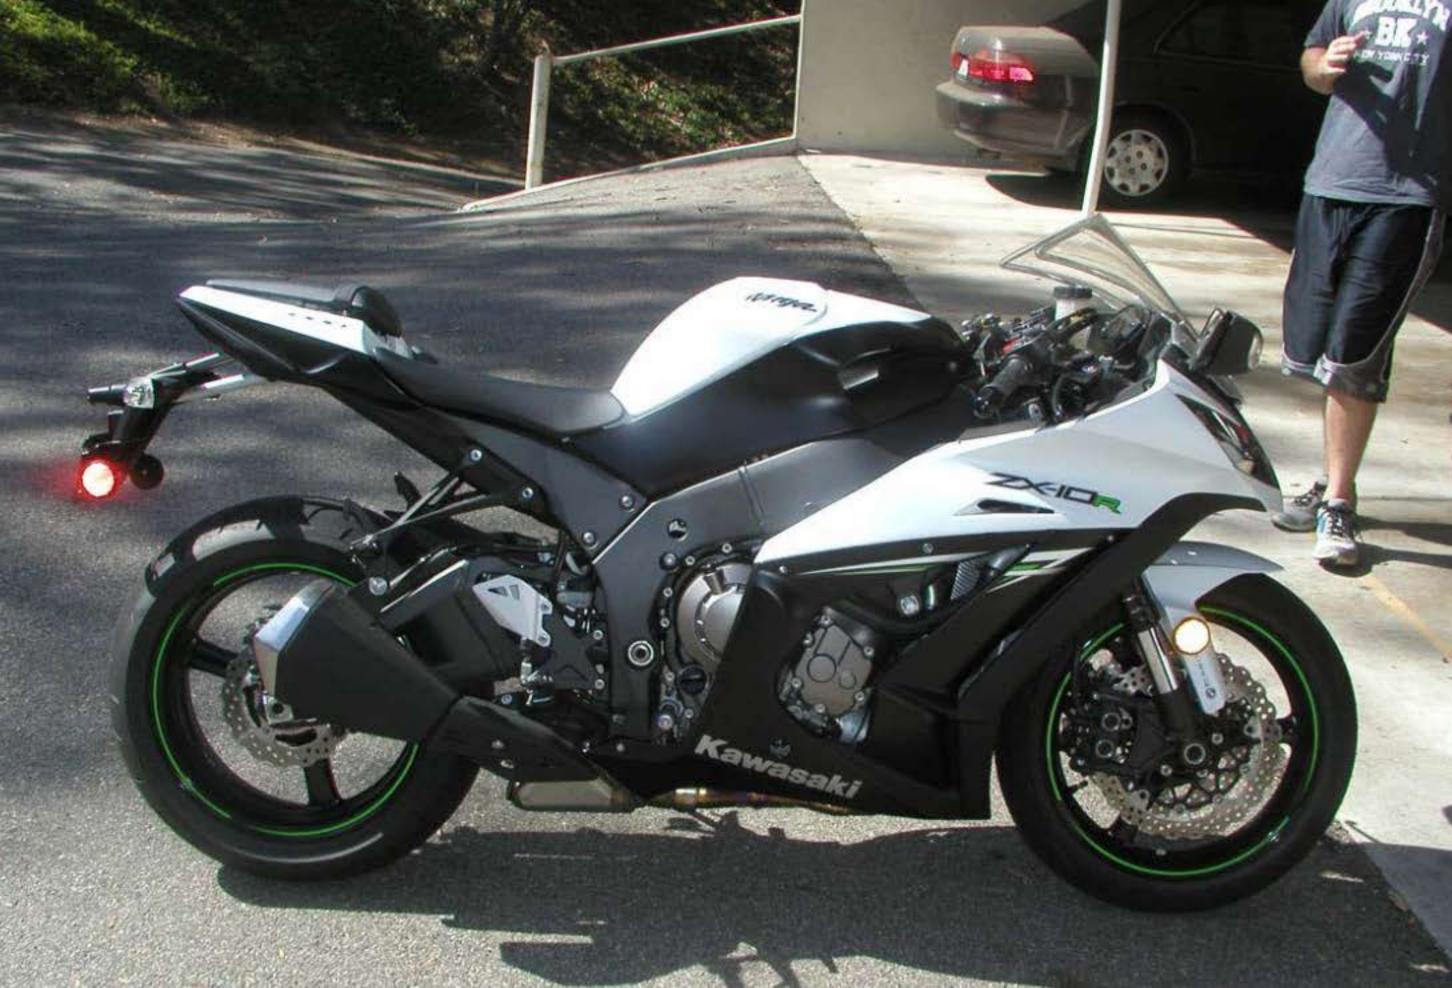
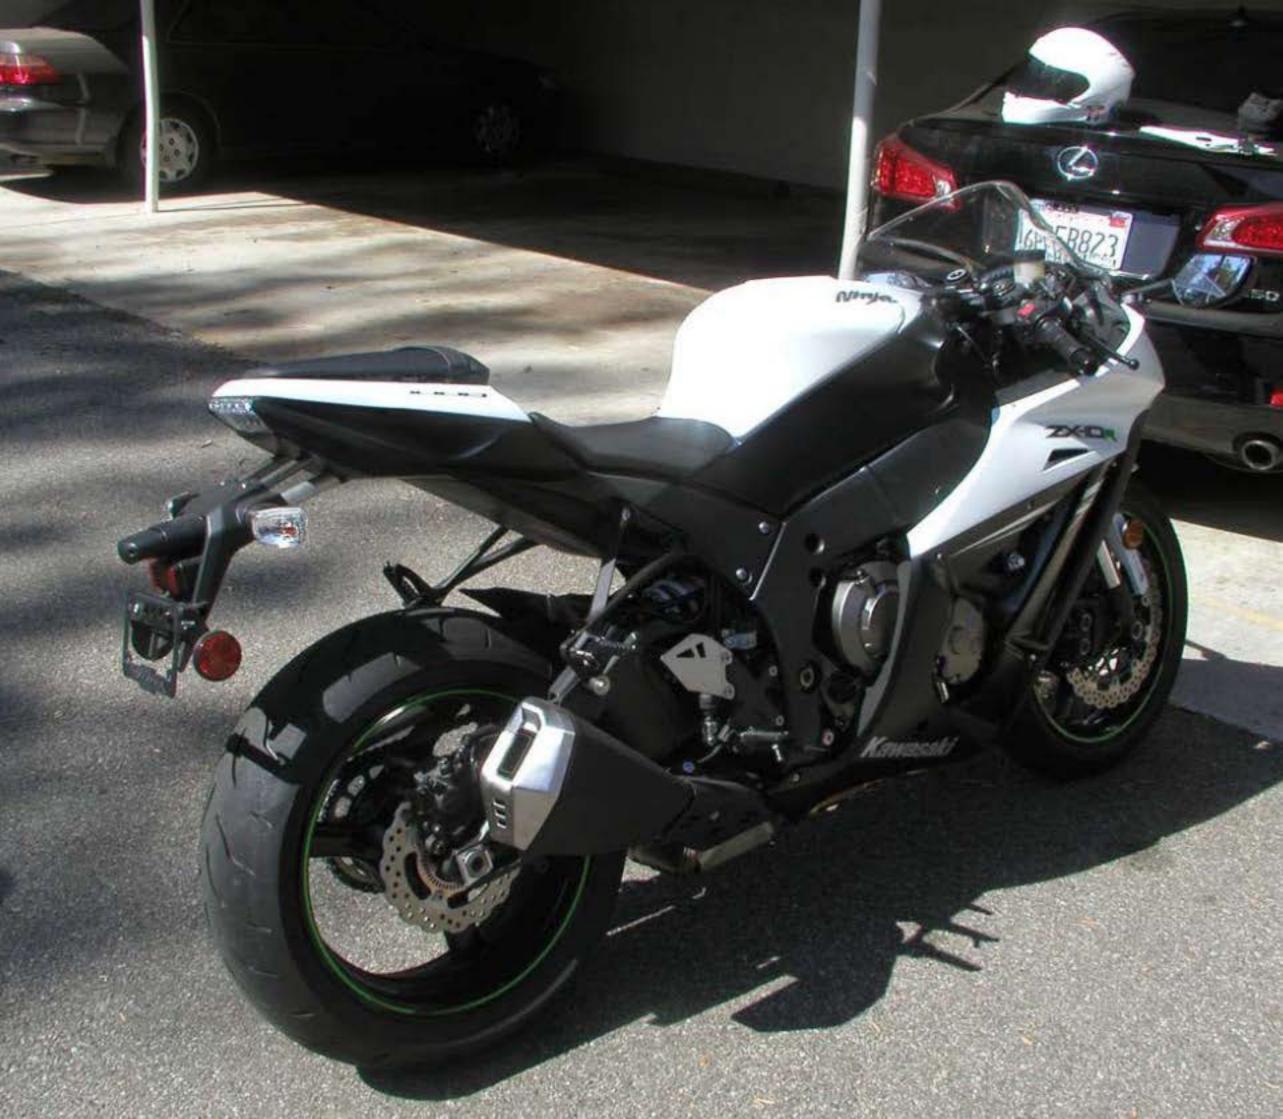
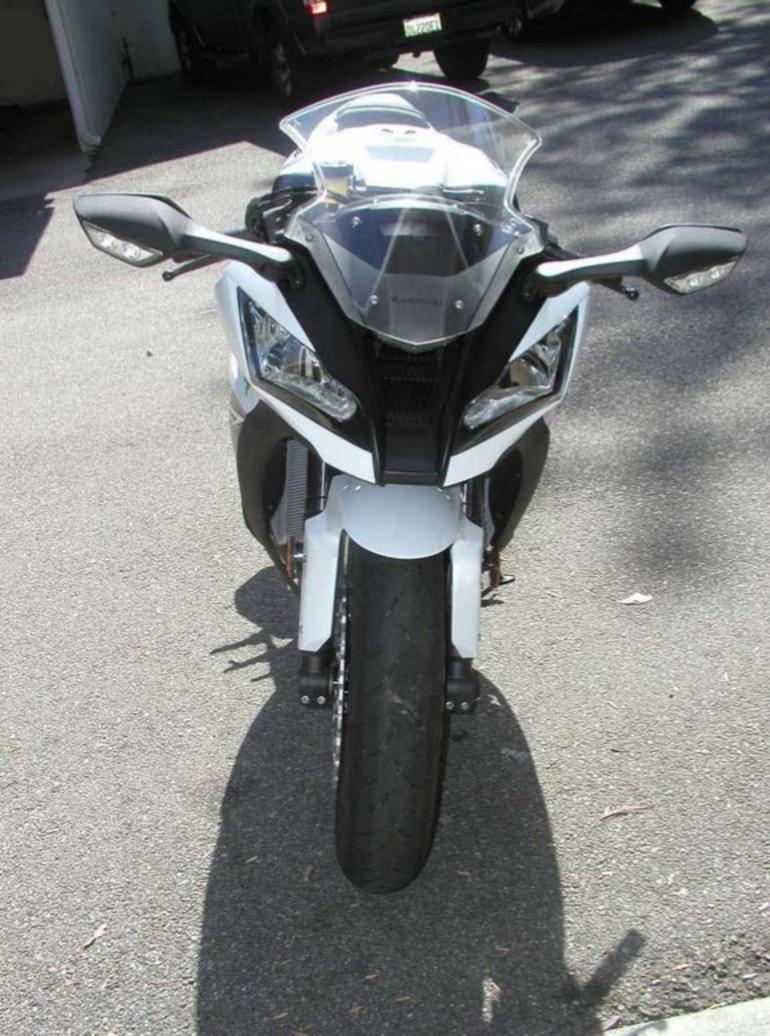
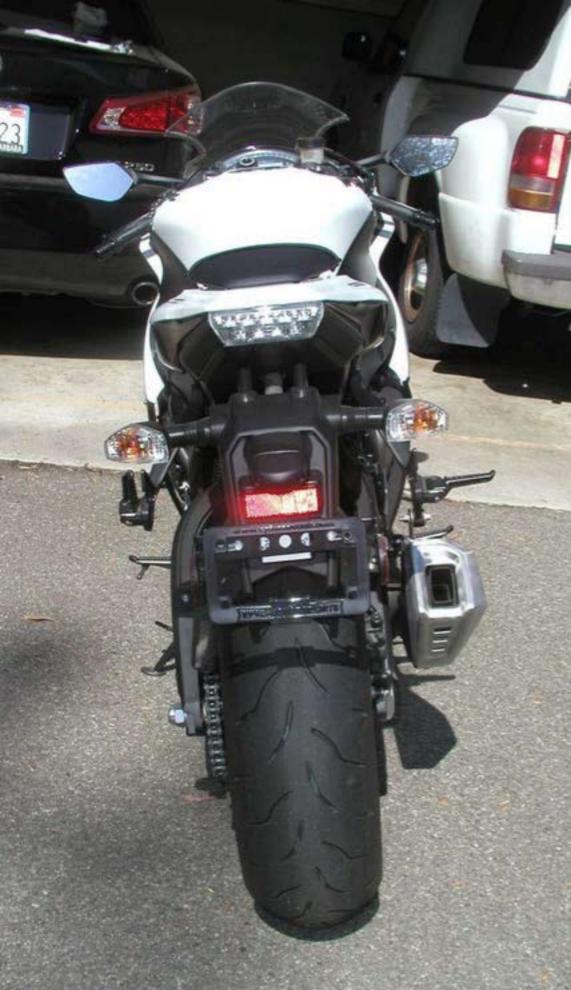
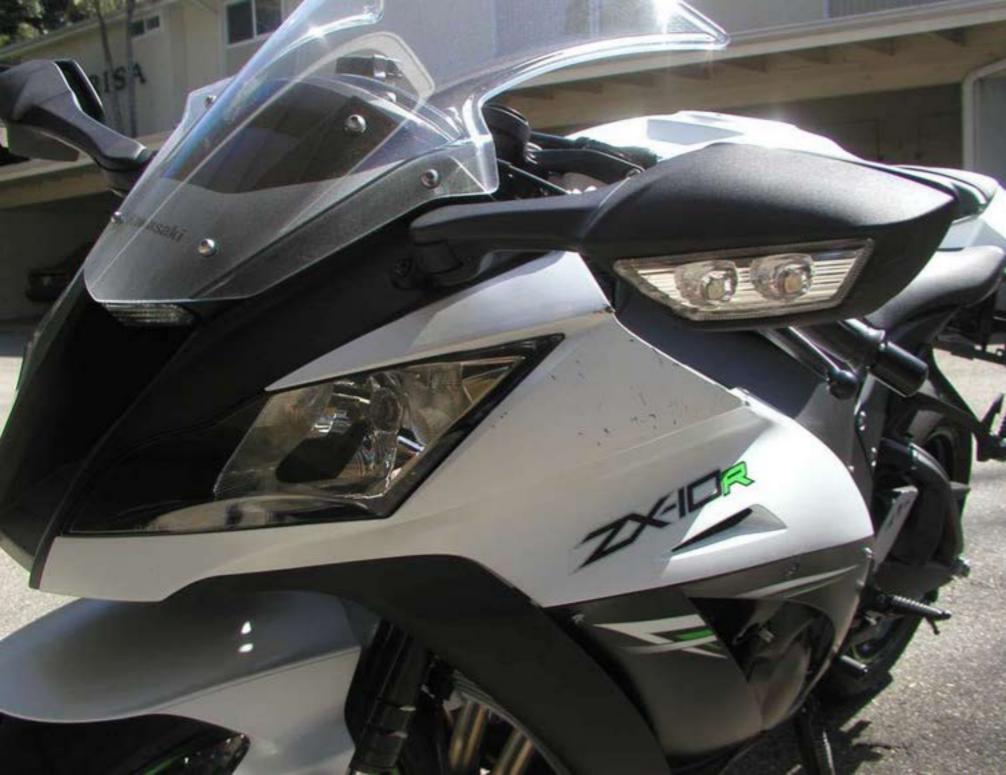
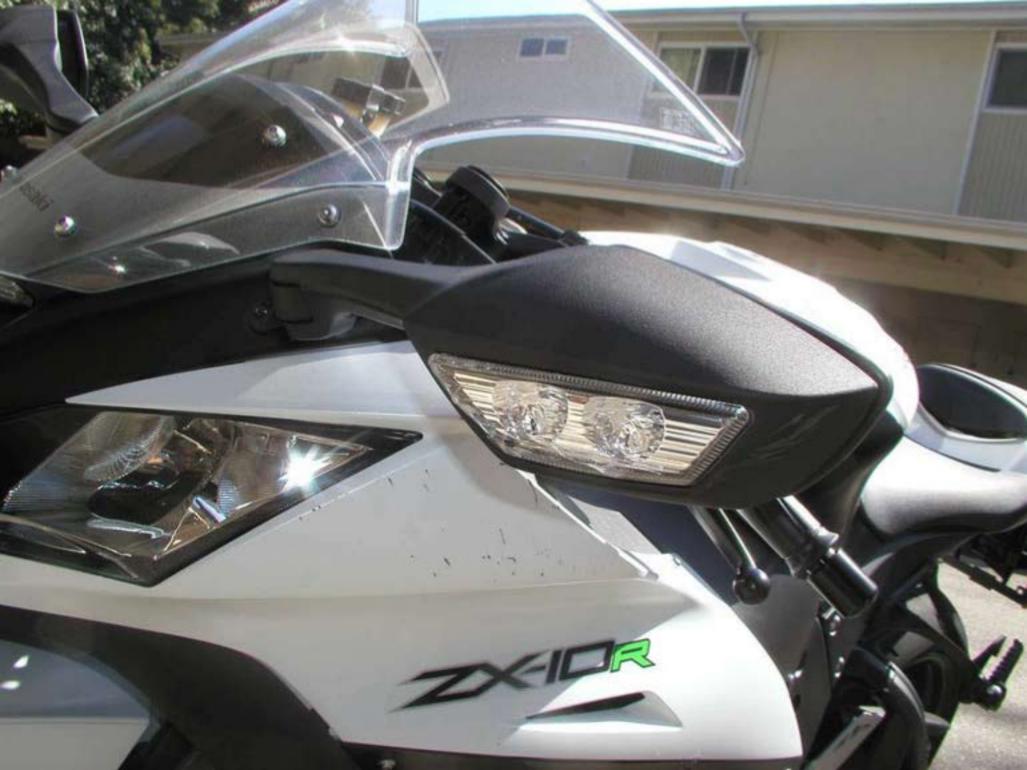
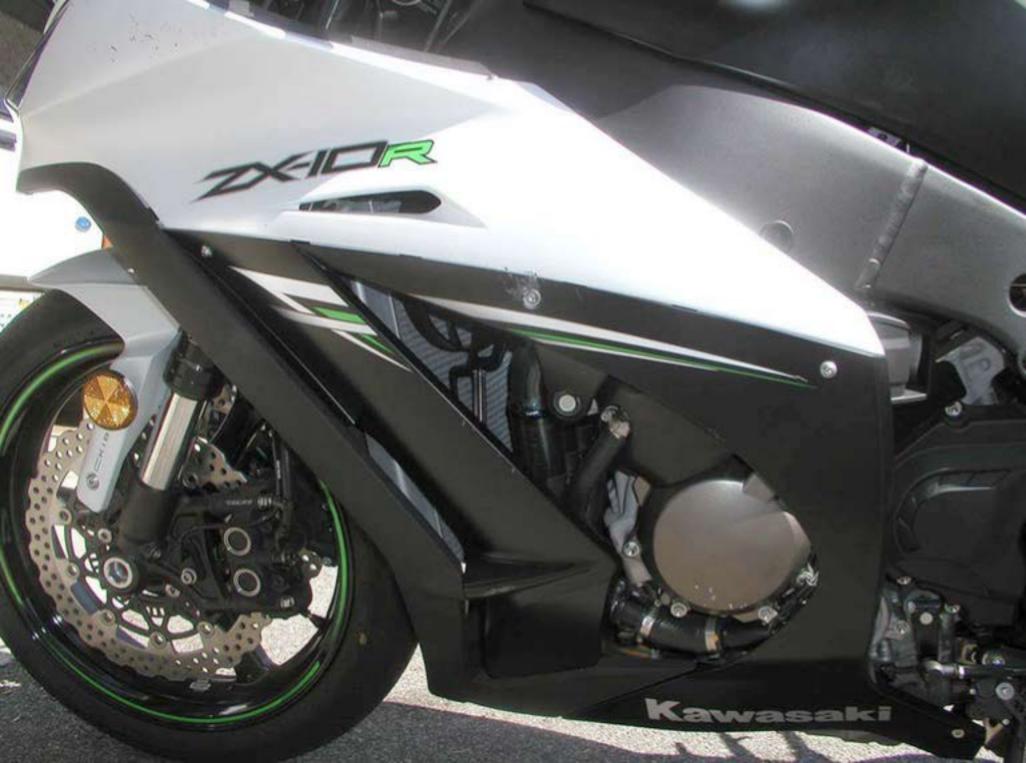
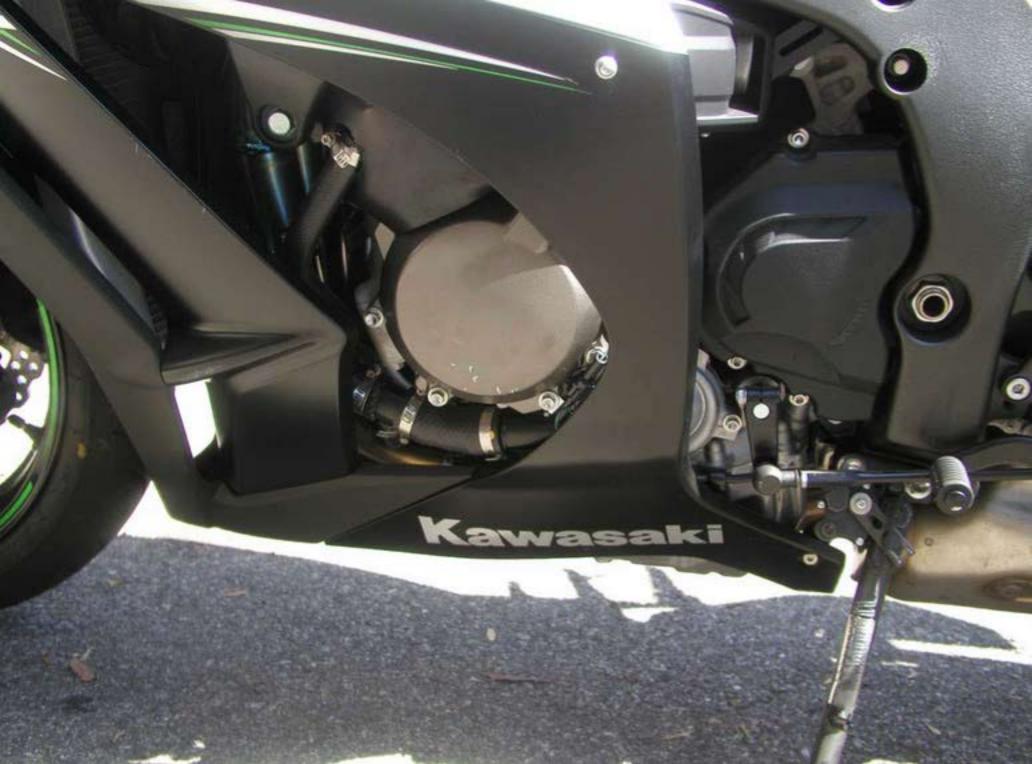
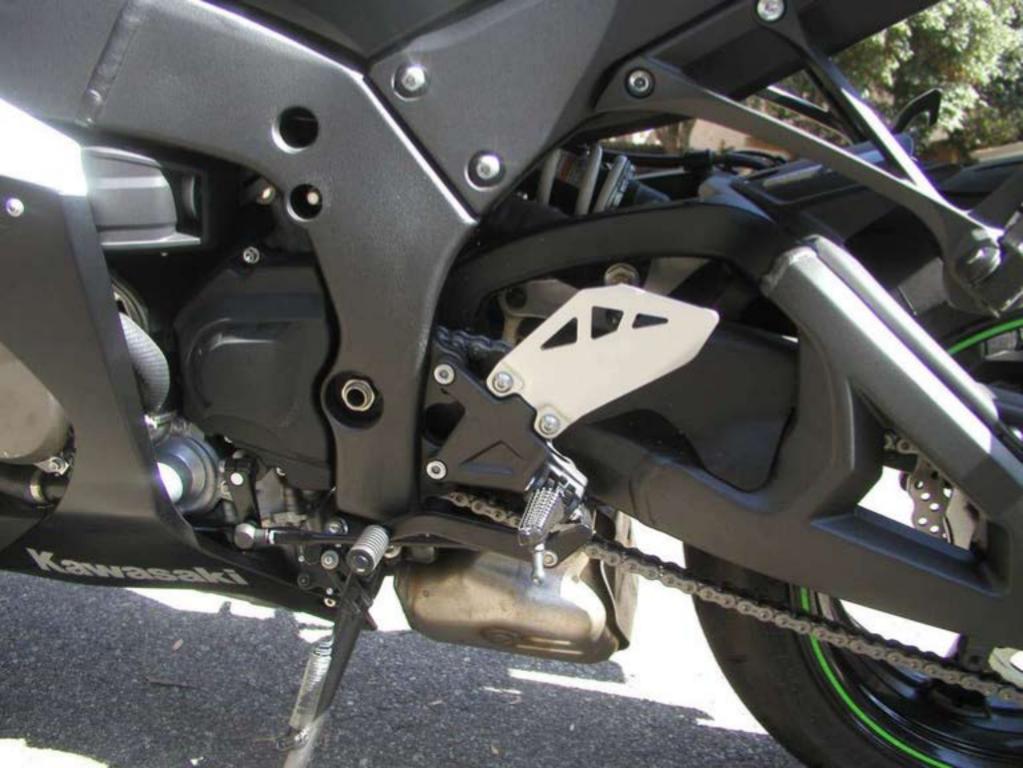
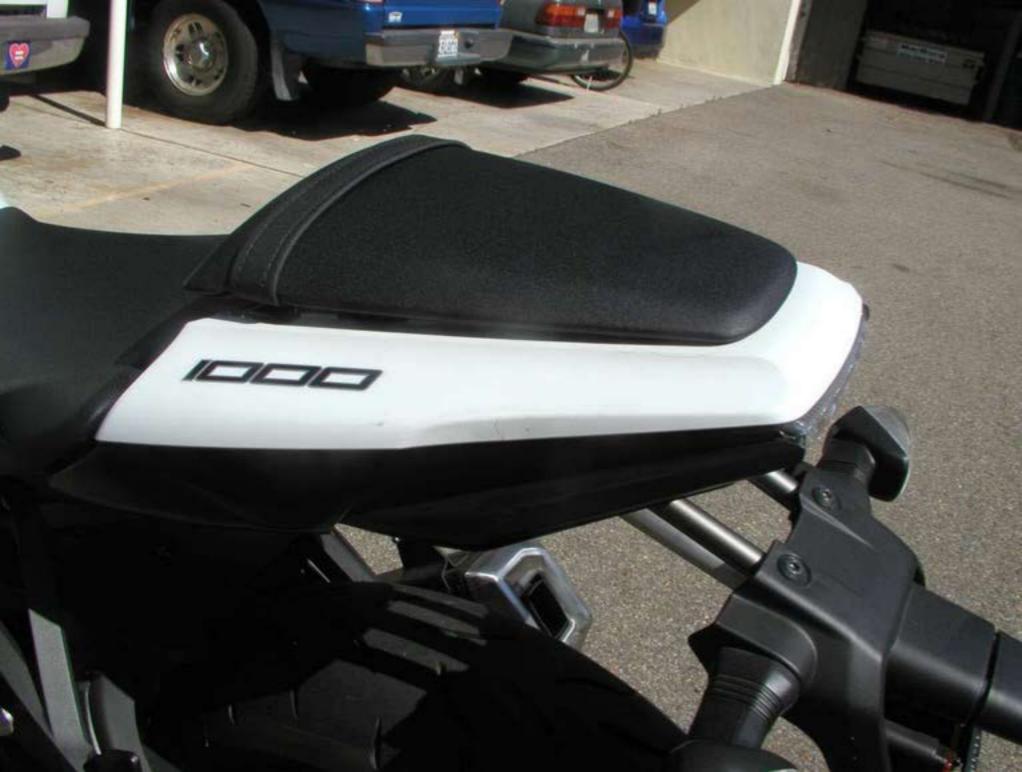
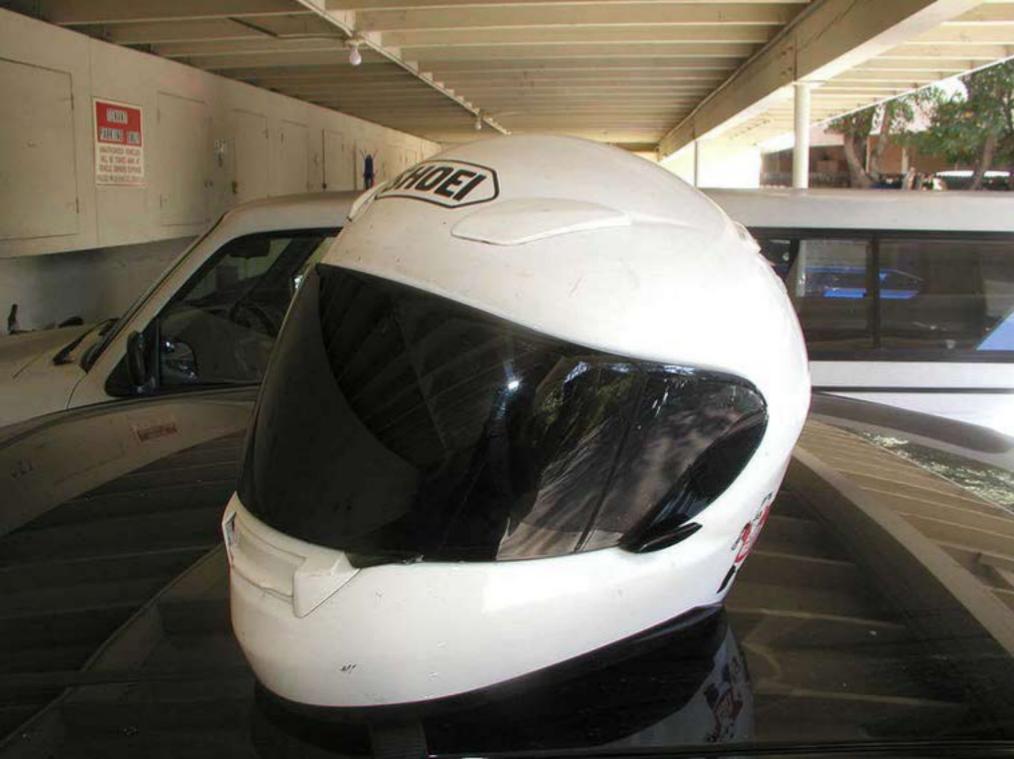
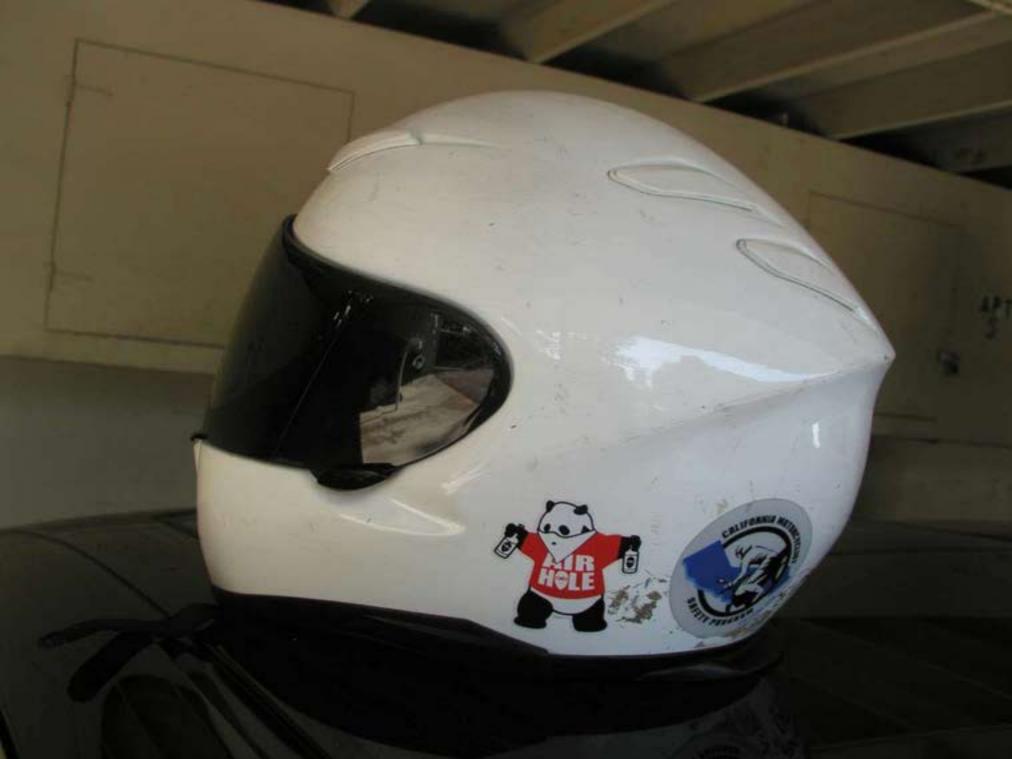
Inspected insured's motorcycle at his residence on 7/10/2015. Left side damage in the form of abrasions, scratches and dents.

Damaged parts include the upper and side cowlings, mirror, handlebar end, lever and perch, engine cover, foot rests and tail cover.

Parts prices are set to current MSRP. Labor is local dealership rate. No accessory damage but the safety gear (helmet), which was attached to the vehicle shows impact damage (photos enclosed).

Repairs are per my estimate of \$ 2,010.50 less twice \$1,000 deductible.
