# Beaver Restoration on Thirtynine Mile Mountain

*An experiment in restoring wetland and watershed functions on  
headwaters streams in the Upper South Platte*

**Mark Beardsley and Jessica Doran, EcoMetrics**  
**Kristen Meyer, Pike National Forest, South Park Ranger District**

**4/3/2015**

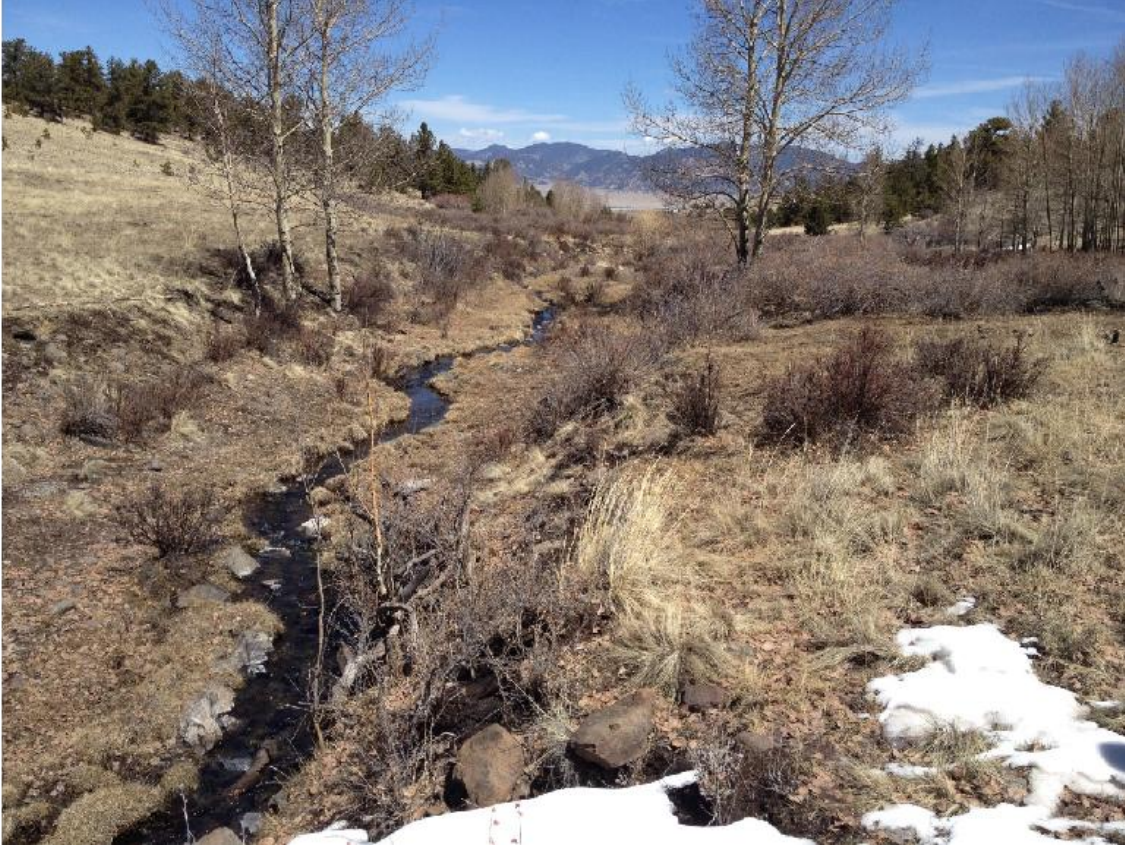
**Figure 2: On artificially channelized reaches, the stream is entrenched and dissociated from its historic floodplain. Deeply entrenched segments such as this have limited wetland restoration potential as bank heights exceed the height of typical stable beaver dams.**

The LP-2 reach apparently has good potential, but the stream is deeply incised on this reach. Some of the historic beaver dams on this reach are, in fact, now perched 5-10 feet above the present elevation of the creek. Some more recent relic dams were observed along the creek at its present elevation within the entrenched channel, which is a strong indication that beavers could gain a foothold on this site and succeed in building dams. Nevertheless, the depth of entrenchment would probably severely limit the potential for expanding wetland area laterally, since hydrologic effects of the dams would be confined within the entrenched channel (see Figure 2).

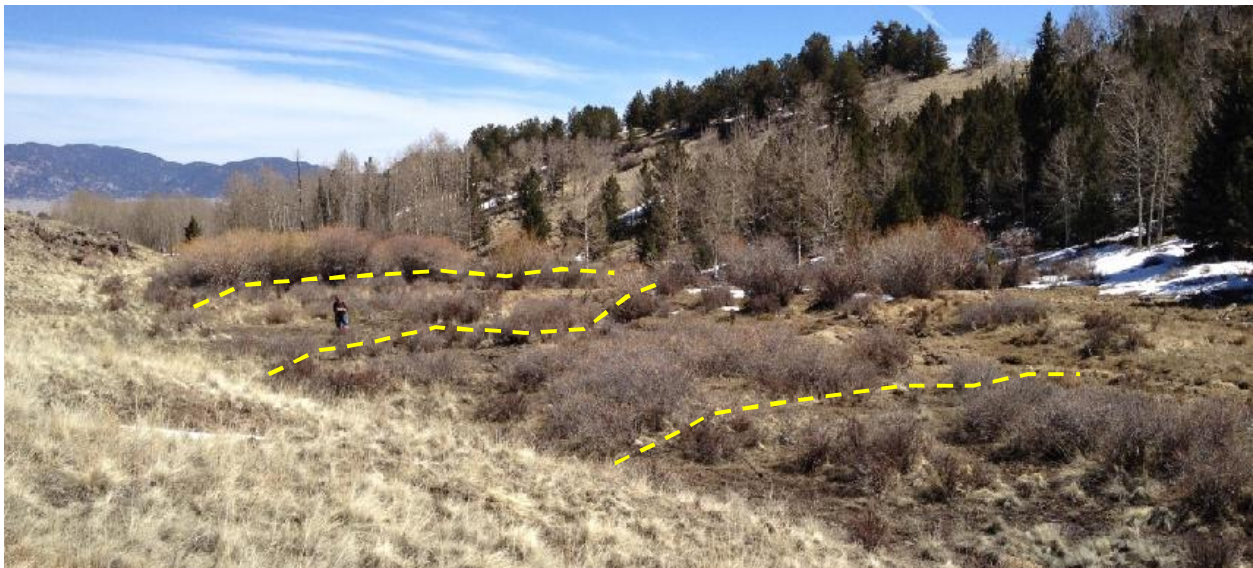
**Figure 3: The single thread channel of Pruden Creek is visible on the right side of the image running through a historically active floodplain. Relic beaver dams are identified by the dashed lines.**

Pruden and Cross Creeks offer good potential for restoration of wetland functions by reintroducing beavers. About 8900 ft of the Pruden Creek drainage and 4500 ft on Cross Creek have good or excellent habitat suitability for beavers. From these suitable reaches, we identified two priority sites on Pruden Creek (about 1900 ft) and one site on Cross Creek (about 700 ft) where beaver reintroduction is predicted to result in the restoration of about 2.5 and 0.9 acres worth of wetland functional units, respectively. (These are the blue segments in Figure 1). Figure 3 is a photo of the selected Middle Pruden Creek restoration site taken in September of 2014.

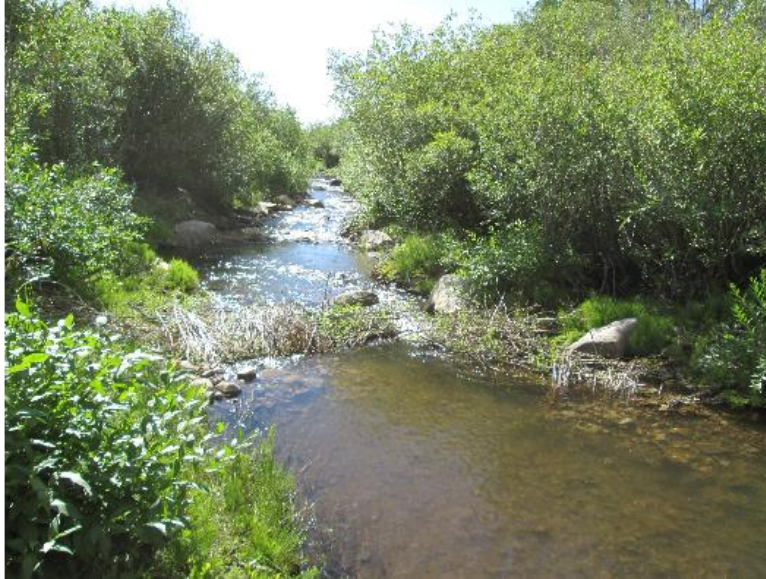
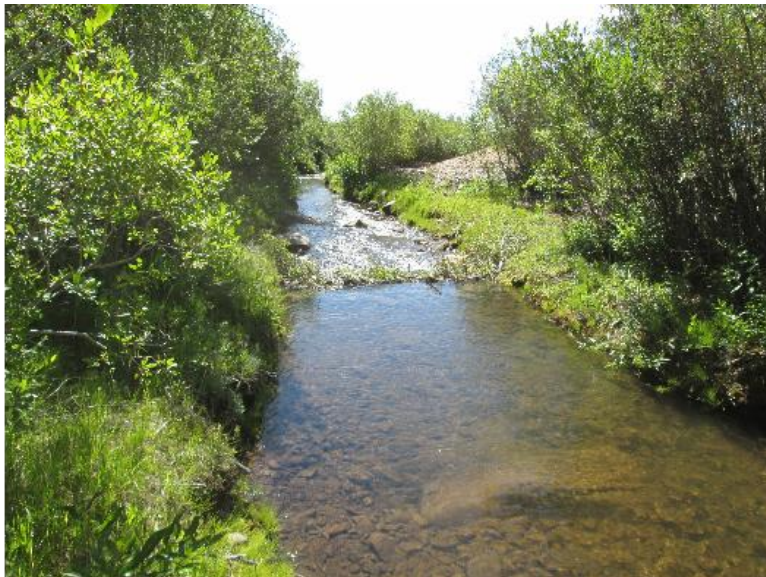
**Figure 4: Example brush dam beaver dam analogs on Tarryall Creek .**

We recommend using brush dams (Figure 4) as the select BDA structure where possible since they are simple and easy to construct using small diameter wood, rock, and sod mats that are

available on site. They are also low impact, temporary, and generally passable by most aquatic organisms including fish. Relict beaver dams are present at both of the recommended release sites, and an ideal strategy would be to utilize these existing dams by simply plugging the areas that are breached with constructed brush dams. Brush dams about five feet wide and one to two feet tall will be sufficient at most locations for this purpose.
