## **Defining the Cost Benefit of Inflow Removal Before Infiltration Exploration**

Frederick Bloetscher, Ph.D., P.E., LEED-AP, DWRE  
Florida Atlantic University and  
Public Utility Management and Planning Services, Inc.

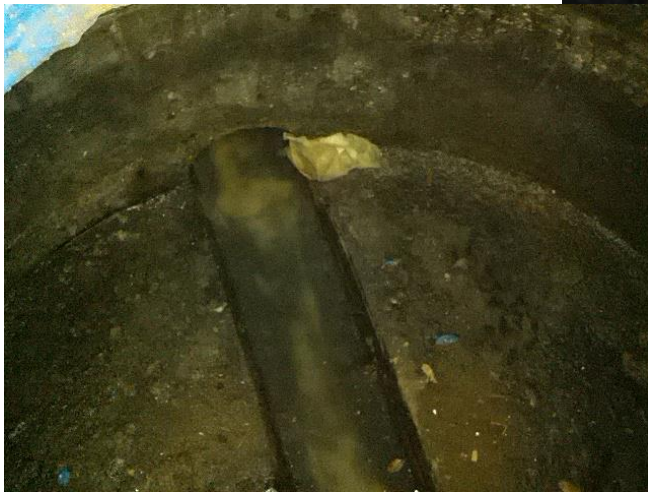
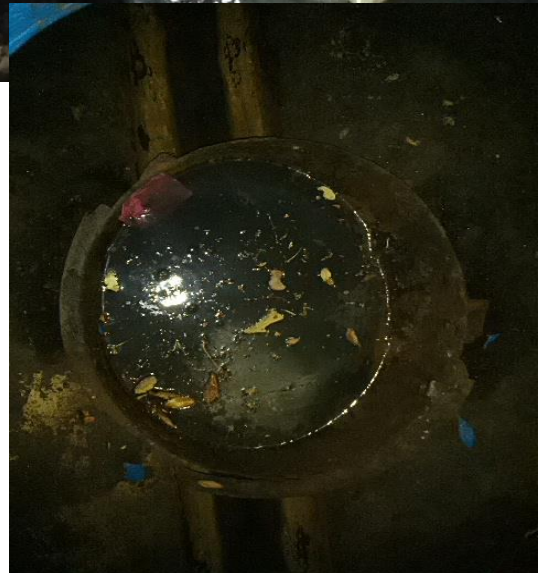
Figure 3a Grease in the manhole 3b. Improper disposal of material 3c Wipes 3d Old manhole dish

often not the case. The manhole inspection documented condition, GPS location, ties to photographic data and some form of numbering if not currently available. Manhole inspections can also document useful information like excessive grease build-ups, improper disposal of feminine hygiene products, wipes, and other trash (see Figures 3a-d). It should be noted that 17 percent of people regularly flush baby wipes down the toilet because manufacturers say they are flushable (Stratton-Childers, 2015). Unknown percentages flush diapers, towelettes and other products, Options to reduce this problem include trash cans, access to towels and wipes in restrooms, bidets and systems like the Heinie-Genie (Rabines, 2015), but none of these are convenient away from home. Education is the best and cheapest solution as the wipes do not deteriorate in the sewers. Instead they clog pumps, stick to grease and clog pipes. Most manholes have limited condition issues, but where the bench or walls are in poor conditions, that should be repaired with an impregnating resin. Deterioration may be an indication of wastewater quality concerns requiring the addition of chemicals to reduce the impact of hydrogen sulfide.

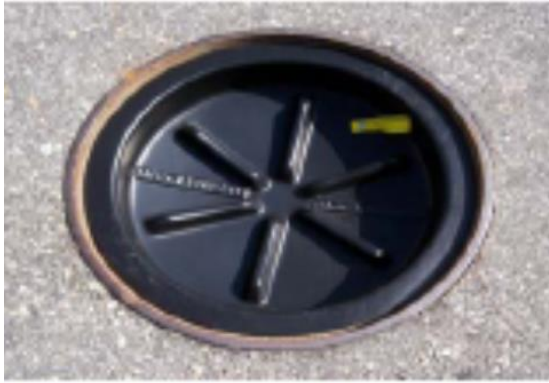
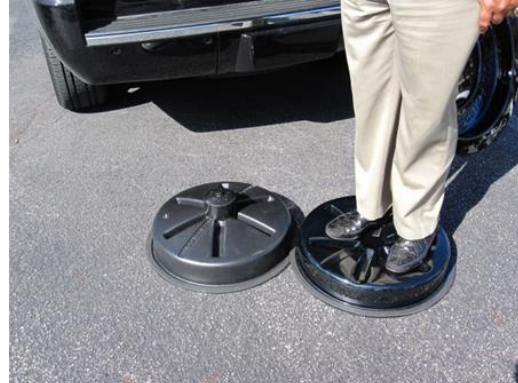
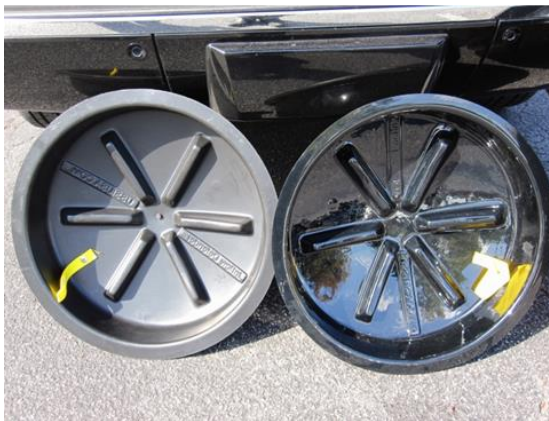
Figure 5: Inflow Defender Manhole Rain Dish showing installed dish, and both polycarbonate and polyethylene versions. \*Note the ribs and depth of dish that improves long-term strength. Note polycarbonate is required for newer, 30 or 48 inch manhole (Courtesy, USSI, Inc.; Bloetscher, 2011)

Next is repair/sealing of chimneys in all manholes to reduce inflow from the street during flooding events. The chimney includes the ring, cement extensions, lift rings, brick or cement used to raise the manhole ring. Manhole covers are often disturbed during paving or as a result of traffic. Temperature, vibration, and traffic breaks the seal between the steel ring and concrete. The crack between the ring and cover can leak a lot of water as demonstrated by a Miami-Dade County test conducted several years ago (MiamiDade, 2010). The intent of the chimney seal is to prevent inflow from the area beneath the rim of the manhole, but above the cone (see Figure 4). The next step is to put dishes into the manholes. One might think that only manholes in low lying areas get water into them, but surprisingly every manhole dish that is properly installed has water in it. Hence assume that all manholes leak water between the rim and cover. Most collection system workers are familiar with dishes at the bottom of the manhole where they are of limited use. This is because those dishes deform when filled with water or are constructed in such a manner that allows them to be knocked in when the cover is flipped. The solution is a deeper dish with reinforcing ribs and a gasket. Figure 5 shows two examples (note the guy standing in the upside-down dish) - one polycarbonate (shiny) and a polyethylene

copolymer material suitable for atmospheres found in manholes. The polymer based dishes eliminate the dissimilar metals issues with stainless steel dishes and are available at a lower cost. The key is the appropriate reinforcing to prevent dishes from dropping into the manhole. The gasket seal should be made of a closed cell neoprene material with pressure sensitive adhesive on one side.

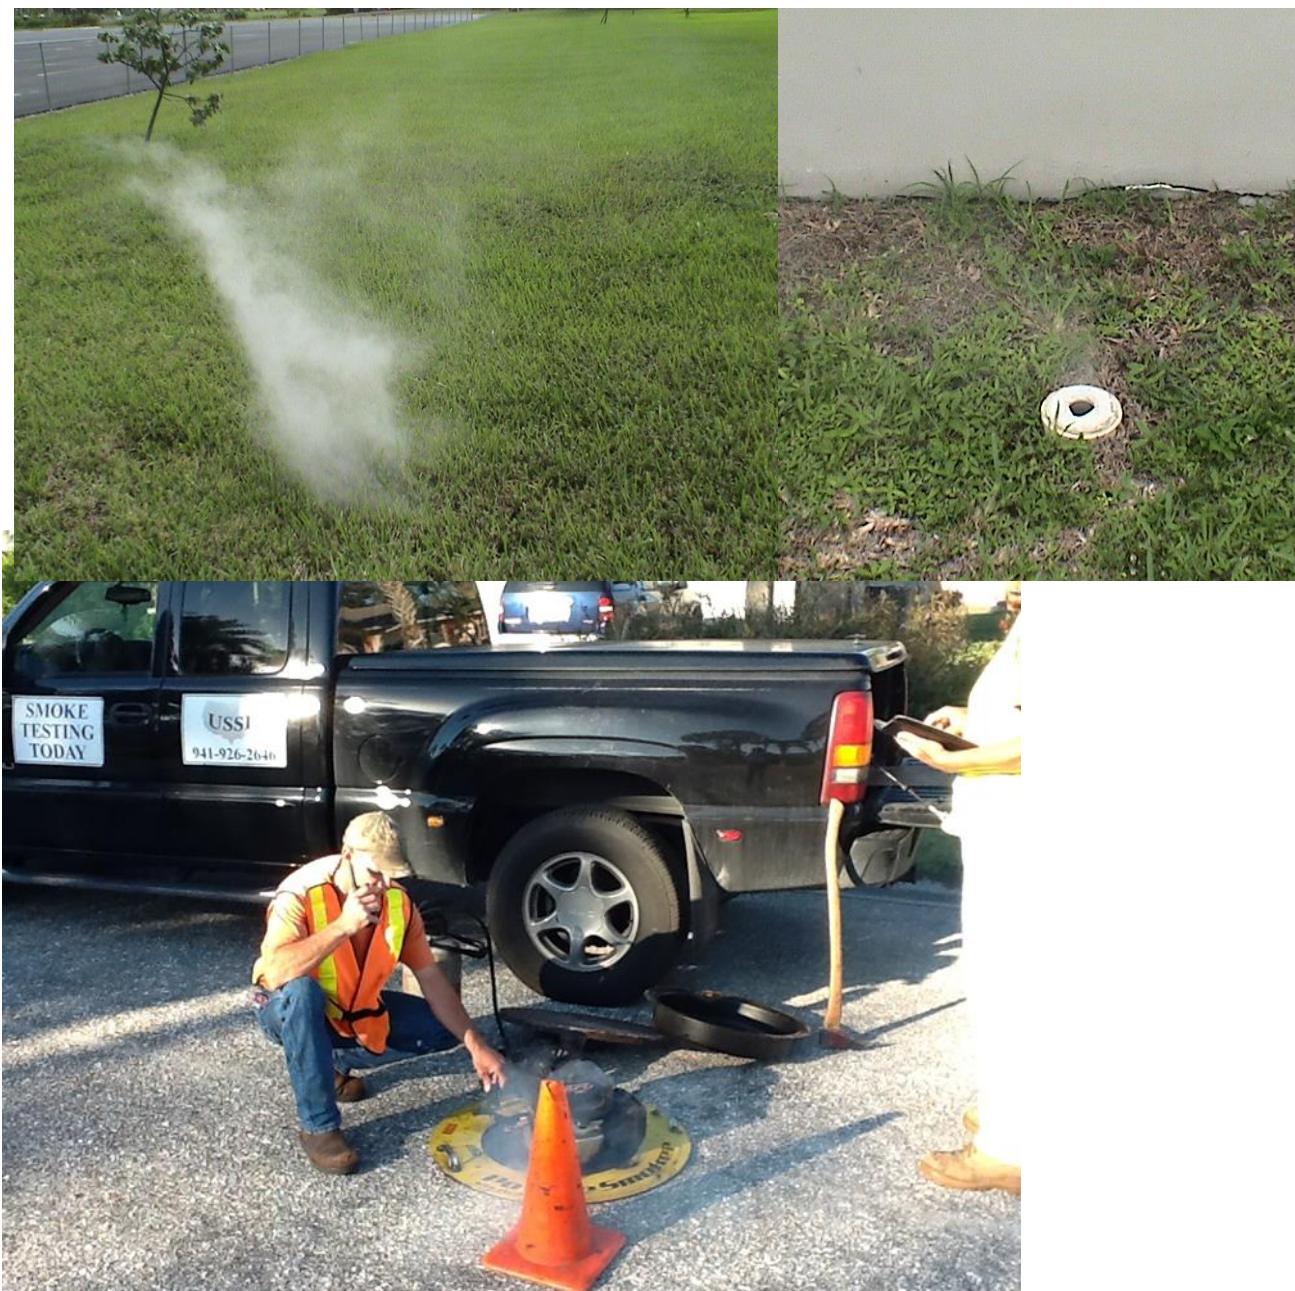
Figure 6 Smoke Test Results

Once the manholes are sealed, smoke testing can identify obvious surface connections (see Figure 6). The normal protocol for smoke testing will identify broken or missing cleanout caps, surface breaks on public and private property, connection of gutters to the sewer system, and storm water connections. All should be documented via photograph, by associated address and public or private location. The public openings at cleanouts can be corrected immediately using utility funds. If the cleanout is broken, it may indicate mower or vehicle damage that can occur again. If missing, the resident may be using the cleanout to drain the yard (more common than we realize). In either case the collection system needs to be protected with a device like an LDL plug (see Figure 7).
