Case 18-T-0604 - Application of Deepwater Wind South Fork, LLC
for a Certificate of Environmental Compatibility and Public Need for the Construction of Approximately 3.5 Miles of Submarine Export Cable from the New York State Territorial Waters Boundary to the South Shore of the Town of East Hampton in Suffolk County and Approximately 4.1 Miles of Terrestrial Export Cable from the South Shore of the Town of East Hampton to an Interconnection Facility with an Interconnection Cable Connecting to the Existing East Hampton Substation in the Town of East Hampton, Suffolk County.

Request Number:	Si Kinsella #12
Request Title:	PFAS Contamination – Griffiths Carpet
Addressed To:	NYS Dept. of Environmental Conservation
From:	Simon Kinsella
Date of Request:	January 13, 2020

Site Characterization Report

East Hampton Airport
Wainscott, Suffolk County, New York

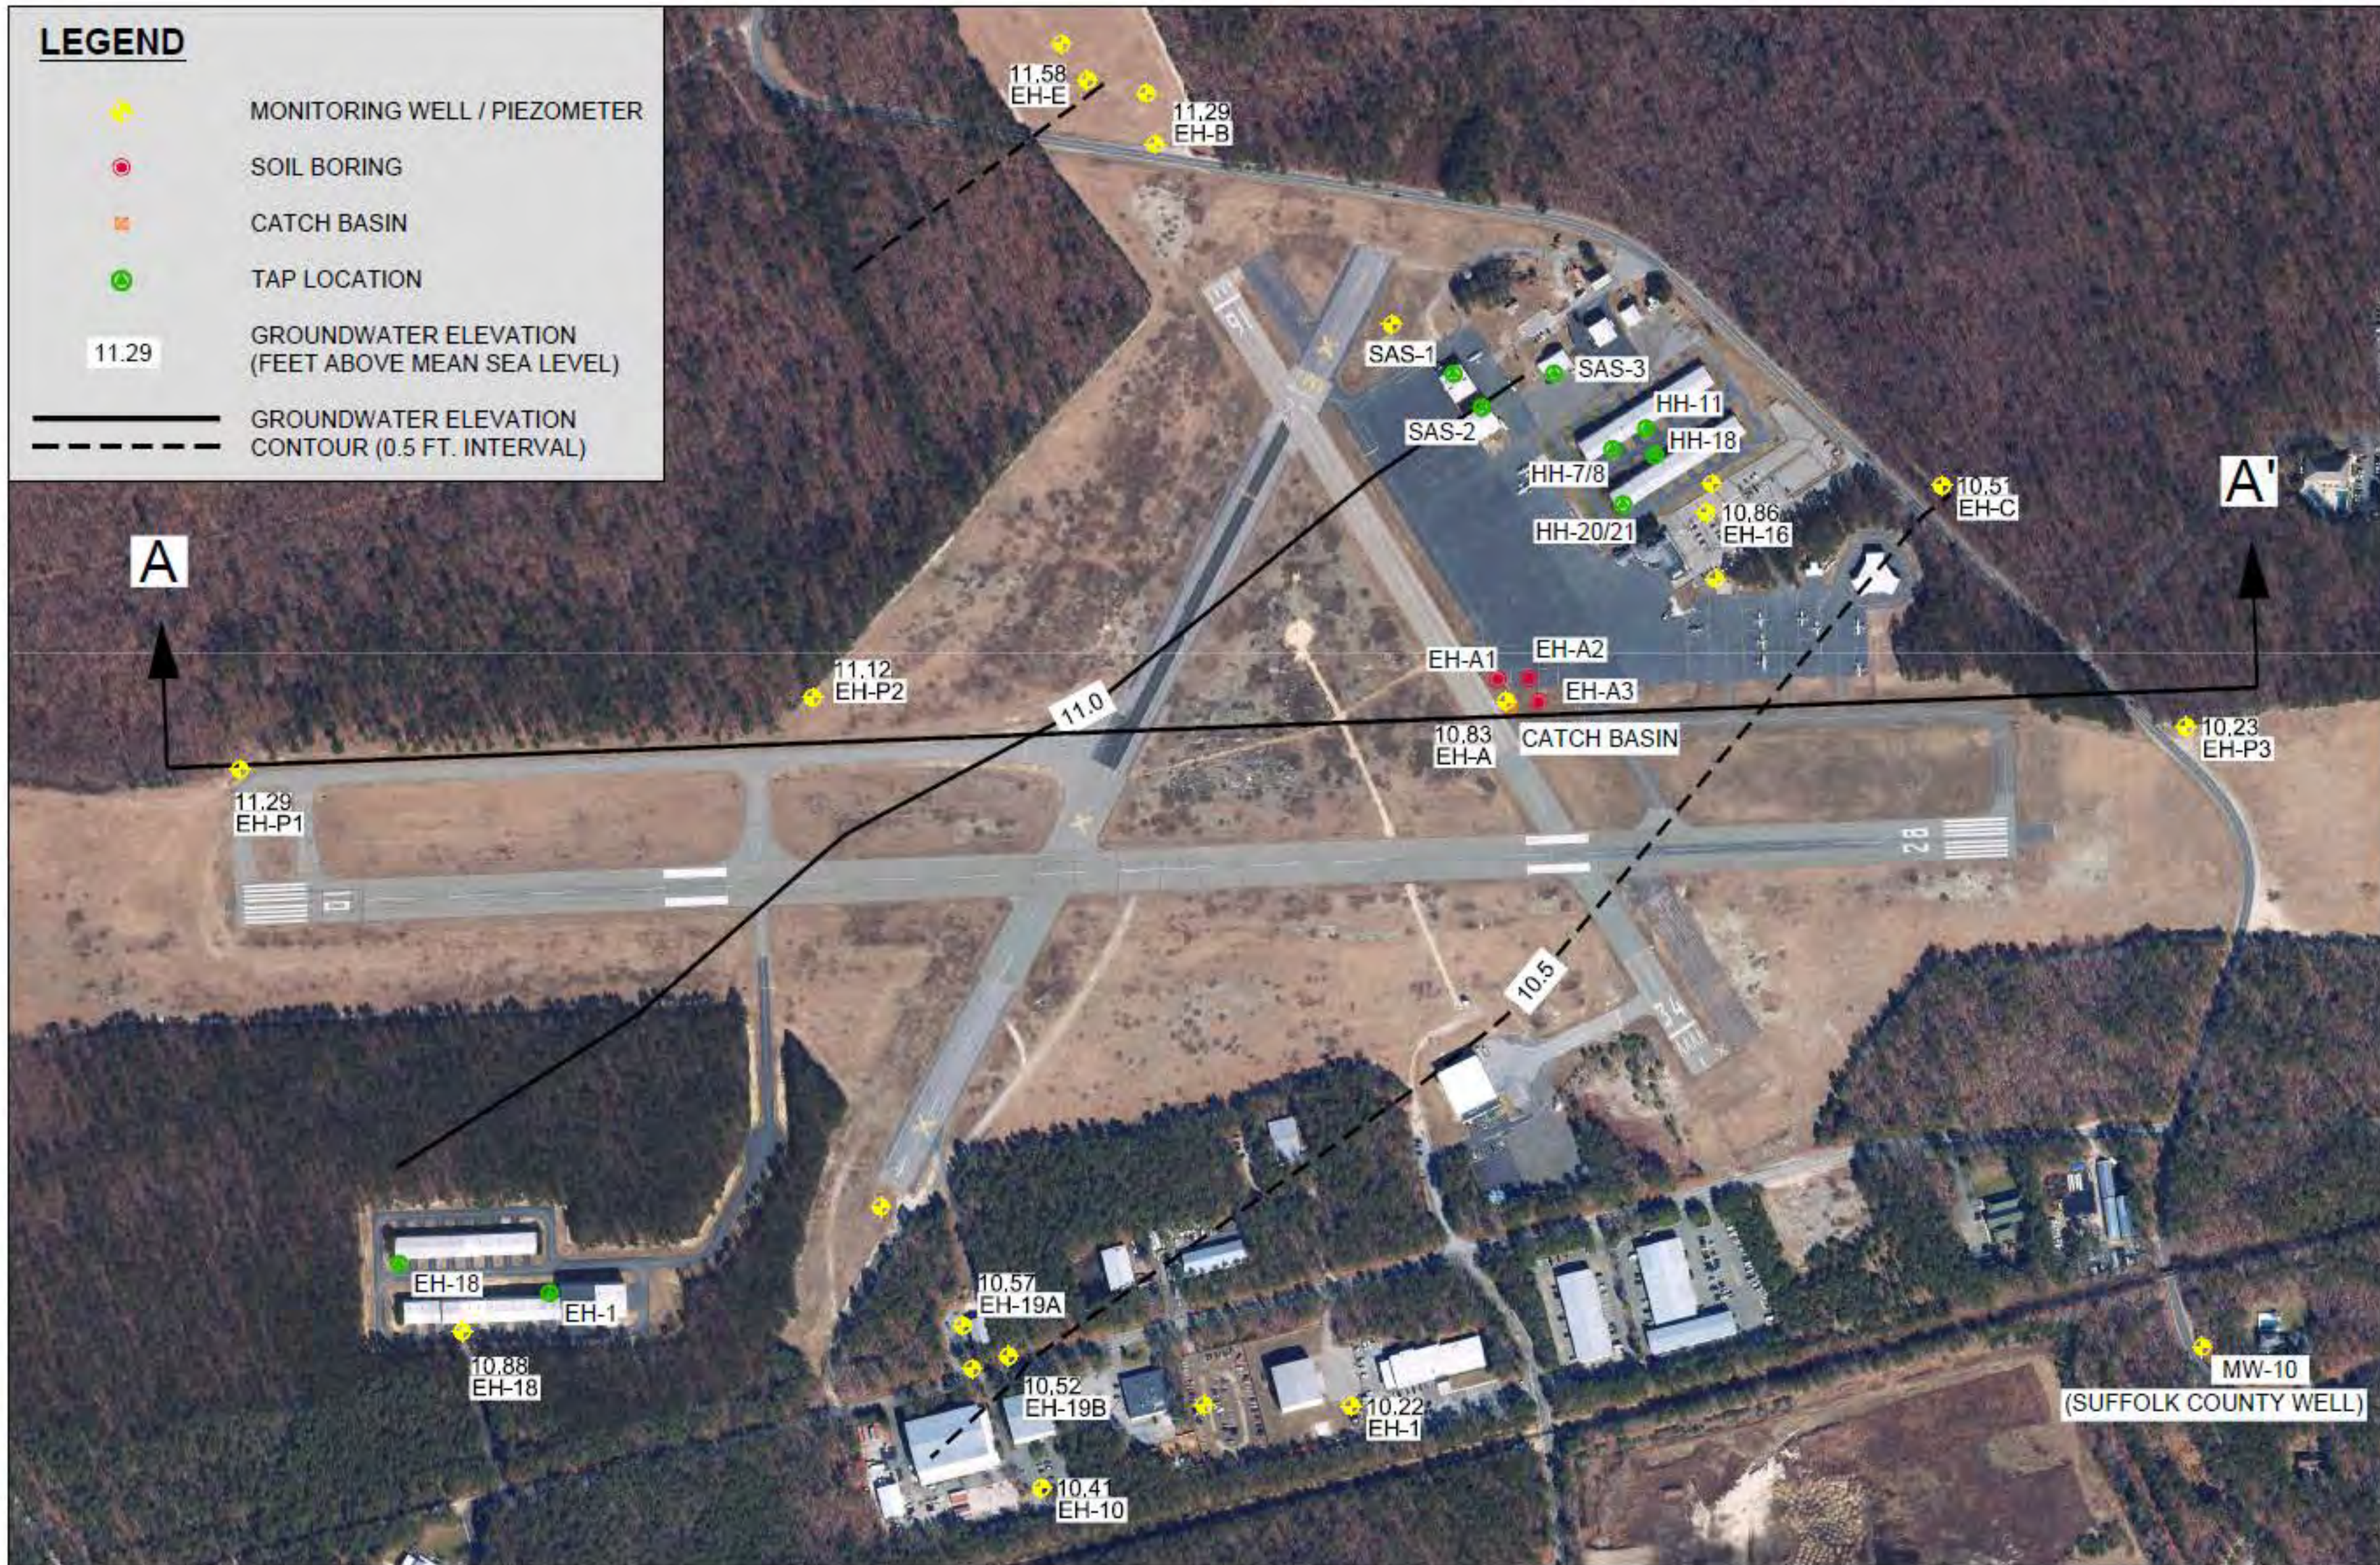
GROUNDWATER ELEVATION CONTOUR (0.5 FT. INTERVAL)

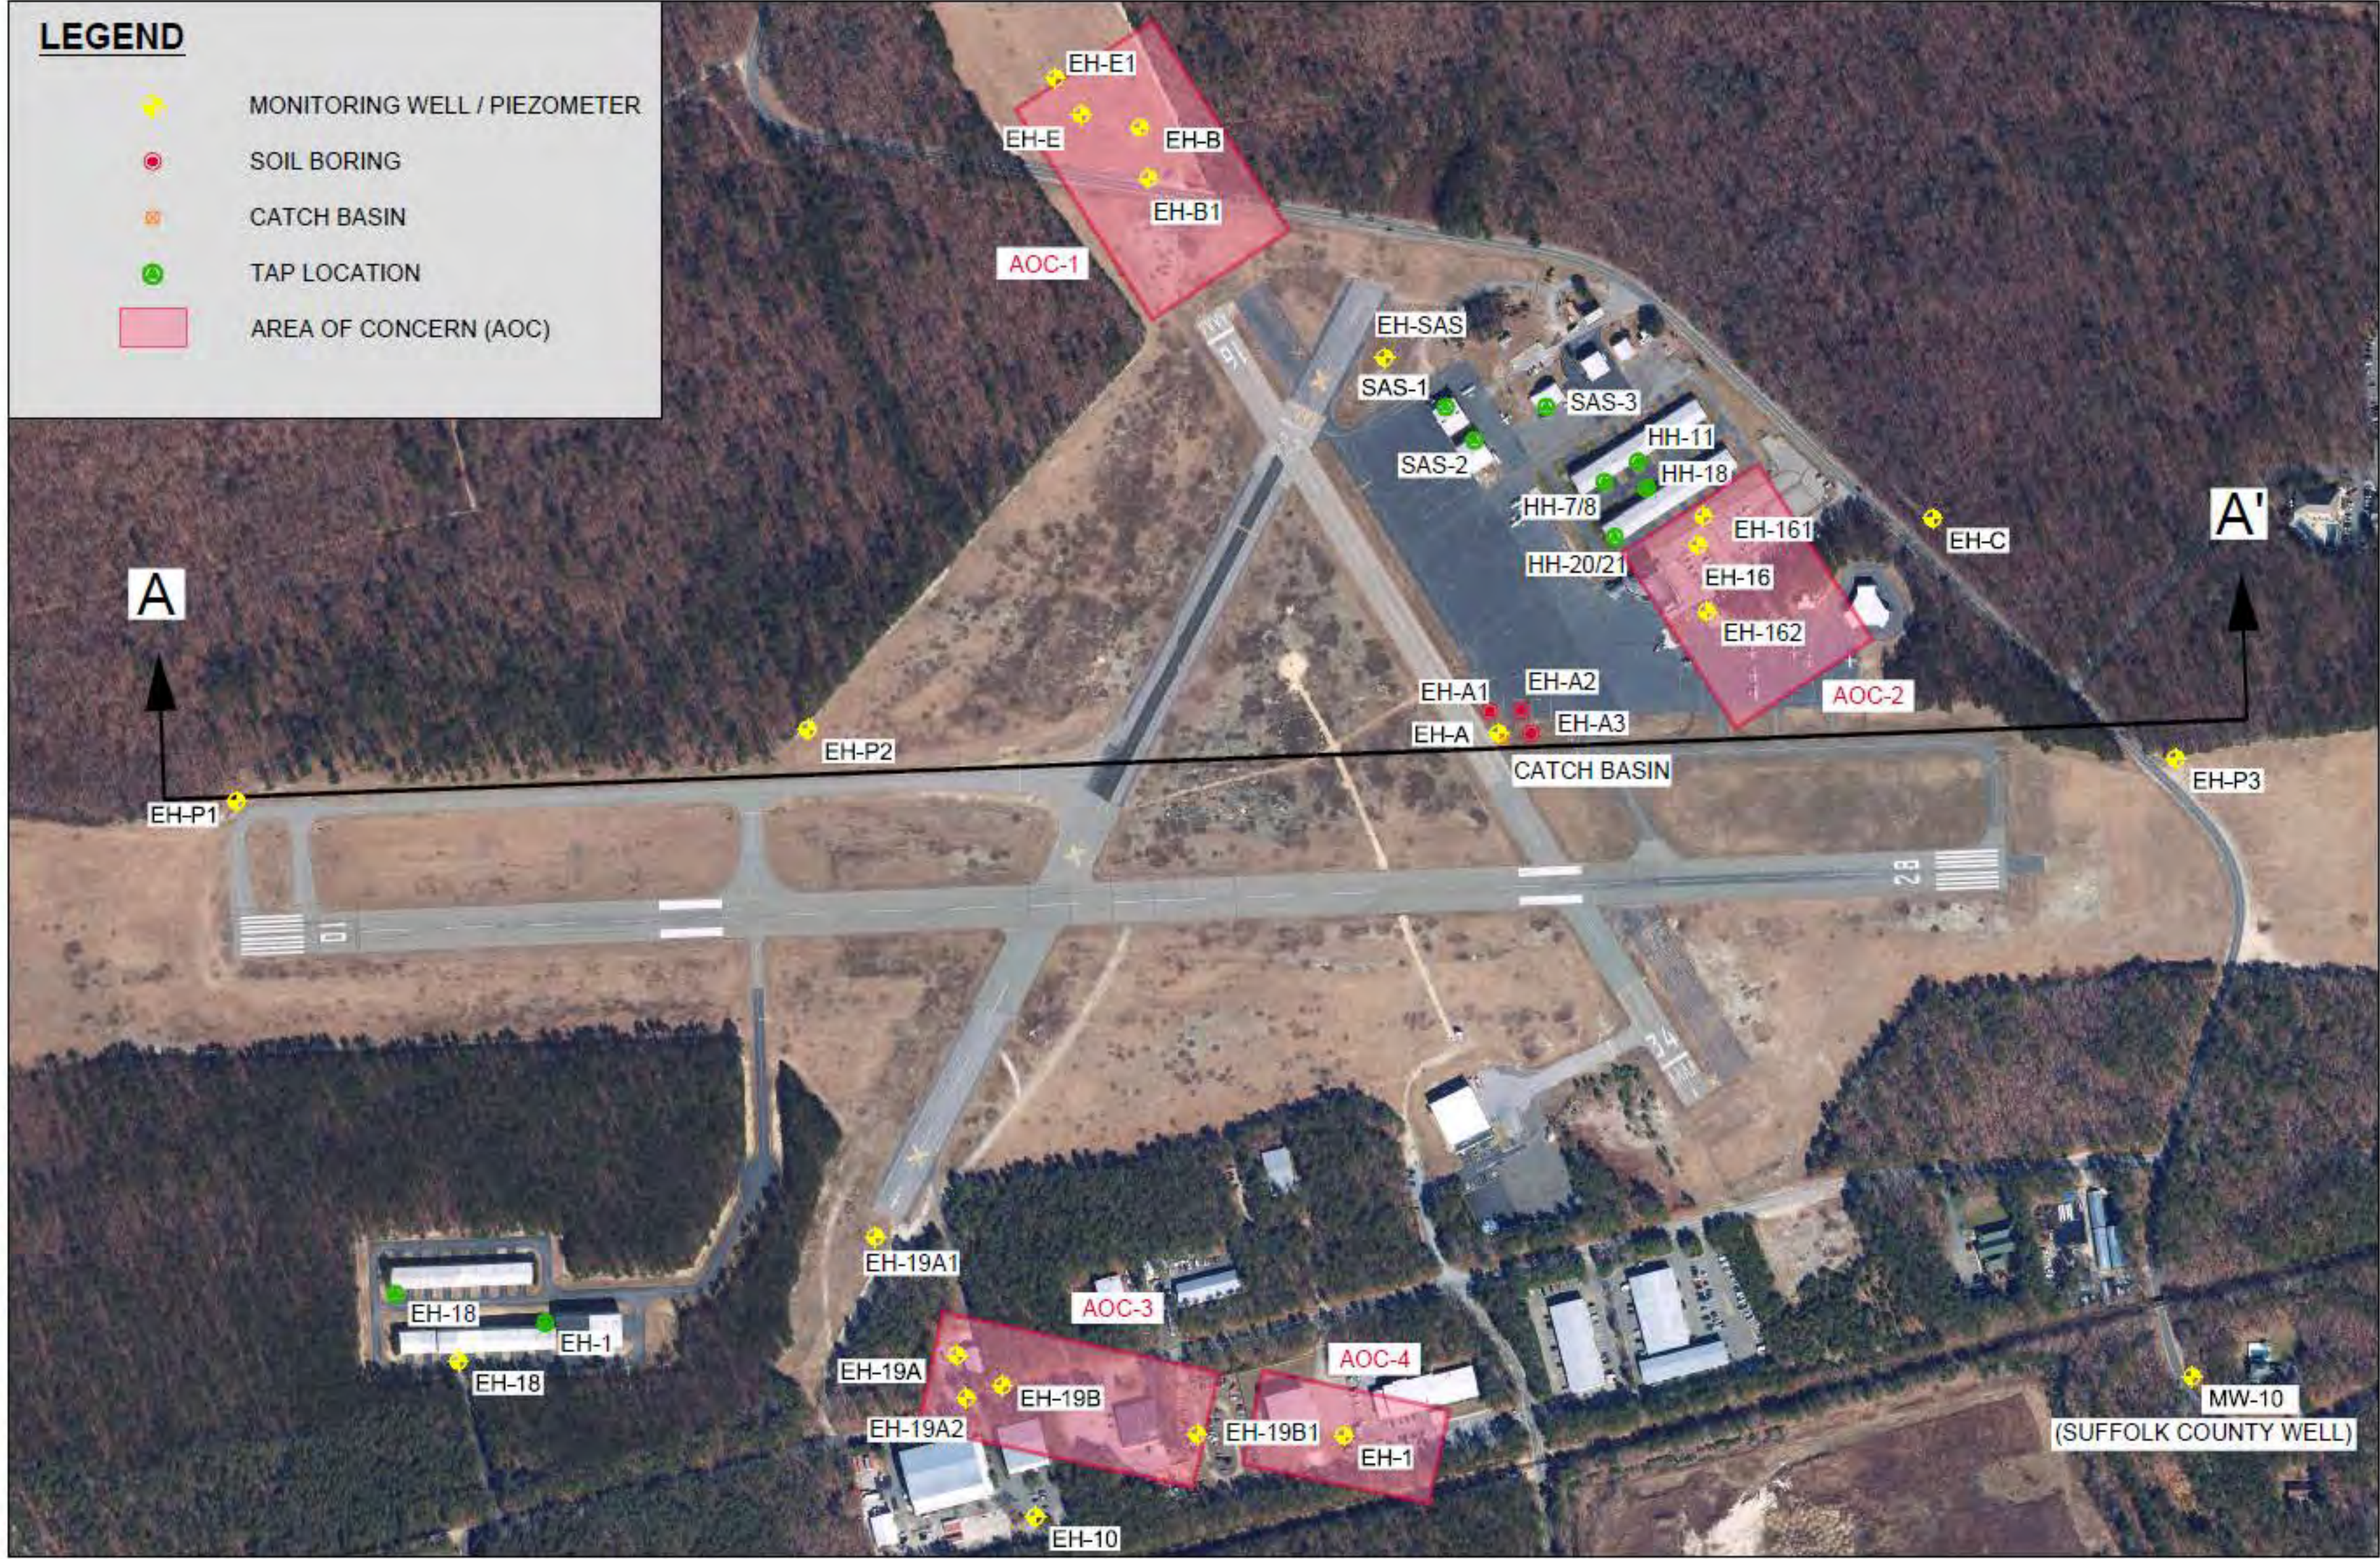
IDENTIFIED AREAS
OF CONCERN

AREA OF CONCERN (AOC)

Base map and well locations were taken from NYS DEC's Site Characterization Report, East Hampton Airport, prepared by AECOM, published November 30, 2018 (see Report, Figure 8)

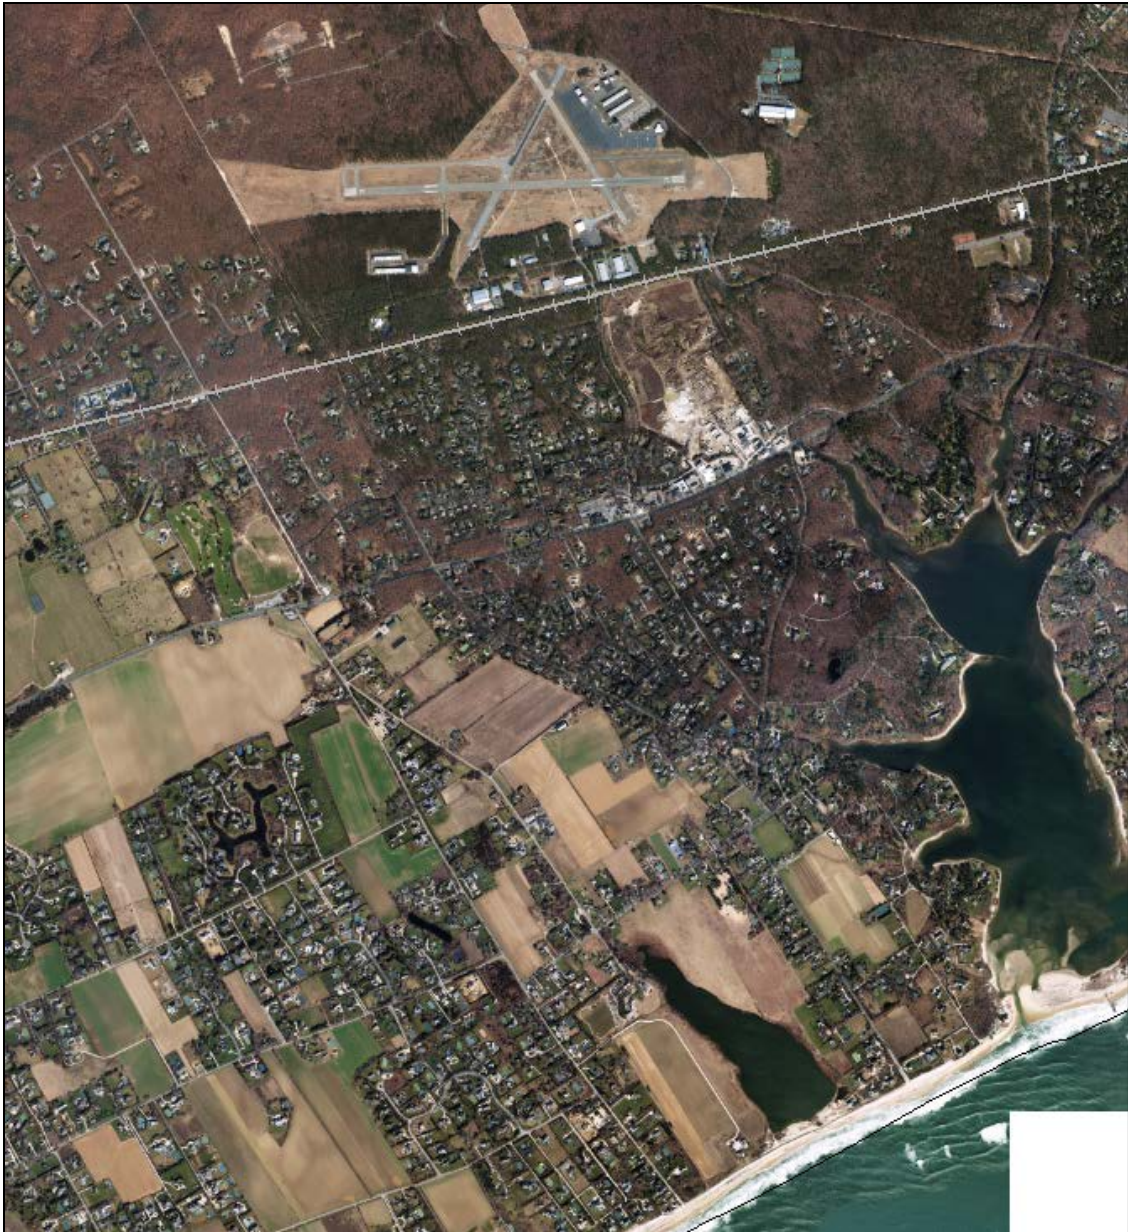
Figure 4 Aerial of the Immediate Vicinity of the Proposed Main Installation

The accompanying map entitled “Location of Water Main Installation - Suffolk County Regional Map” Figure 2 presents a generalized regional illustration of the location of the main installation in Wainscott. Figure 3 is a contour map of the Wainscott area made from the Light Detection and Ranging (LiDaR) Suffolk County Digital Elevation Model, and Figure 4 is an aerial of the immediate vicinity of the proposed main installation.

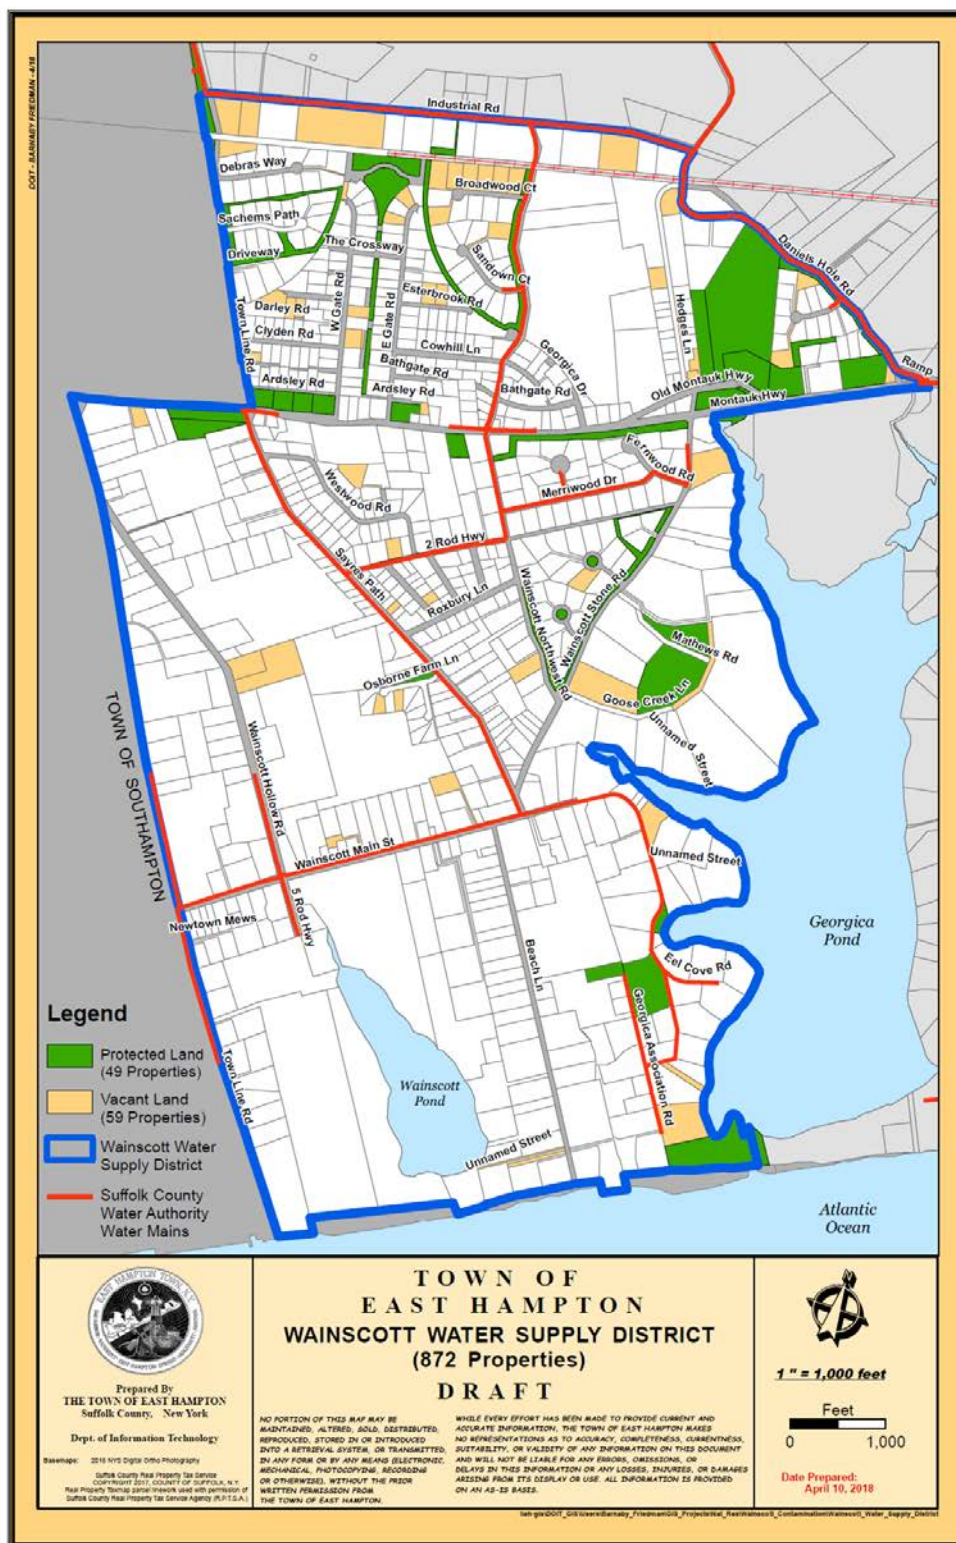
Figure 7 Town of East Hampton Wainscott Water District with existing Suffolk County Water Authority Water Main

As part of the plan to fund the project the Town of East Hampton will create the Wainscott Water Supply District. Figure 7 shows the boundaries of the district, parcels (872 properties), as well as existing SCWA water main. The Wainscott Water Supply District is the hamlet of Wainscott, in the Town of East Hampton, south of East Hampton Airport. Such area is delineated on the north by Industrial Road, on the west by Town Line Road and the East Hampton Town line and eastern boundary of the Incorporated Village of Sagaponack, south by the Atlantic Ocean and east by Georgica Pond and Daniels Hole Road.
