Part II: GROUNDWATER MANAGEMENT

Part II: Groundwater Management—Sources of Fresh Water

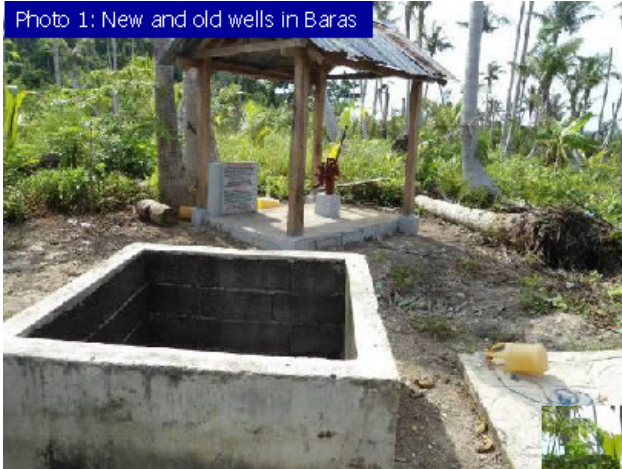
Slide 15

Despite the best efforts of local leadership to effect remedial measures and improvement after the widespread destruction of Typhoon Yolanda, examples of contaminated and neglected wells are still found throughout Guiuan. One of the most glaring illustrations of this is found in a pair of neighboring wells in Baras. In Kabadlungan, a fishing village to the south of the main population center of Baras, there is a new deep well that provides high quality water to the residents. Easily recognizable as a recent Operation Blessing installation, it is appropriately adorned with Biblical verses concerning the vital and spiritual force that water provides. The angelic benefactors were apparently unaware that the devil has set up shop about 10 feet away. The previous well, abandoned for some reason and pump in disrepair, is left unsecured. At the time of the survey, it was found to be collecting garbage. If left to fill up with debris and trash the newly installed well will also be threatened with contamination from the abandoned well (Slides 15 & 16).

Photo 1: New and old wells in Baras

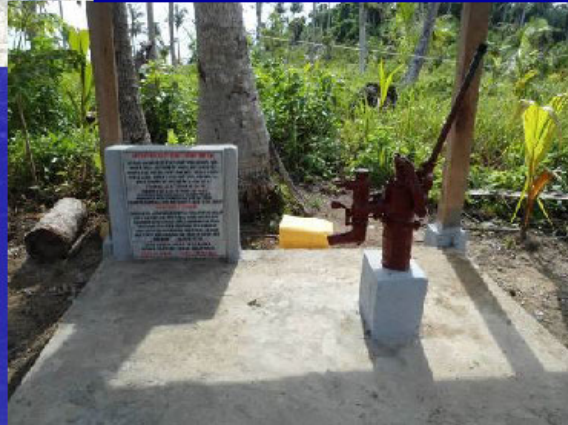
Photo 2: New installation by Operation Blessing

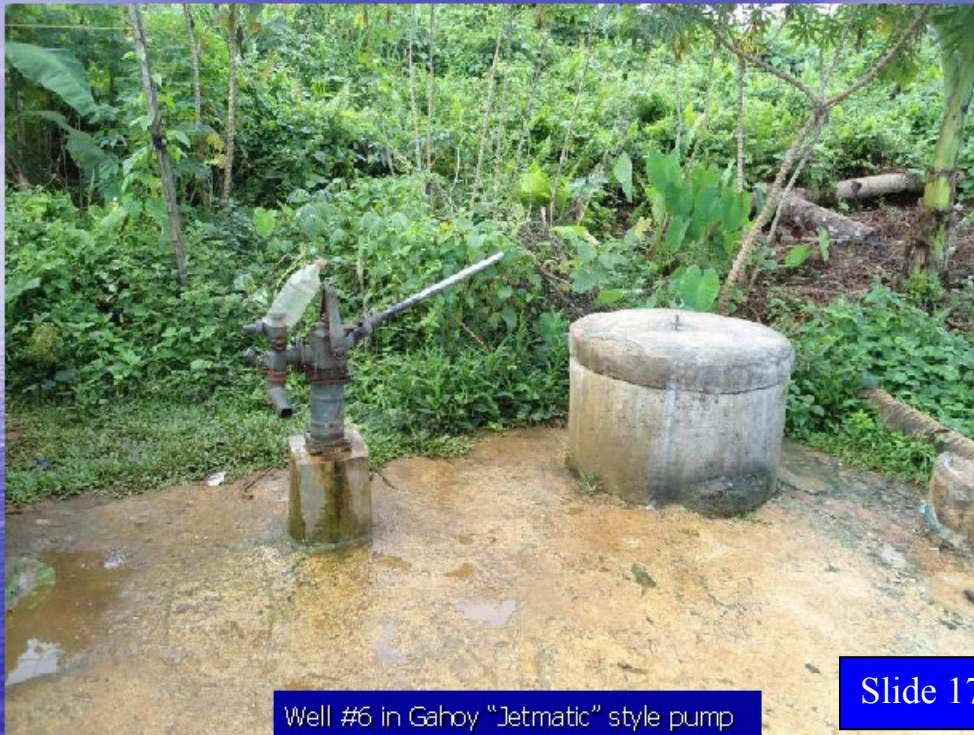
Slide 17

Some wells have associated with the water source a manual "Jetmatic" pump (Slide 17). This ubiquitous cast iron, positive displacement pump can be configured remotely away from the water source and plumbed horizontally or can be integrated in a concrete complex directly over the source. Because it uses suction pressure to draw water from the source, Jetmatic pumps are limited to areas where the distance to the water table is less than ten meters (Mihelcic 2009). The Jetmatic allows for flexibility as to the location of the source. Some sources are sealed with concrete covers. Others are simply the dug well with the connecting pipe fitted over rim and into the water below. Many sources are located adjacent to the pump or sealed underground. Jetmatics can be located in common community areas or can be applied inside residences.

Well #6 in Gahoy "Jetmatic" style pump

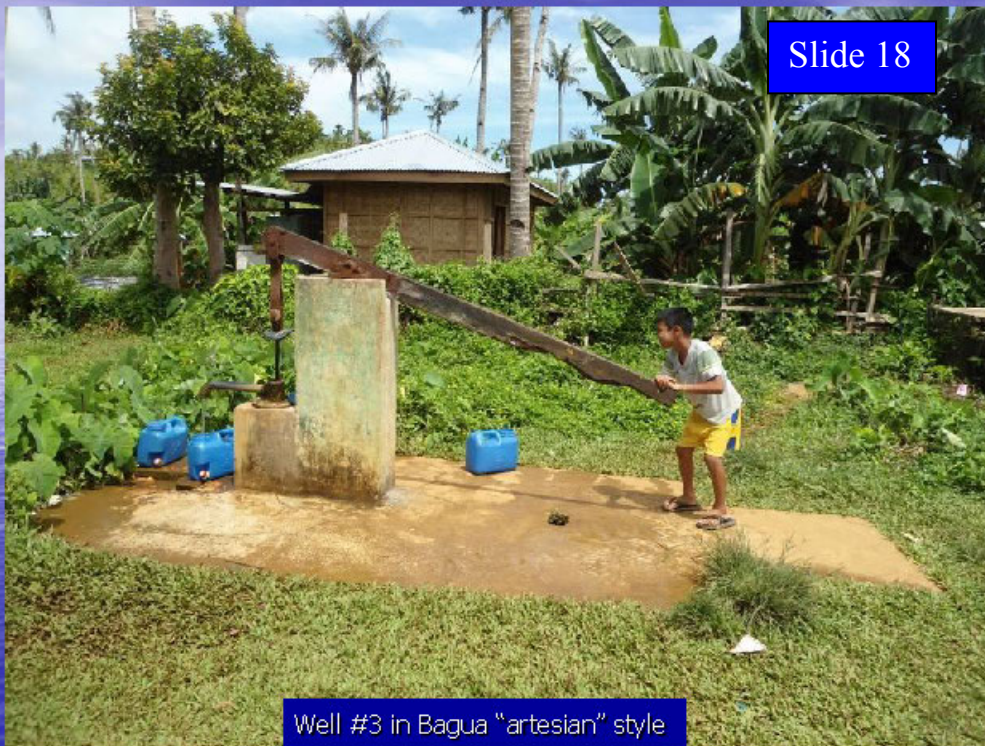
In many locations where the water table exceeds the maximum that can be lifted by a manual suction pump, drilled wells with downhole positive displacement pump applications are used. Locally called "artesian" wells, these pumps have concrete pillars that support long levers and linkages to push the water up from the bottom (Slide 18). They should not be confused with free flowing artesian wells. Many of these pumps are in various states of damage, disrepair and disuse. The remnants in the form of the abandoned pillars and pipe headers can be found throughout the common areas in barangays and along roads. These pumps are designed for maximum leverage of human power to lift the water and require more energy and time to get the water flowing. A common problem expressed with these pumps is the contamination due to rusting linkages and the time and energy it takes for water to run clear.

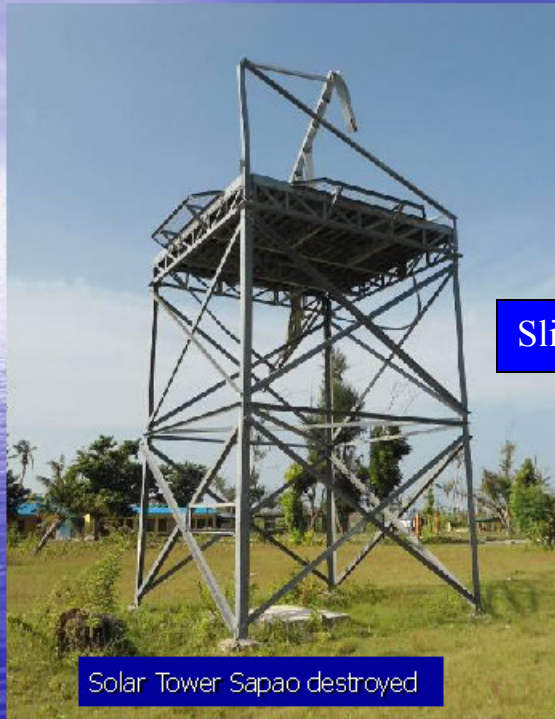
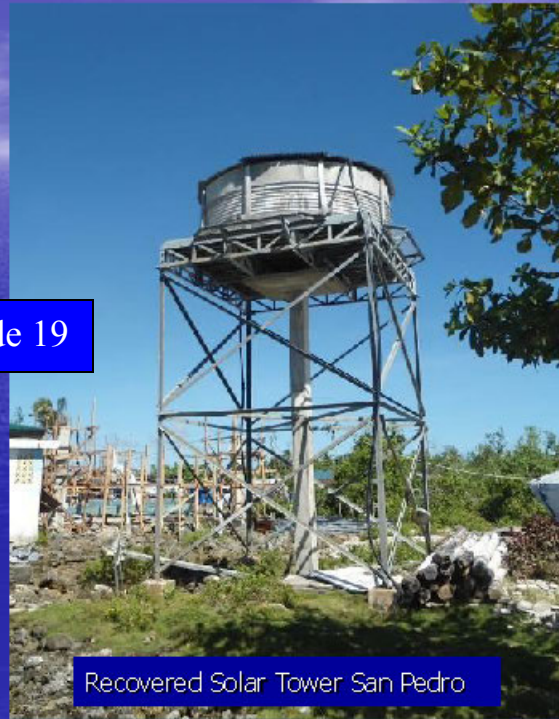
Slide 19

Commonly referred to as “Solar” tanks, almost every barangay visited had one of these systems that had been decimated by typhoon Yolanda (Slide 19). Representing an extensive water improvement project, these tanks were once configured with solar panels and storage batteries to pump the water to a large elevated tank. The surveyor only found two of these tanks that had been recovered from storm damage. Both tanks are located on Tubabao Island in barangays San Pedro and Camparang. In other barangays, these tanks are otherwise being replaced by various sized plastic or metal tanks on new towers, rehabilitated solar tank towers, or at ground level.

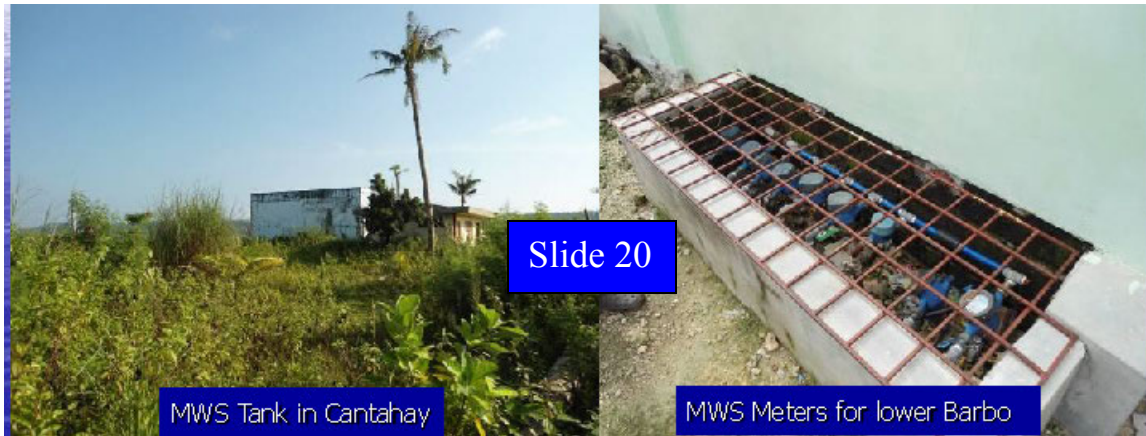
Municipal Water System (MWS:) Another source of fresh water is the municipal water supply (Slide 20). The core of the system consists of large concrete tanks with multiple sources with high capacity pumps located at higher elevations on the peninsula. Located in Cantahay, Surok and Timala, one of the tanks is dedicated to supply the barangays situated on Calicoan Island to the south. This metered system also supplies the denser populated areas of Guiuan at lower elevations. Since the typhoon, the MWS has been working at building capacity and improving the quality of the water.

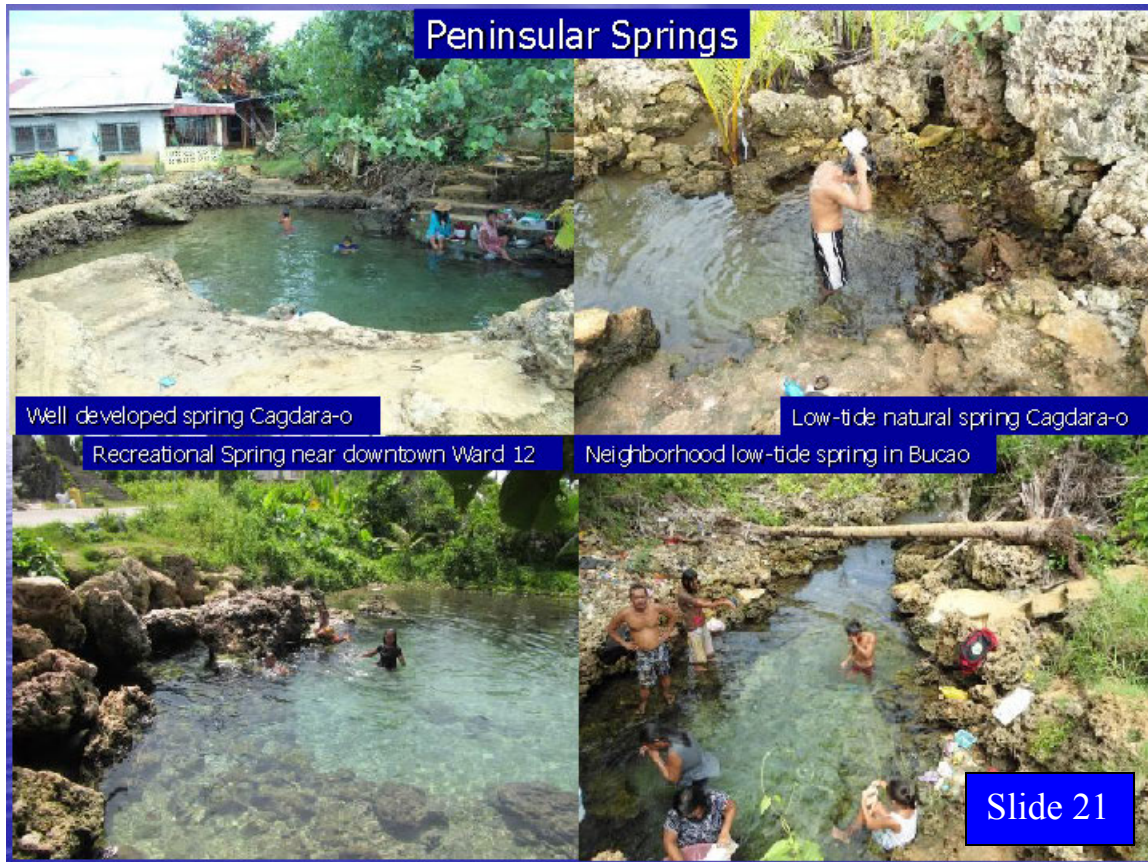
Springs and Creeks: In a few peninsular barangays, where spring flow is plentiful, confining structures are built to effectively separate the fresh water from tidal flows or capture the spring at higher elevations (Slide 21). These springs are often incorporated into the village landscape for recreational, bathing and laundry purposes. In the locations blessed with such a convenient, plentiful, and refreshing resource of fresh water, pools have been established that vary in configuration from natural areas with simple concrete jumping and access platforms to elaborate concrete structures incorporating culverts and retaining walls to channel rainwater around the pool. Some springs adjacent to tidal areas are only useable during low tides.

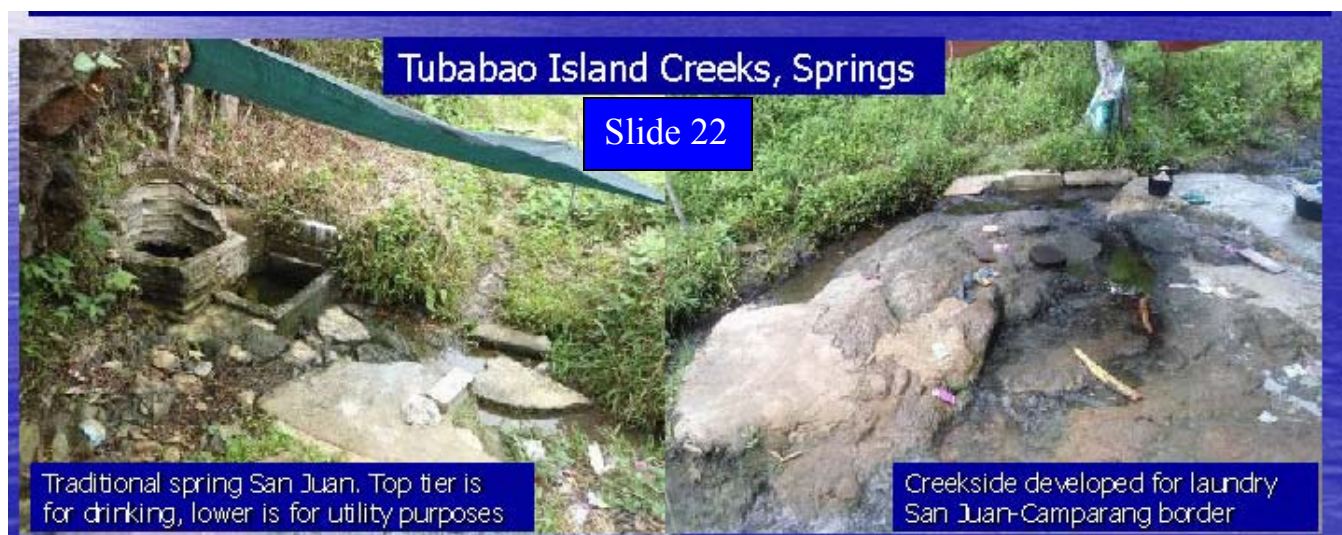
Guiuan, having retained much of their clay mantle, flowing water is relatively abundant (Slide 22). Springs and their associated creeks, range from unimproved pools along the stream to sturdy concrete spring boxes or other more permanent stream capture methods that provide improved water quality and access. When these outflows are captured at higher elevations, they are commonly used as the BWS supply with large concrete tanks. Overflow is managed nearby for bathing and laundry purposes.
