# Defense-Related Uranium Mines Location and Status Topic Report

## Final

August 2014

Legacy  
Management

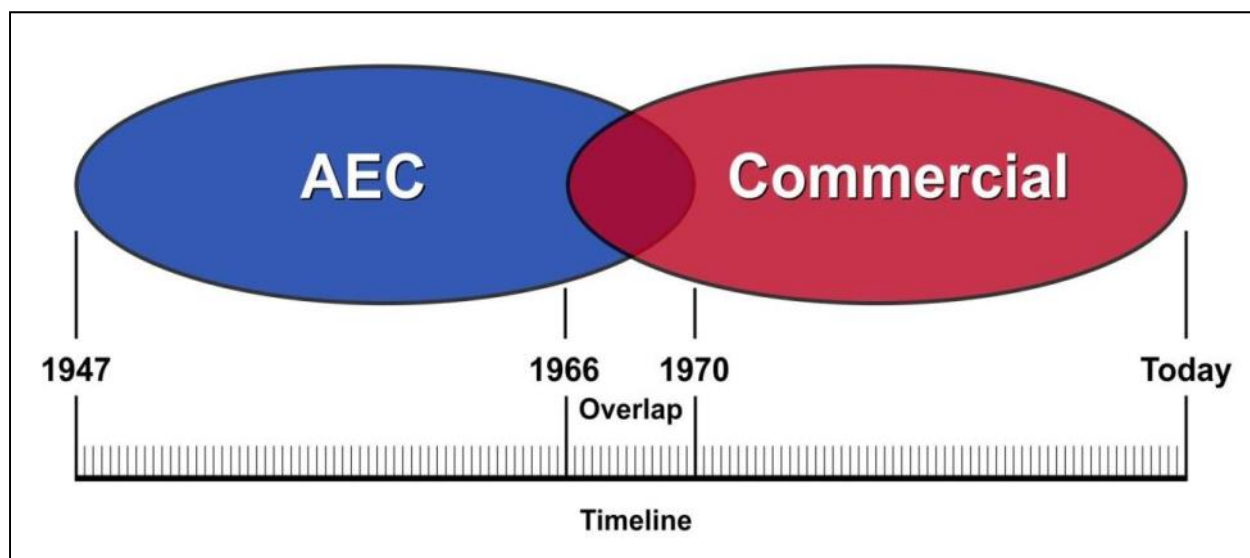
*Figure 2. Timeline of Uranium Ore Production*

Federal contracts for purchasing uranium concentrate ( $U_3O_8$ ) to support defense activities were made by the Manhattan Engineer District (MED) from 1942 to 1946 and by the AEC from 1947 through 1970.

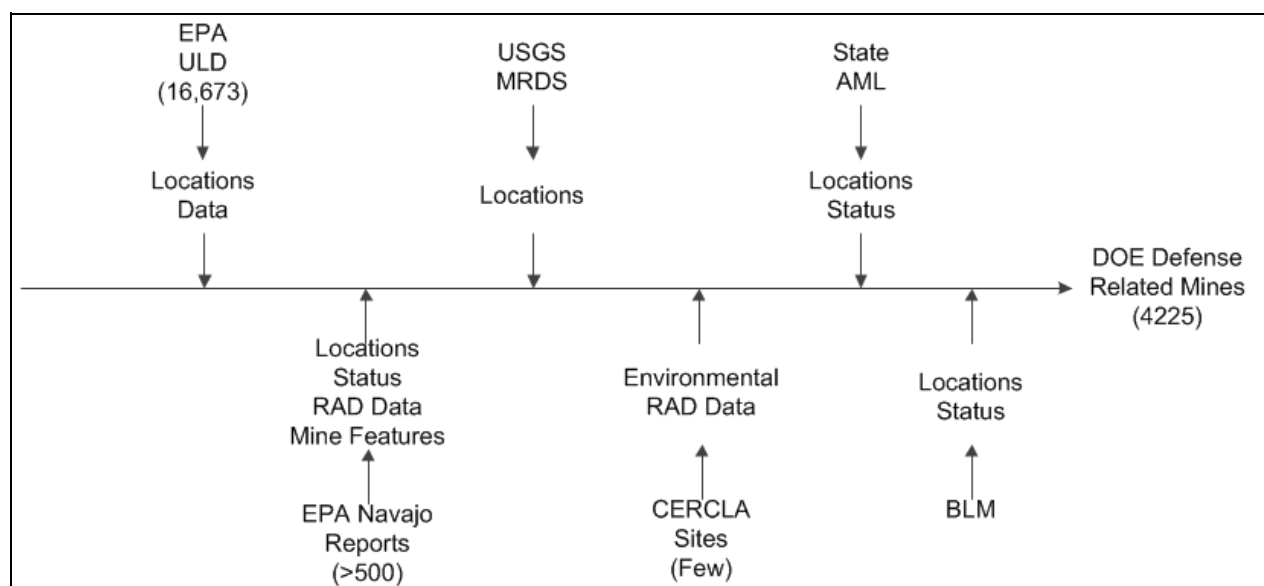
The DOE mine database was constructed in several stages. The first step was establishing the number of mines and their locations. The second step was reconciling known mines with locations identified in EPA's ULD and other sources. The third step was determining the data fields and then populating data tables with available information. Concurrent with this step was providing a link in the database to the original source data, in case verification of specific data fields was needed and also as a reference for additional data that might not be included in the selected data fields. The fourth step was a combination of matching mine names and other source database attributes with the AEC base records. The final steps occurred after a majority of mines identified in the AEC records had been reconciled to other sources, primarily for location. These final steps included developing a process to evaluate the data, conducting data validation, identifying data gaps and other issues, and selecting production-size categories. The categories were determined by listed amounts of uranium ore production (tons of ore). Figure 8 illustrates the general development process and some of the sources used.

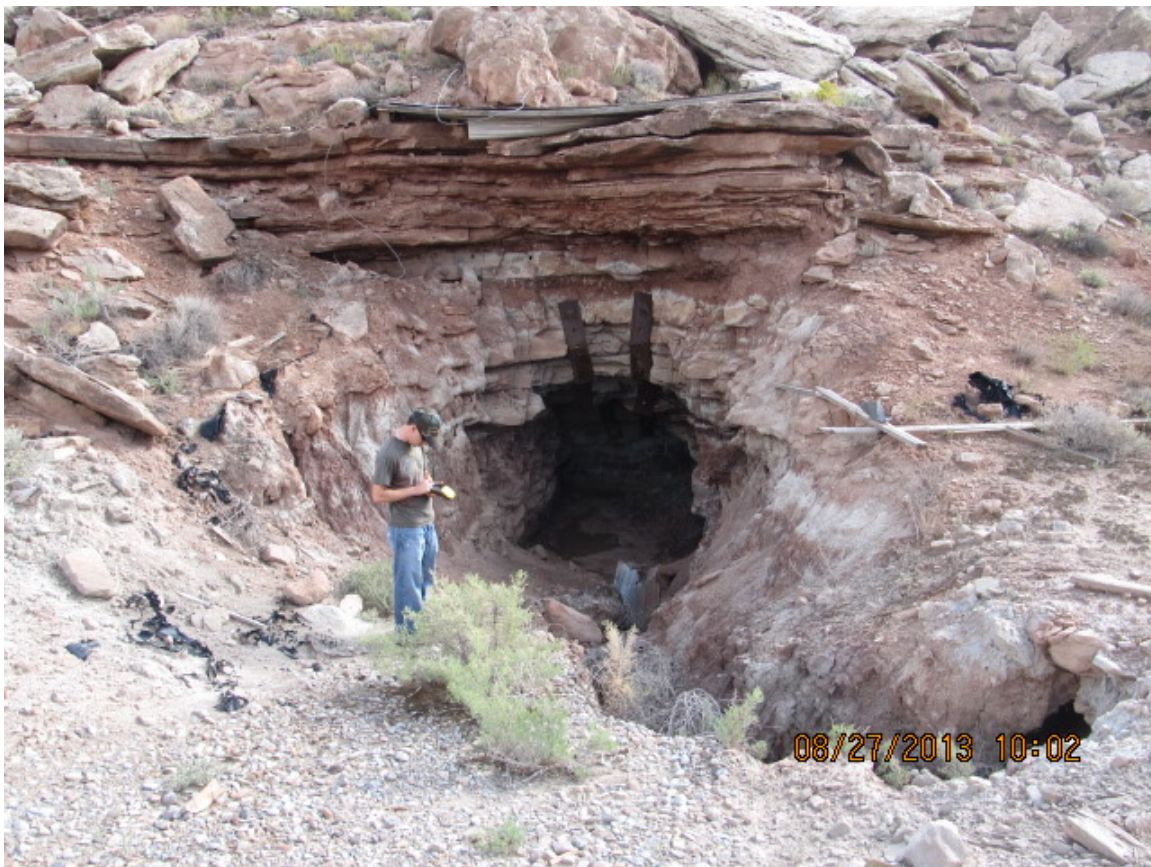
*Figure 15. Yellow Cat District, Utah—Unstable, Unprotected Mine Opening*

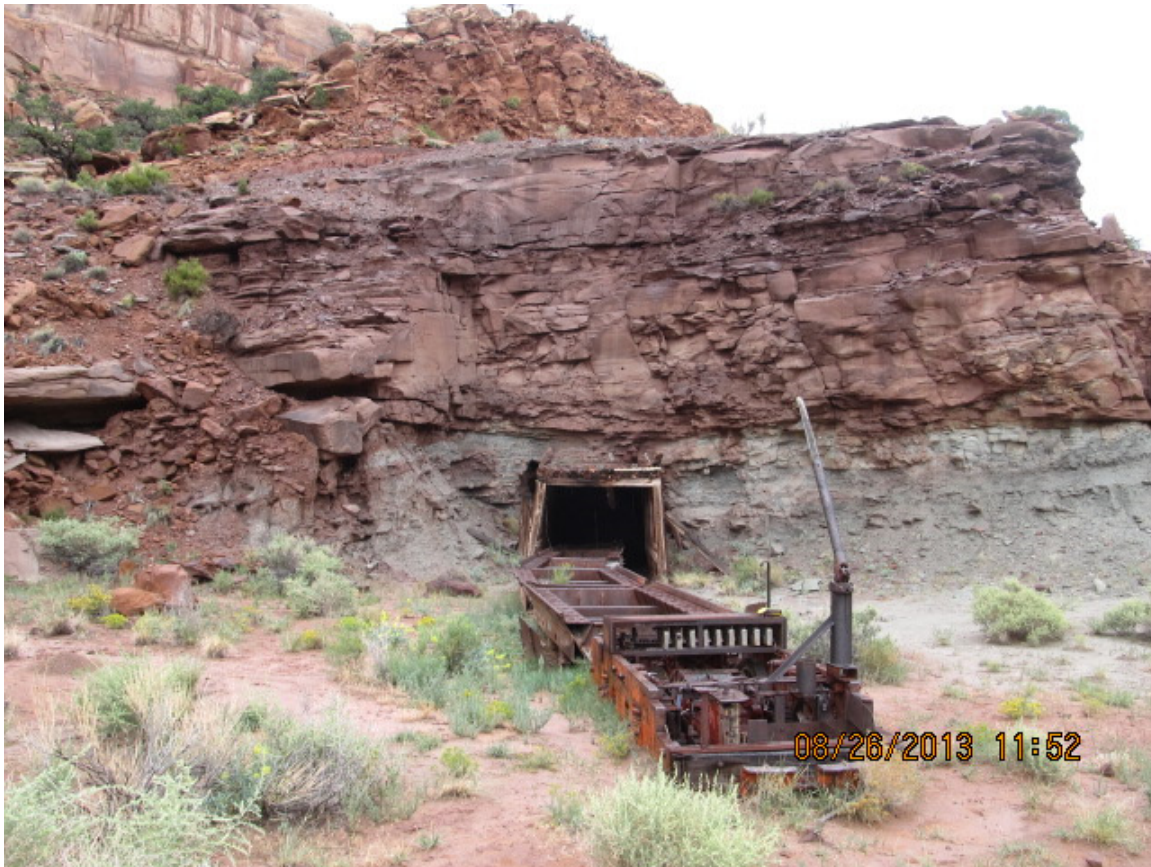
*Figure 16. Lisbon Valley—Big Indian District, Utah—Unprotected Mine Opening*

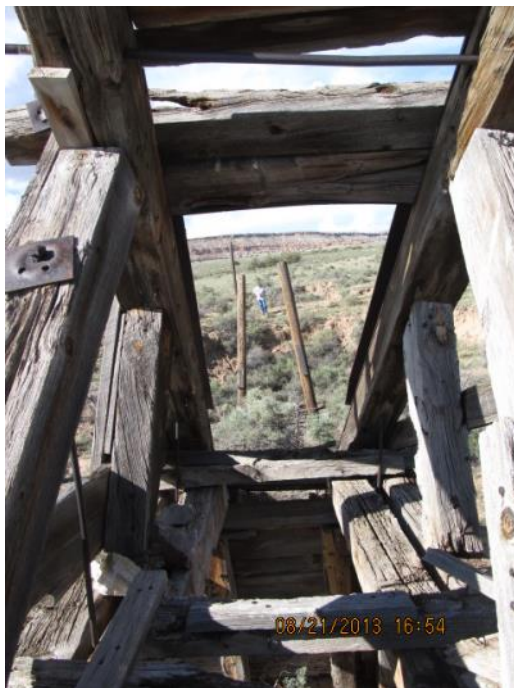
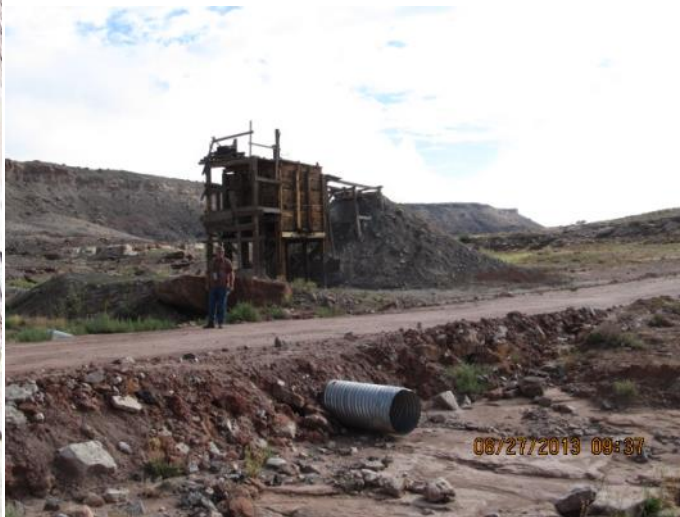
*Figure 17. Grants Mineral Belt, New Mexico—Wooden Support Infrastructure (Left);  
Yellow Cat District, Utah—Support Infrastructure and Waste-Rock Pile (Right)*

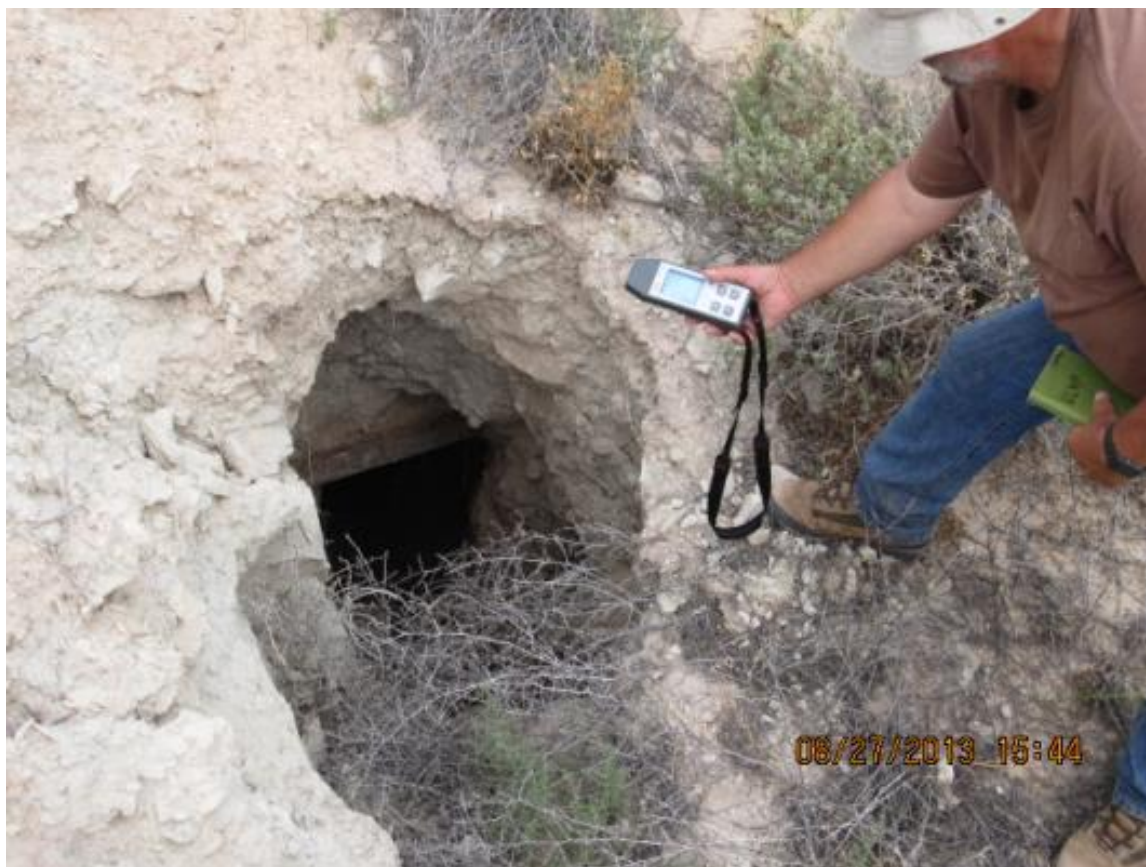
Gamma-exposure-rate measurements were collected using handheld scintillometers at selected locations at each site (Figure 18), primarily at a background location and on any waste-rock dump and ore-storage areas. Radon measurements were taken at each site as time allowed using a handheld portable meter. Radon measurements were taken to determine background levels near the waste-rock pile and at the area suspected of highest radon (i.e., near a portal or vent). The status (degree of cleanup, if any) of the mine site was also noted for assessment of potential long-term surveillance costs for mine categories.

*Figure 18. Collecting Gamma Measurements at Mine Opening, Yellow Cat District, Utah*

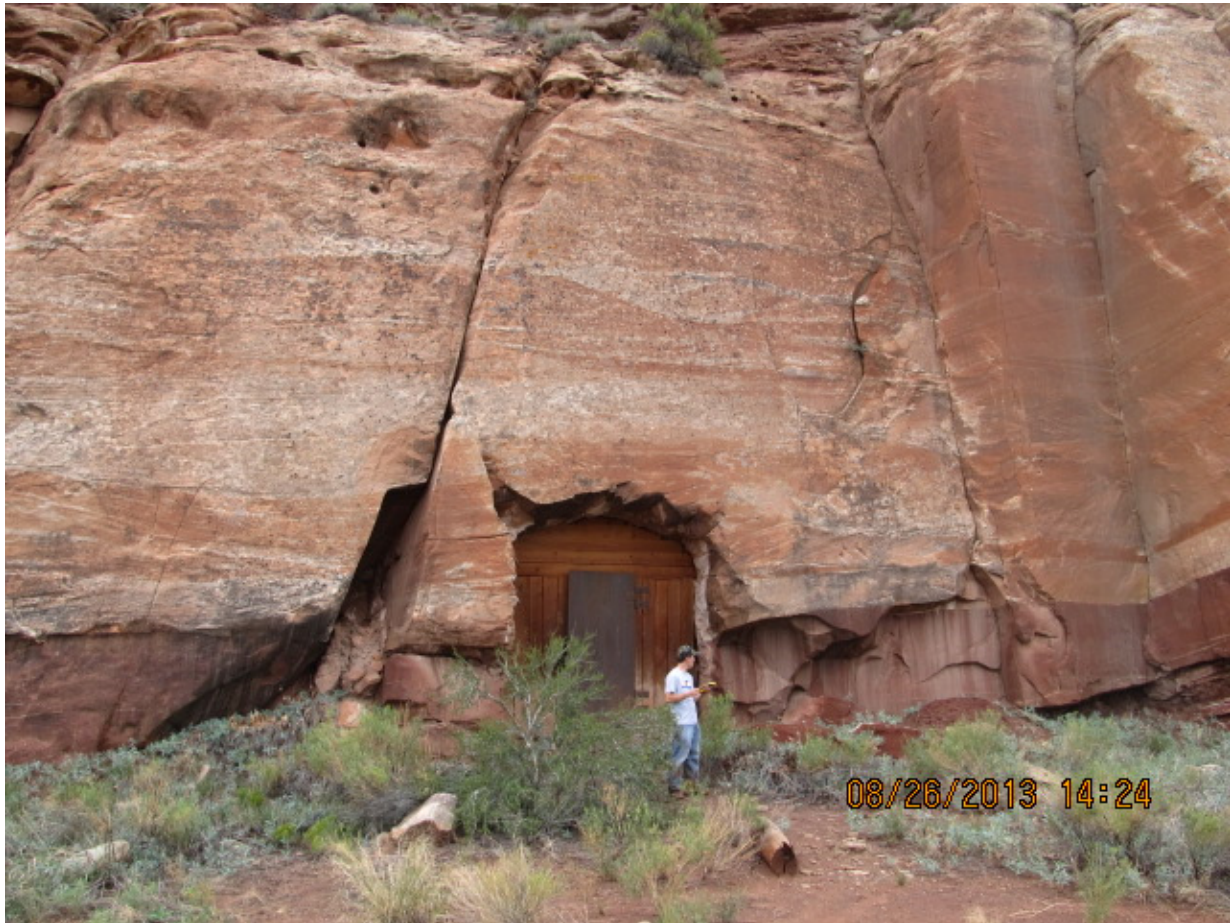
*Figure 20. Mine Closure by Metal Door and Timbers. Lisbon Valley–Big Indian District, Utah*

Different state AML programs have closed (or are in process of closing) adits, portals, and similar hazards to reduce the physical hazards associated with underground mines. Many of these mines have been closed through burial with soil and rock or constructed closures (Figure 20 and Figure 21), while others have been closed with metal gates or grating (Figure 22) that prevents humans and large animals from entering but allows bats and other mammals access to nesting areas. Those barriers remove the physical threat, but radon might still be venting, resulting in radiological exposures to the public in some cases.

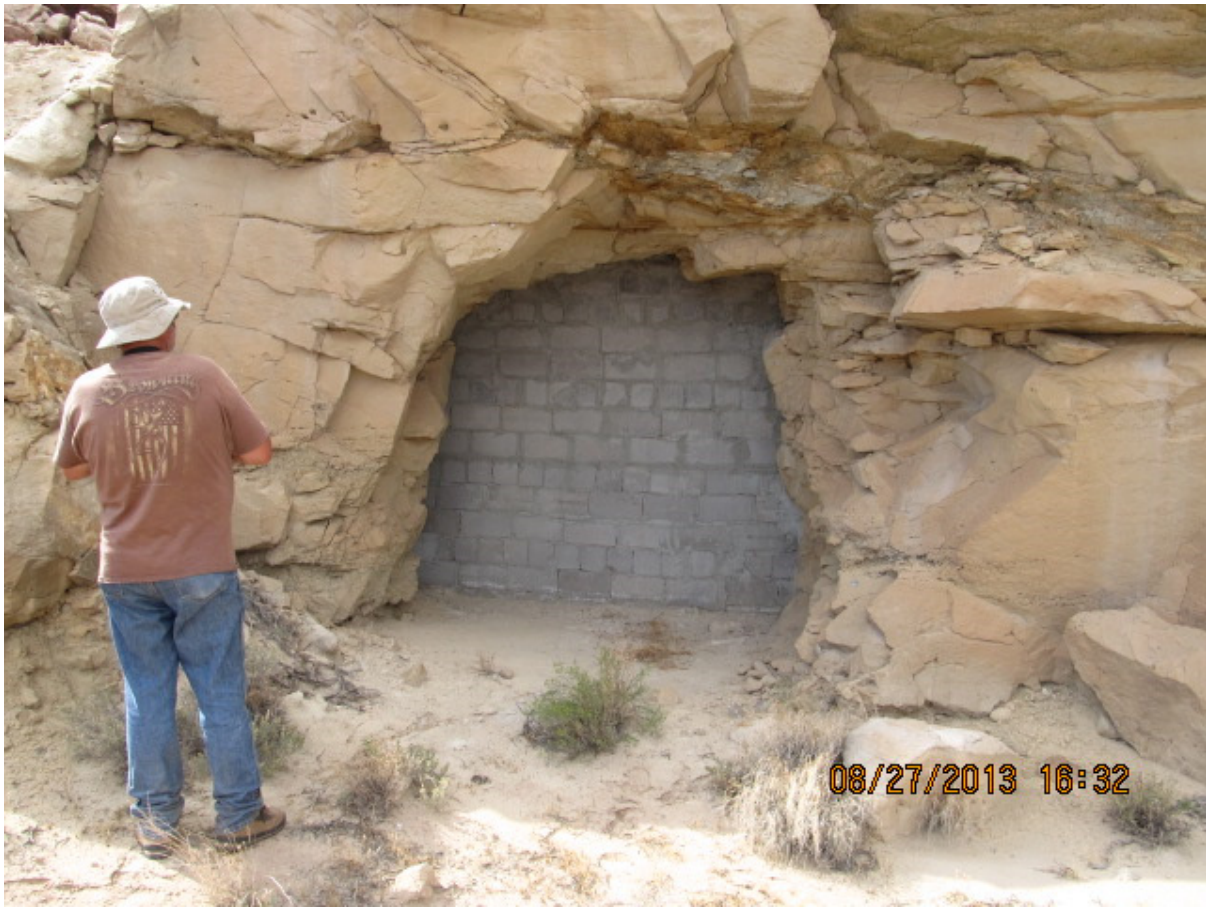
*Figure 21. Mine Portal Closure by Concrete Blocks, Yellow Cat District, Utah*

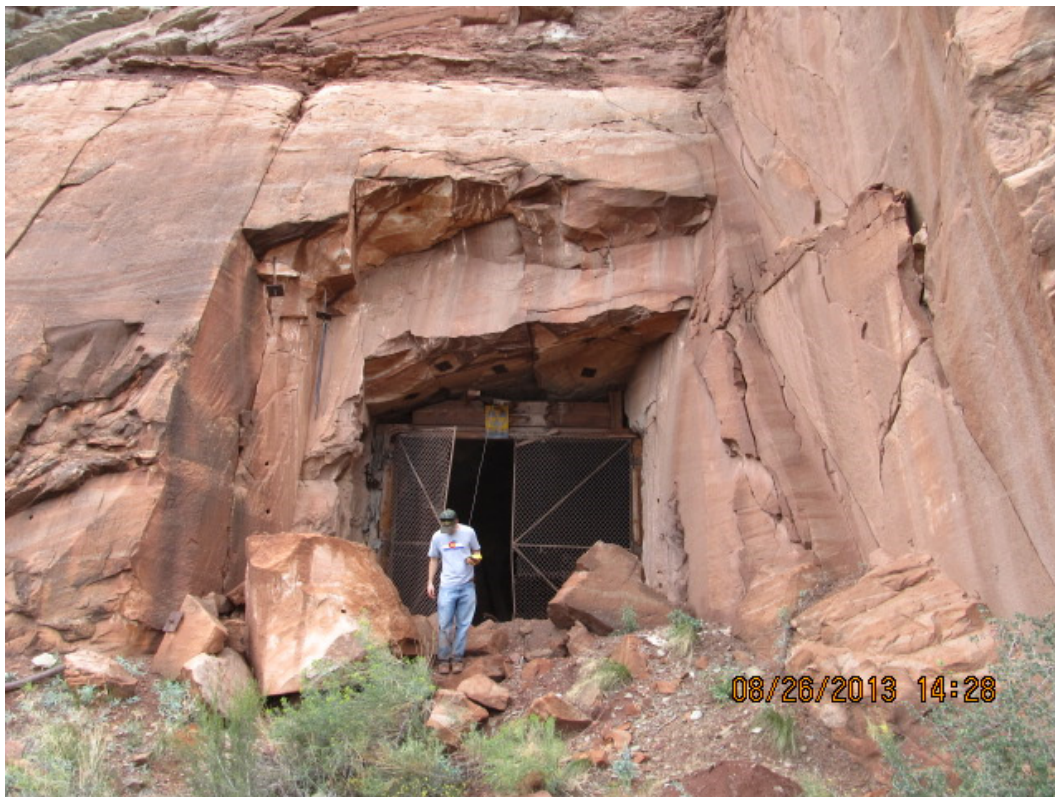
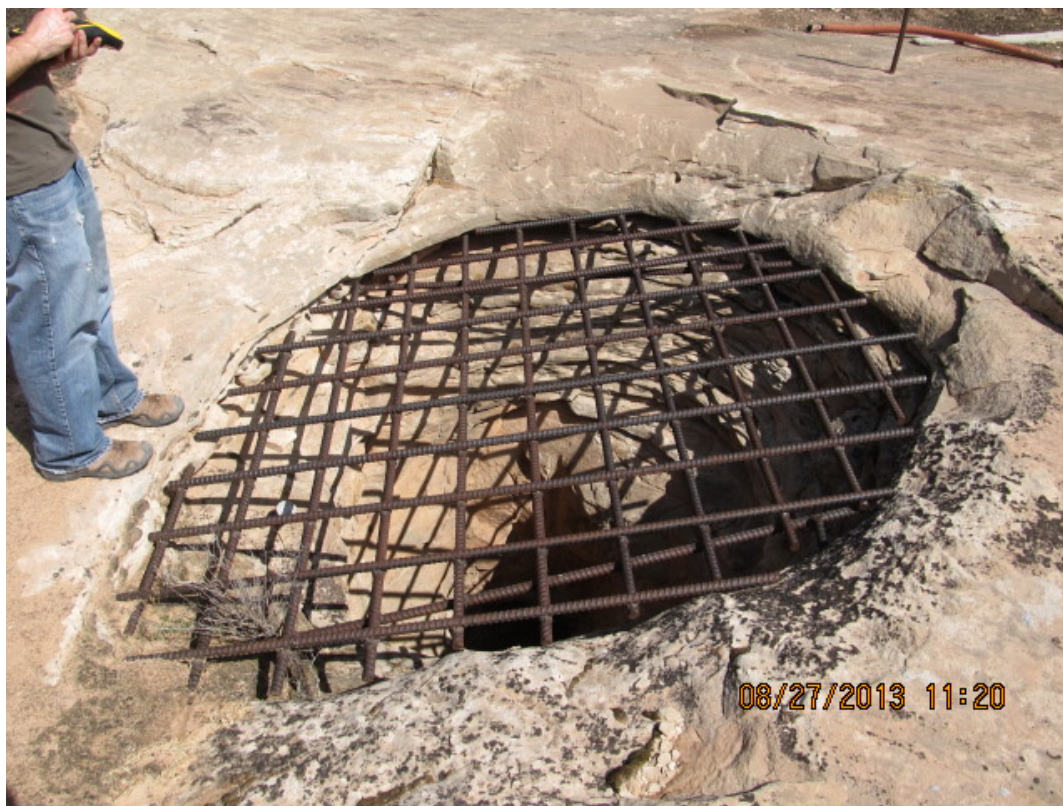
*Figure 22. Top: Mine Portal Closure by Metal Gates  
Bottom: Mine Vent Shaft Closure with a Large Grid Rebar Typical of "Bat Gates"*

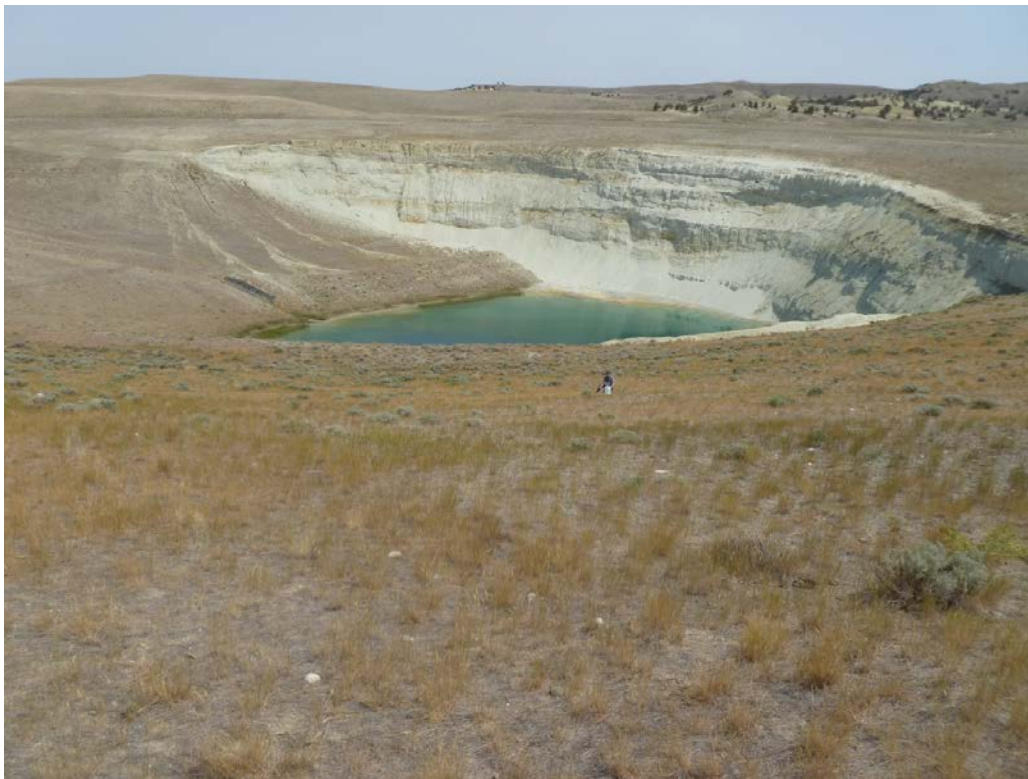
*Photo 1. Looking northeast at the Mars Group pit and the surrounding reclaimed area.*

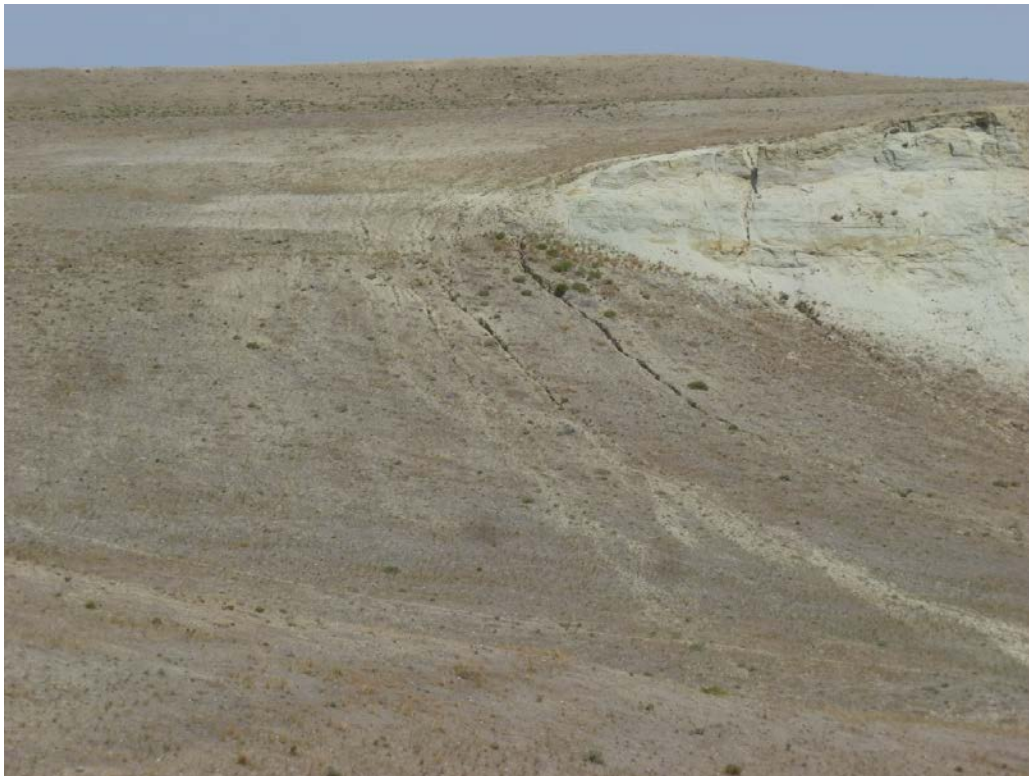
*Photo 2. Minor erosion of recontoured and reclaimed area near the northeast end of high wall.*

Mine site appeared to be reclaimed, although some of the reclaimed areas showed some minor erosion.

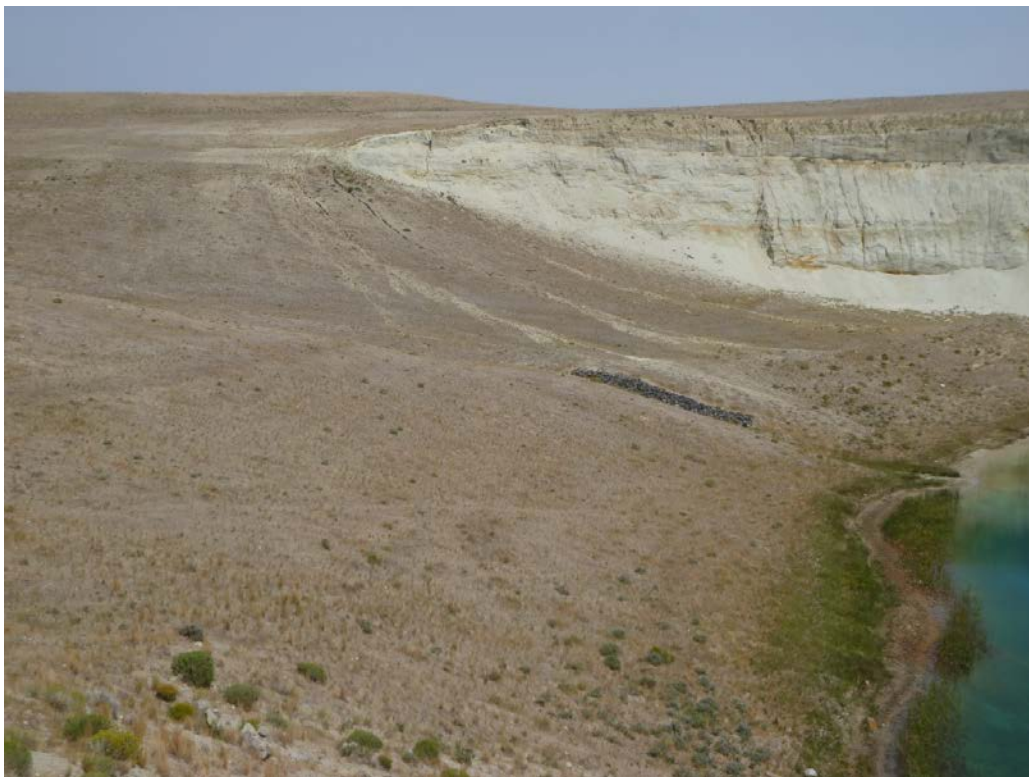
*Photo 3. Recontoured and reclaimed area with channel stabilization on the north side of the Mars Group pit.*

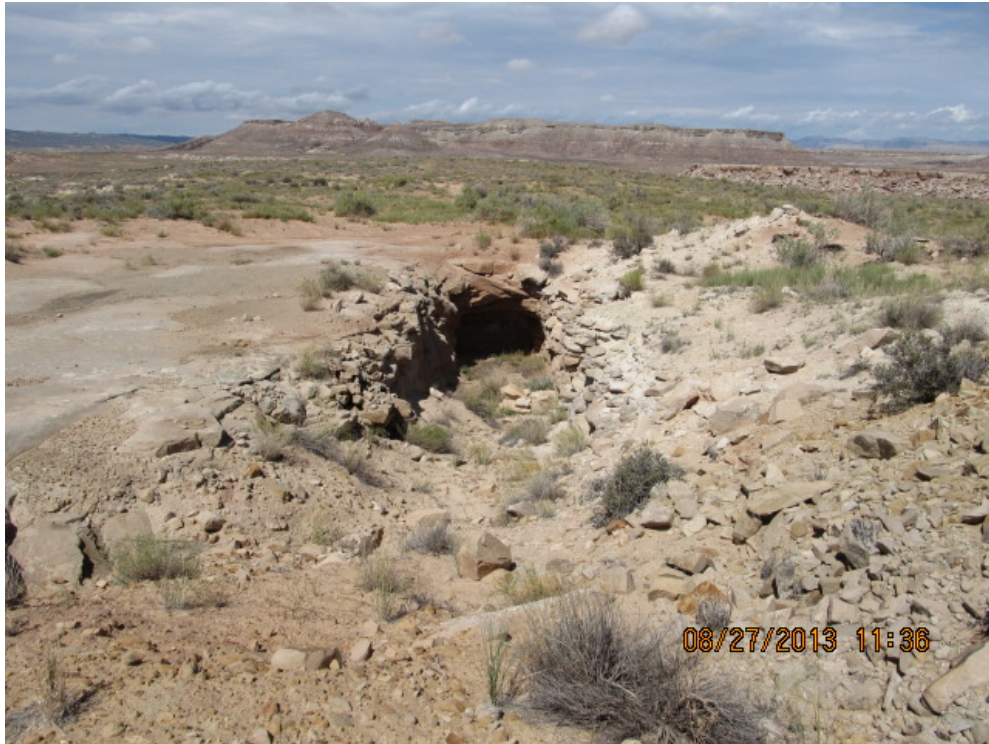
*Photo 1. Paris 25 mine area portal #1 east of access road, looking west.*

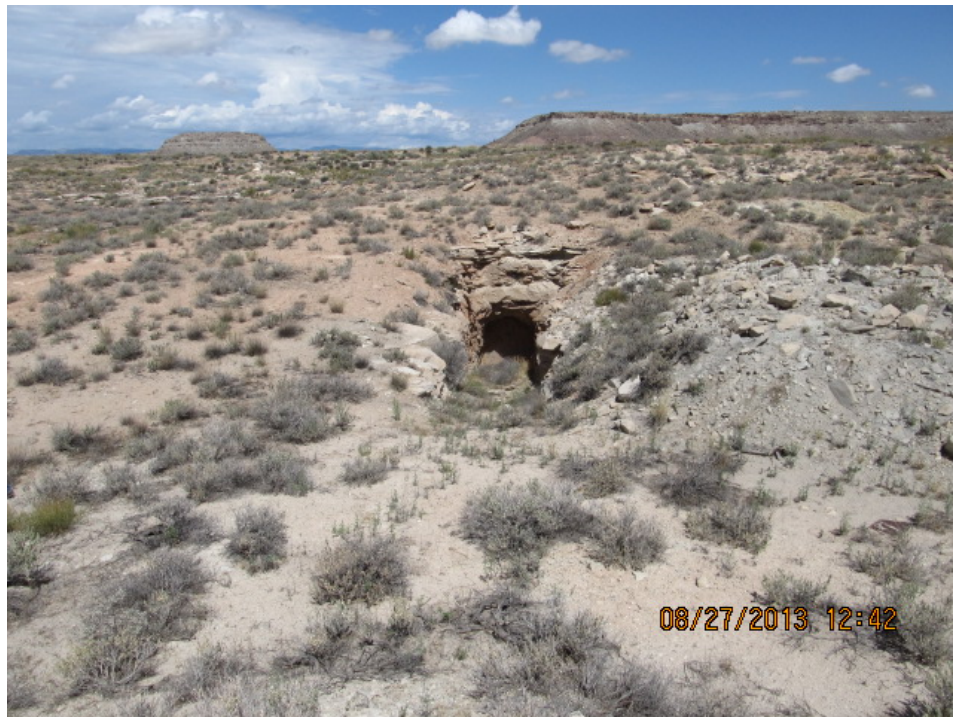
*Photo 2. Paris 25 mine area portal #2 east of access road, looking north.*

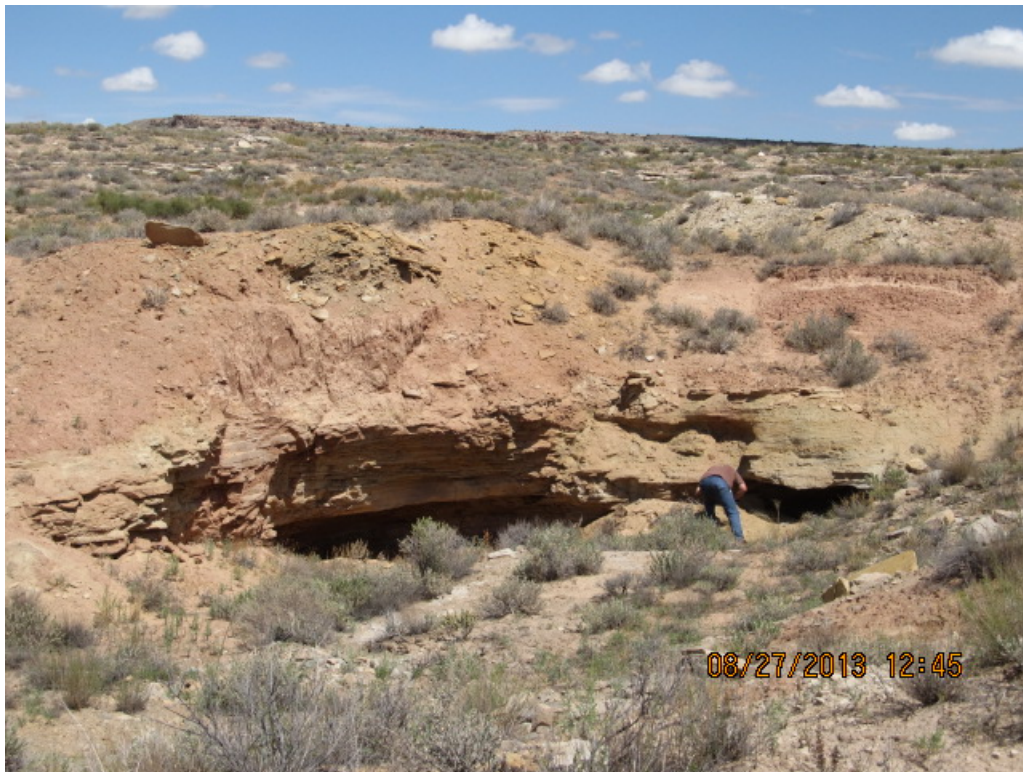
*Photo 3. Paris 25 mine area alcove-type portal, looking north.*

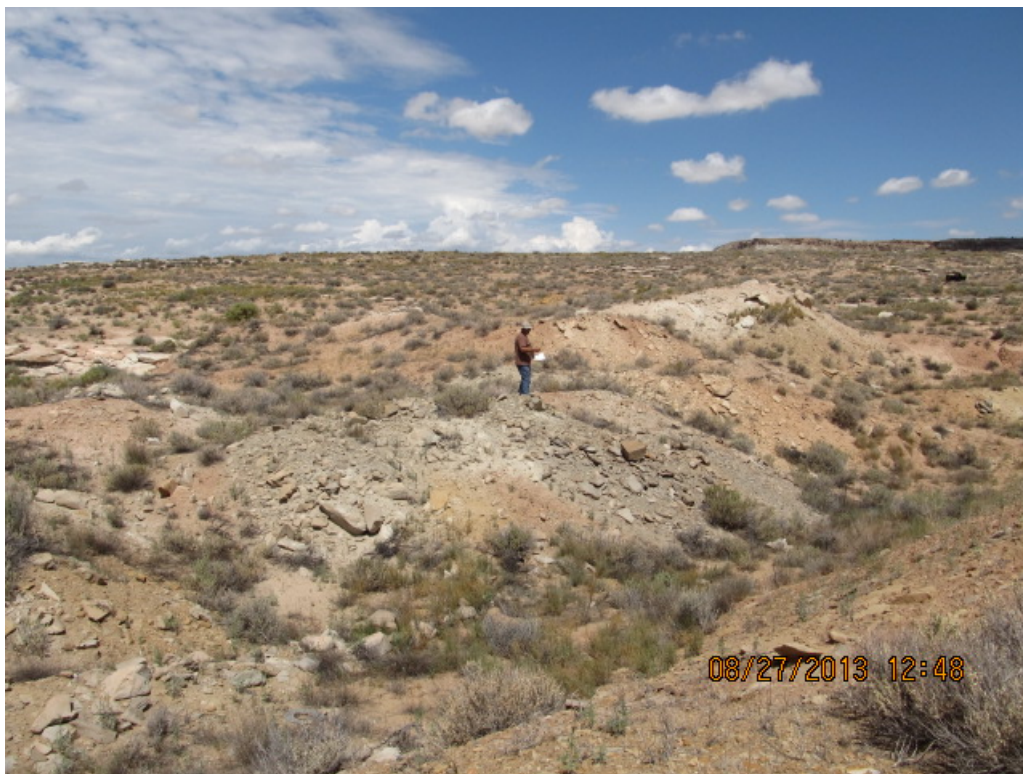
*Photo 4. Paris 25 mine area waste rock piles, looking northwest.*

- Was the mine reported to be previously reclaimed, or did the mine appear to be reclaimed?  
The mine area had been partially reclaimed. The two decline trenches had all been closed with concrete block bulkheads placed near the entrance. Mine-waste rock piles remained unreclaimed and some scrap metal was present.
