REPLACING A SOLENOID (PHOENIX ORO MODELS)

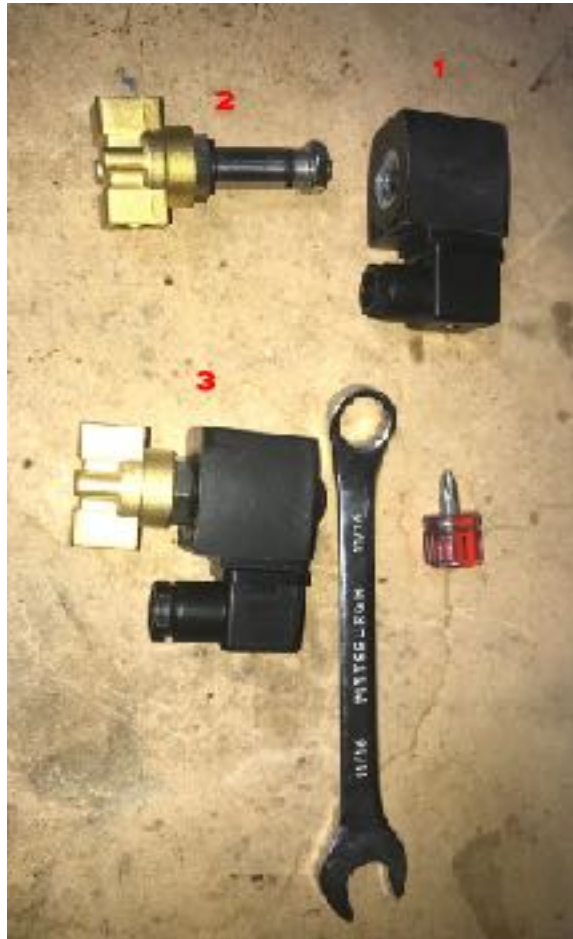
There are two parts to most solenoids:

1. SOLENOID COIL (Black part with wires to it)
2. VALVE BODY (Metal part that pipes connect to)
3. Together they are called Solenoid valve.

In most cases when a solenoid goes bad what happens is the ignitor buzzes (sparks) trying to ignite burner but no gas is coming through the line and therefore you see no movement on the gas gauge and there is no gas getting to burners to ignite.

In most cases the cause is the Solenoid Coil has gone bad and therefore you just need to replace the coil. This can be done rather quick by

1. Loosening the Top bolt holding Coil to Valve body.
2. Remove coil
3. remove wiring to coil. There may be two colors of wire (generally Red and Blue or red and black) In a 220V setup the colors of wire represent POSITIVE & NEUTRAL. These are not polarized so can be switched out.
4. On the Solenoid there are 3 connectors. The two on each side are for the positive & Neutral. The one in upper middle is GROUND and not used in the ORO or BC OR SEDONA roasters.

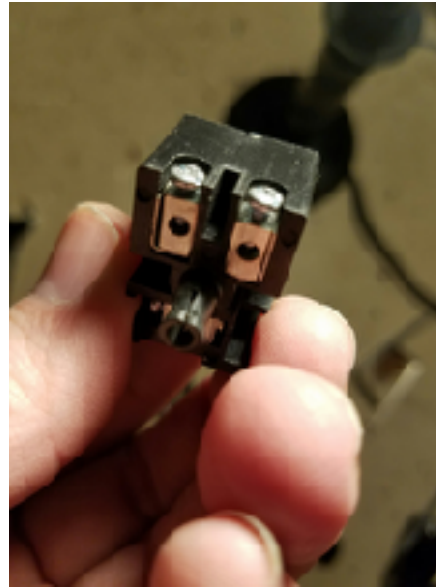
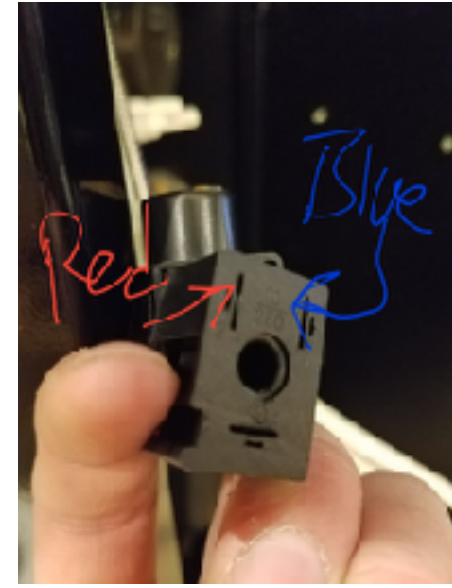
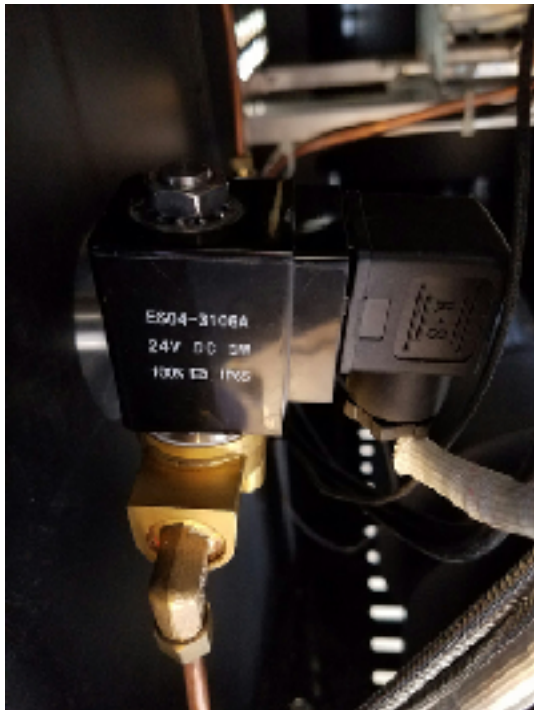
WIRING:

GENERALLY WIRING WITH POSITIVE & NEUTRAL IS A BIG DEAL WITH 110 BUT NOT AS MUCH WITH 220 AS POSITIVE AND NEUTRAL ON A 3 WIRE SYSTEM SHARE THE VOLTAGE AND ONLY THE GROUND BECOMES THE BIG ISSUE- BUT SINCE FACTORY TRICKED ME WITH THIS NEW SOLENOID I SAY BE SURE ON THE SAFE SIDE TO KEEP POSITIVE ON POSITIVE.

ON THE ORO 2.5 & 5 MODELS:
THE POSITIVE IS #1 AND NEUTRAL #2
POSITIVE GOES ON 1

To remove wire harness loosen the Phillips crew and pull off wire harness. Next gently pry open the wire connector and remove wiring from old coil and put on new cool in the same way.

Now you can reattach the new coil to valve body, tighten bolt and test.
