RE: Sunnyside Cogeneration Associates
Annual Inspection Report, #2 Ash Landfill
CCR Rule 257.84(b)

CCR Unit: SCA #2 Ash Landfill

Owner: Sunnyside Cogeneration Associates

Annual Inspection: January 2016

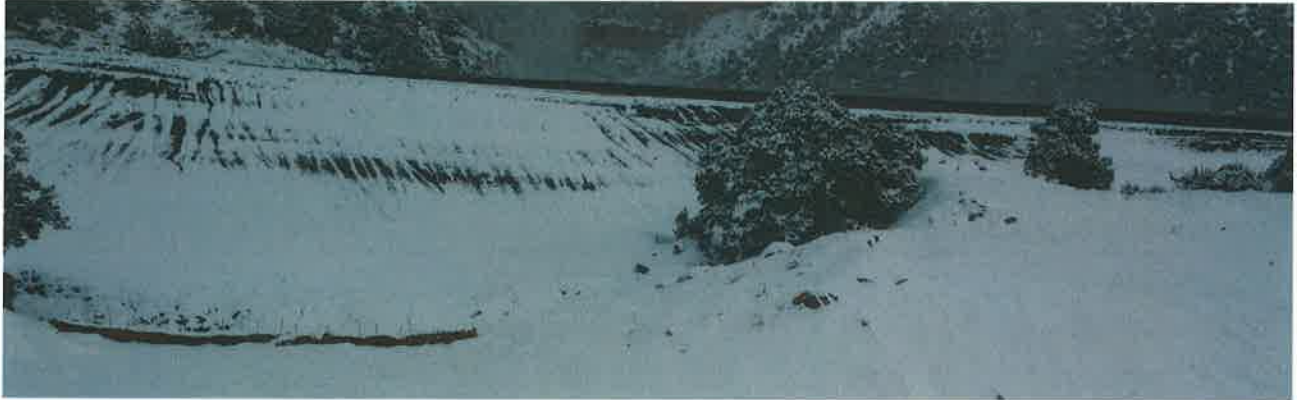
January 7, 2016

SCA#2 Ash Landfill – lower face looking easterly

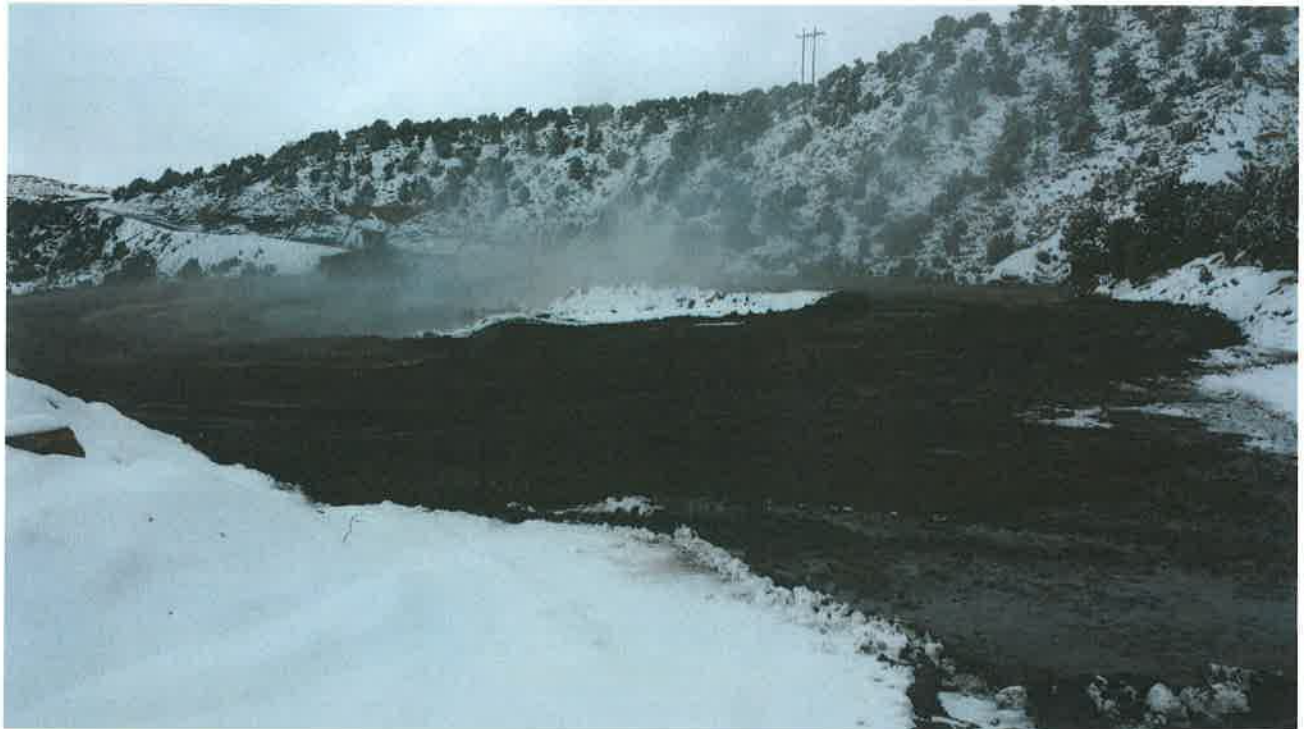
January 7, 2016

SCA#2 Ash Landfill – working surface looking northwesterly
(note steam coming from hot ash with dust control/compaction moisture added)
