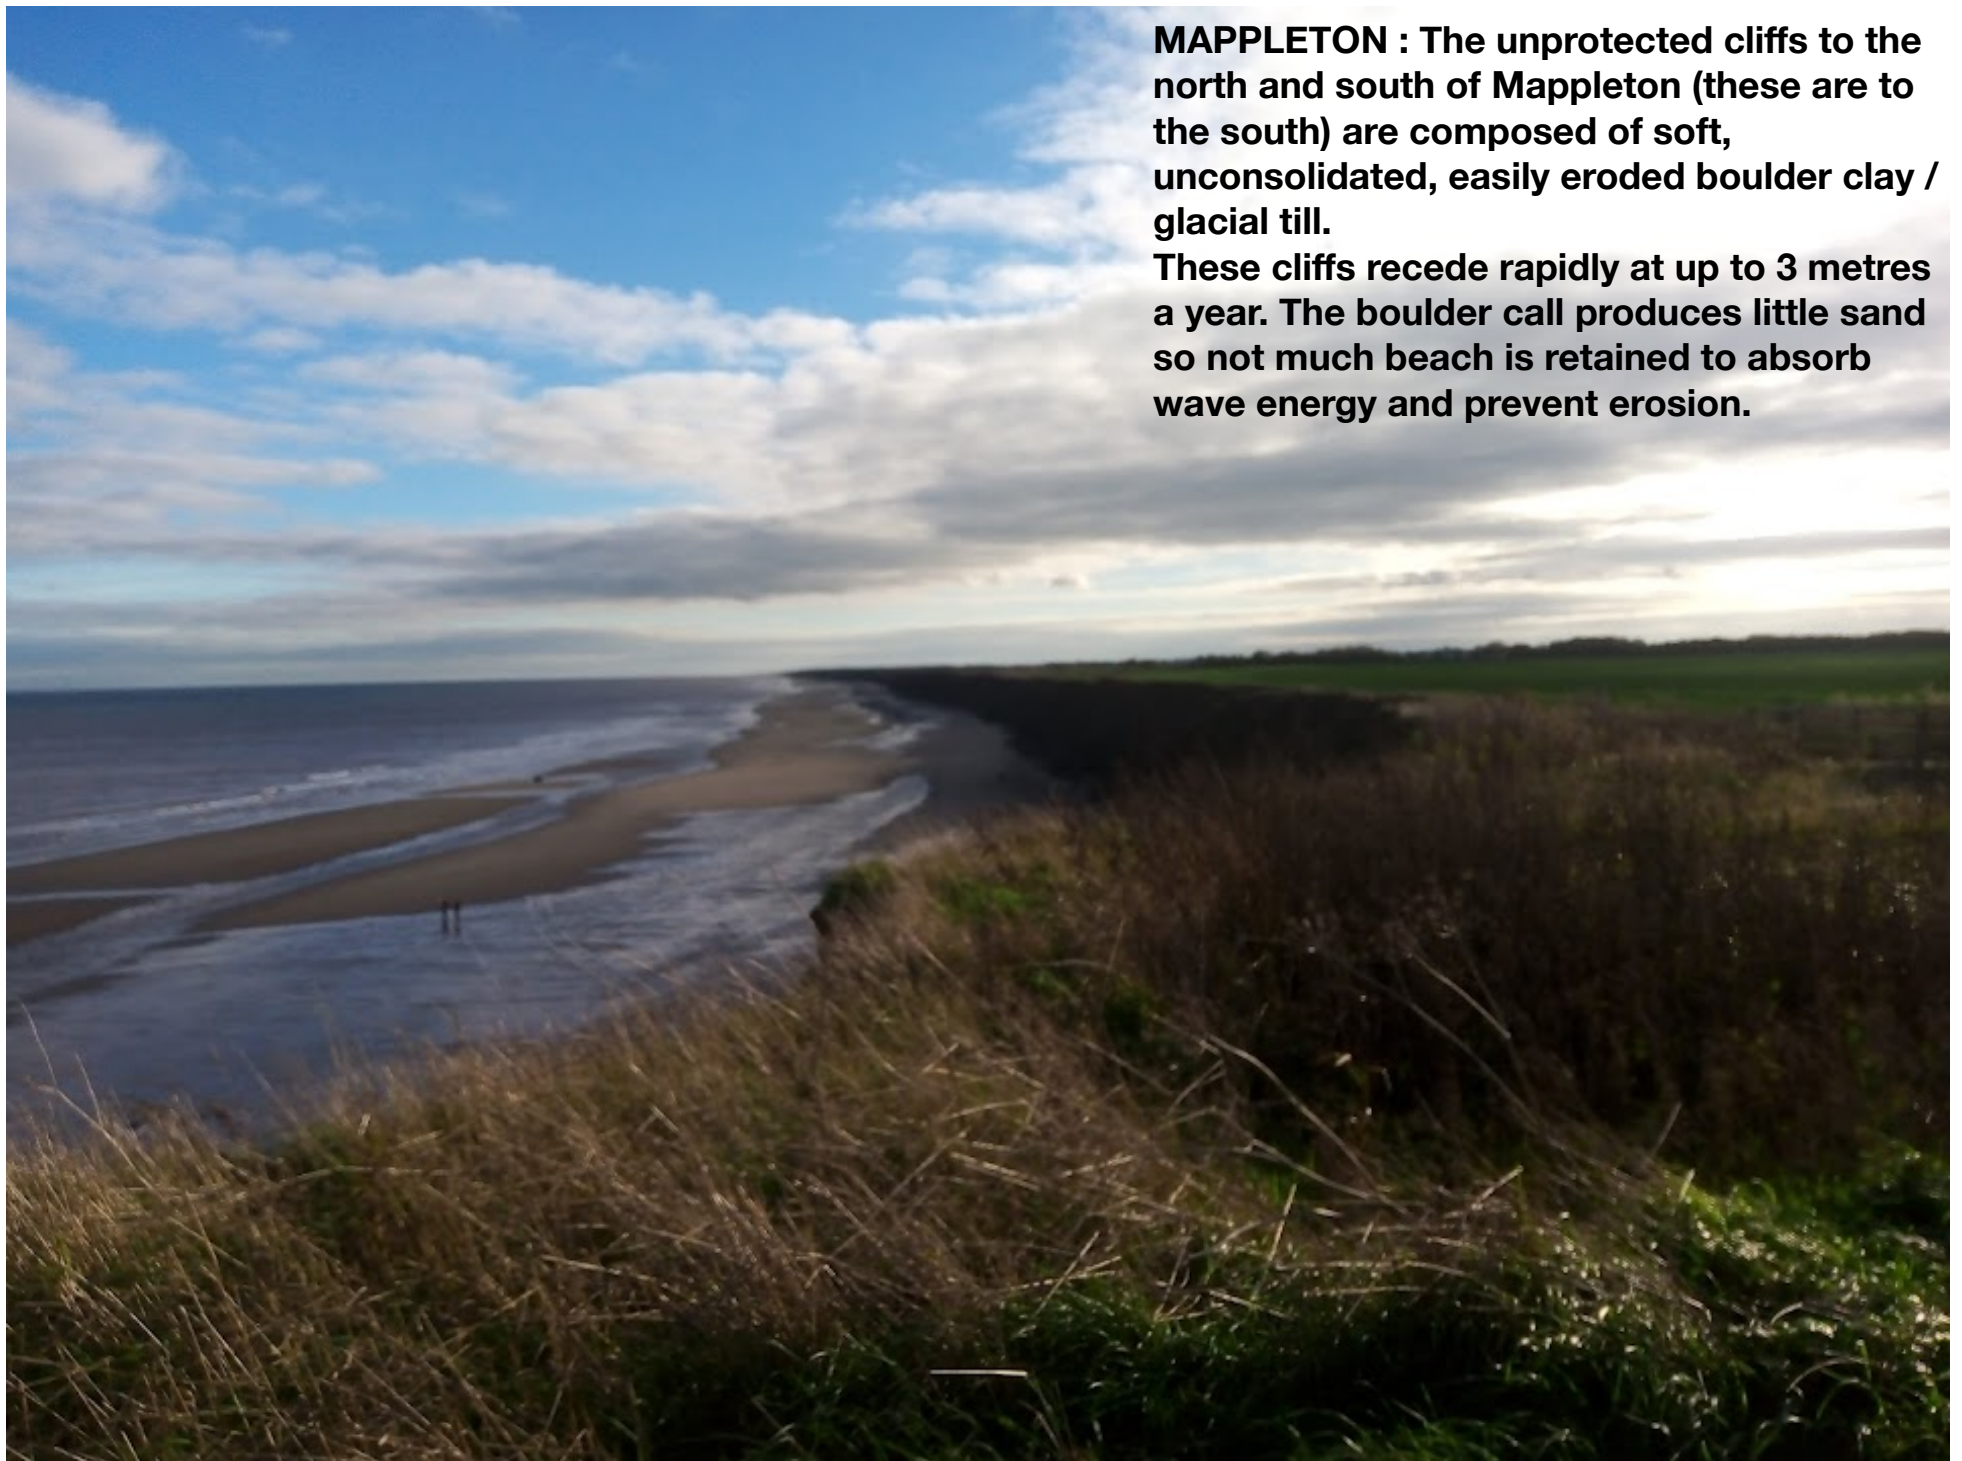
MAPPLETON : The unprotected cliffs to the north and south of Mappleton (these are to the south) are composed of soft, unconsolidated, easily eroded boulder clay / glacial till.

These cliffs recede rapidly at up to 3 metres a year. The boulder clay produces little sand so not much beach is retained to absorb wave energy and prevent erosion.
