# **Water Resource Inventory Area 19 (Lyre-Hoko) Salmonid Restoration Plan**

**June 28, 2015**

**North Olympic Peninsula Lead Entity for Salmon**

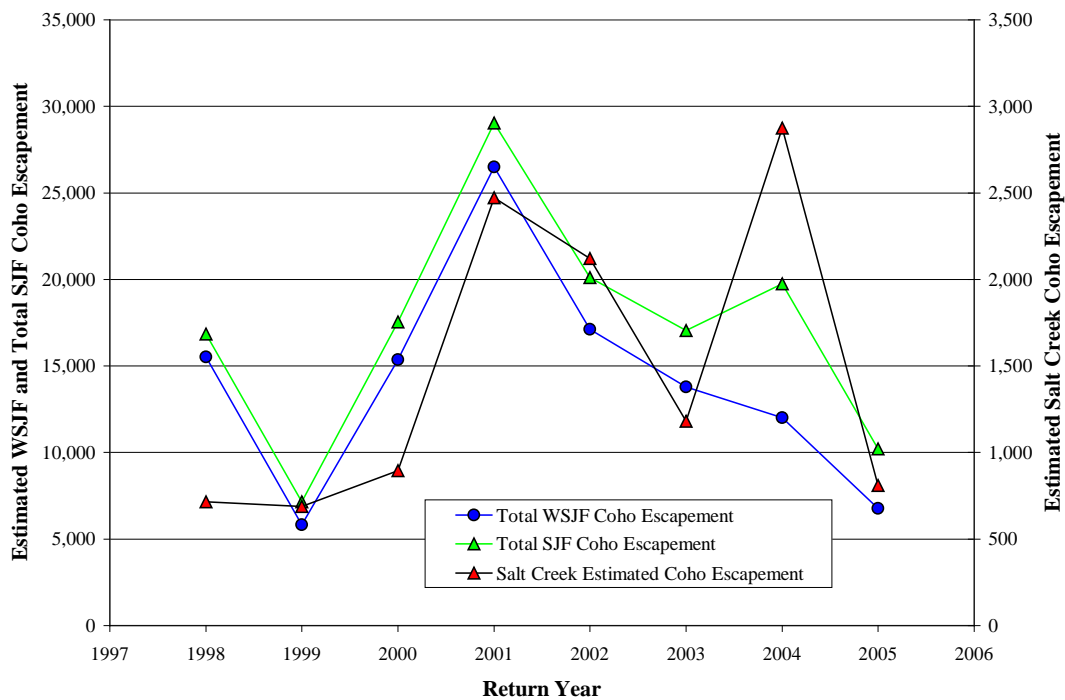
Figure 18. Estimated coho spawning escapement for SJF, WSJF, and Salt Creek for return years 1998-2005 (source: WDFW and Lower Elwha Tribe, unpublished data).

McHenry et al. (2004) state that between 1961 and 1973 the peak coho density (fish/mile) was significantly higher than observed in the 1980s and that recent coho counts per mile have been similar to those observed in the 1980s, suggesting that the initial decline in the population started in the 1980s. Coho salmon spawning escapement data collected by WDFW in their index survey reaches from 1984 through 2006 are included in Figure 17. These data show a downward trend from 1984 through 2000, followed by an increasing trend from 2001 to present. None of these trends are statistically significant. Salt Creek coho also display a dominant cohort year class during this period (RY '86, '89, '92, '95, '98). This year class experienced a significant ( $p=.0016$ ) decline from 1986 through 1998 and has since been increasing (see 2001 and 2004). Total estimated escapement for the Salt Creek watershed for return years 1998 through 2005 are included in Figure 18.

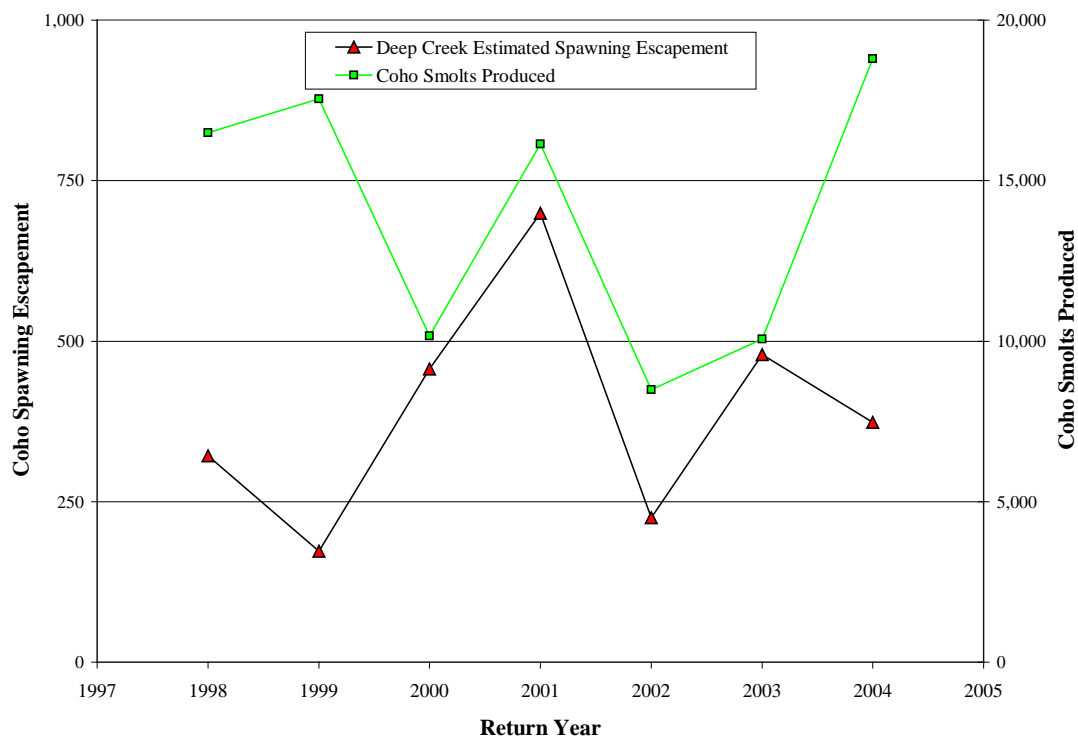
Figure 39. Deep Creek coho spawning escapement and subsequent number of smolt produced (source: Lower Elwha Tribe, unpublished data).

Figure 39 depicts the estimated coho spawning escapement for Deep Creek and the subsequent number of smolt produced. No clear relationship between spawning escapement and coho smolt production are evident based on the data collected so far. Several regressions using 14-day, 30-day, and 60-day low flow ratios (at age 0+) and smolt production were calculated and no significant relationship was found. The number of smolt produced per adult spawner shows the same inverse relationship seen with Salt Creek and East Twin River coho, where increasing numbers of spawners results in a decreased number of smolts produced per spawner (Figure 40).

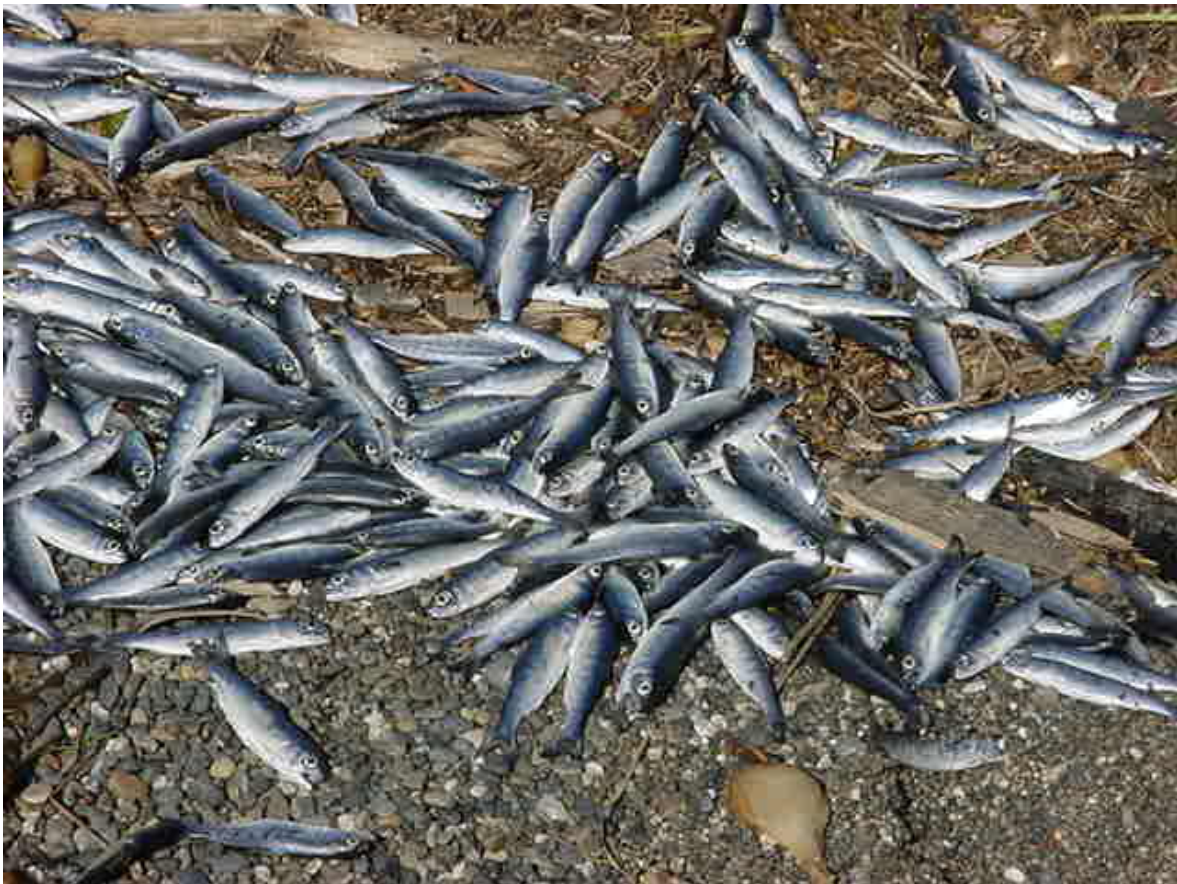
Figure 91. Photograph depicting a portion of the May 2004 fish kill (most of the fish in the picture are coho salmon) at the mouth of the Clallam River (Photo by Jeff Shellberg).

River became bar bound in May, large scale juvenile mortalities were documented when juvenile salmonids that were attempting to enter the Strait of Juan de Fuca were left stranded on the bar during the falling tidal cycle (Figure 91).
