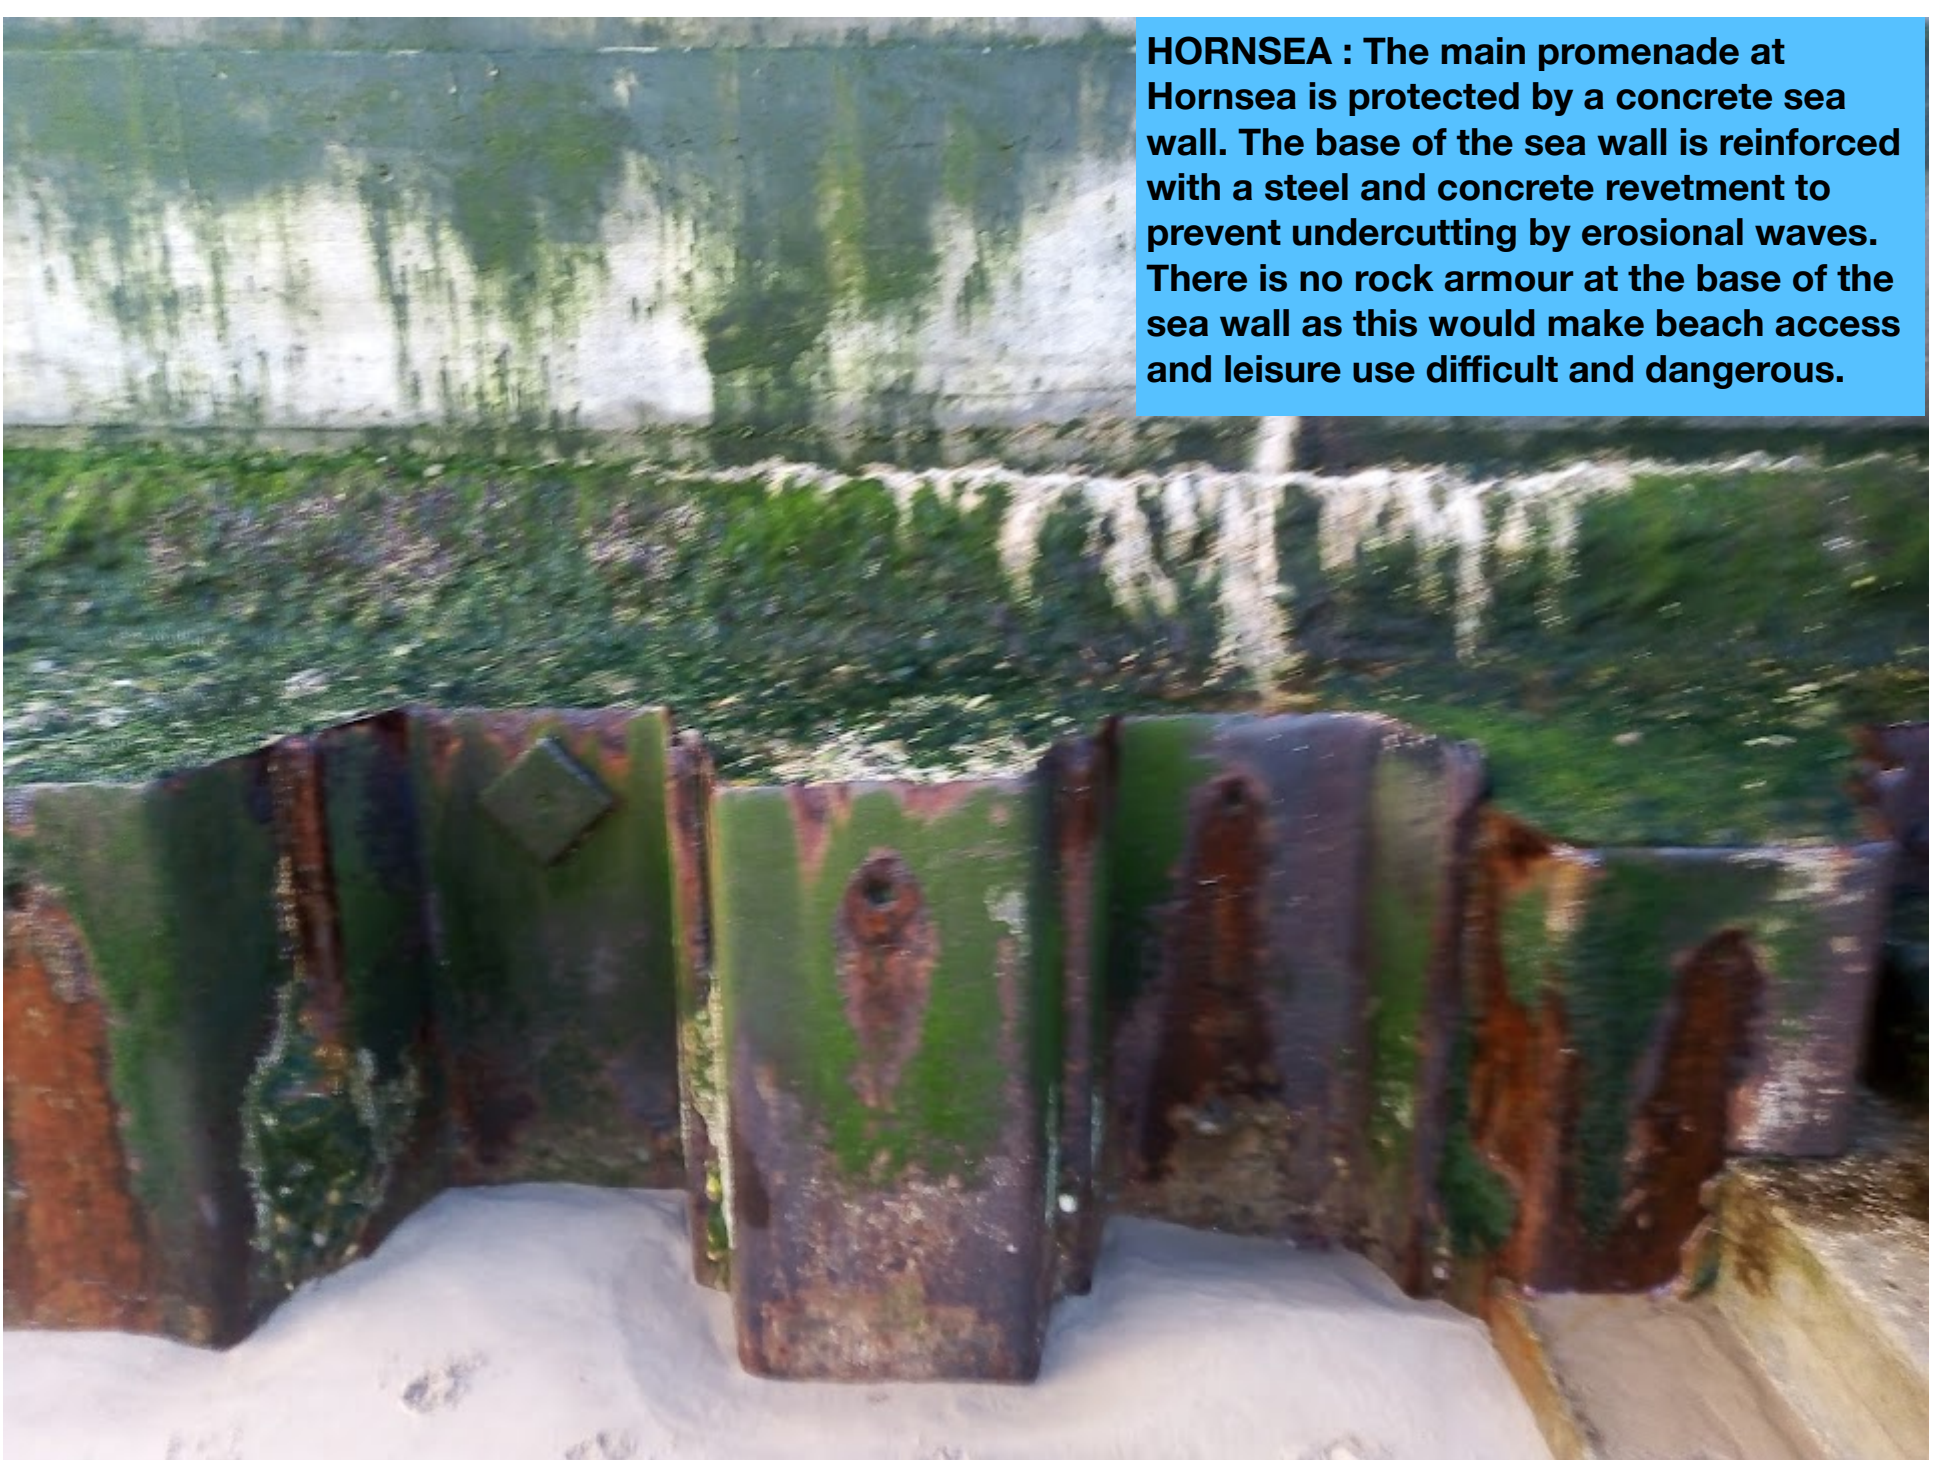
HORNSEA : The main promenade at Hornsea is protected by a concrete sea wall. The base of the sea wall is reinforced with a steel and concrete revetment to prevent undercutting by erosional waves. There is no rock armour at the base of the sea wall as this would make beach access and leisure use difficult and dangerous.
