Tin Lizzie Hospital Wagon

+ WWI ambulance recreated +

by David L. O'Neal

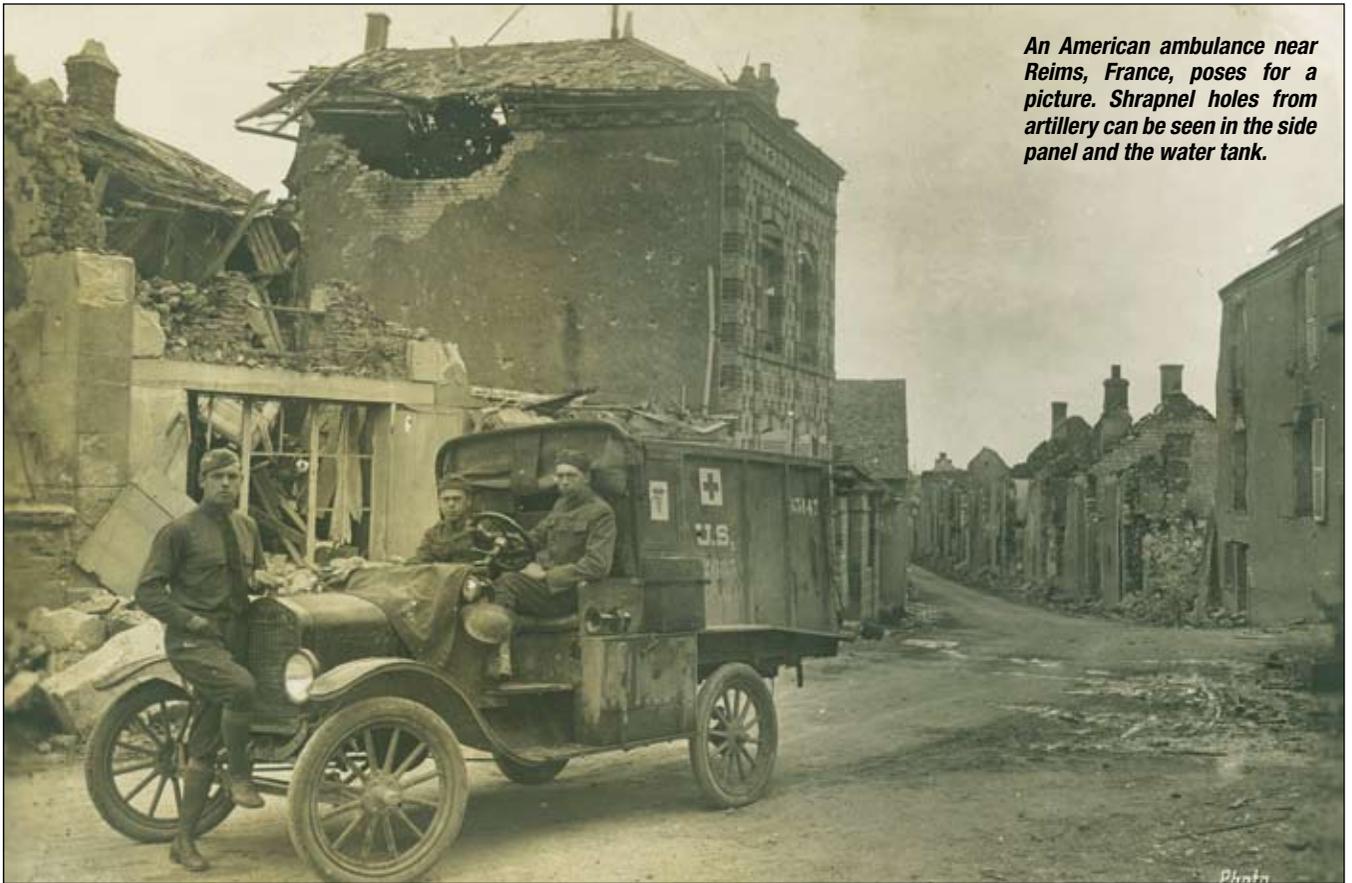
An American ambulance near Reims, France, poses for a picture. Shrapnel holes from artillery can be seen in the side panel and the water tank.

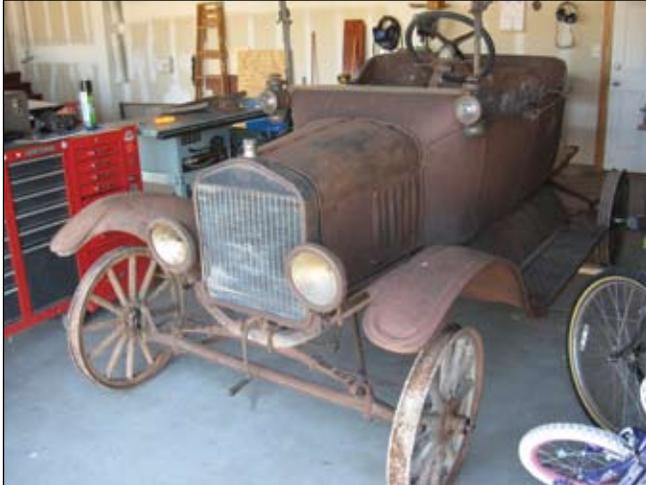
The Ford Model T project car off the trailer and rolled into the garage ready for disassembly.

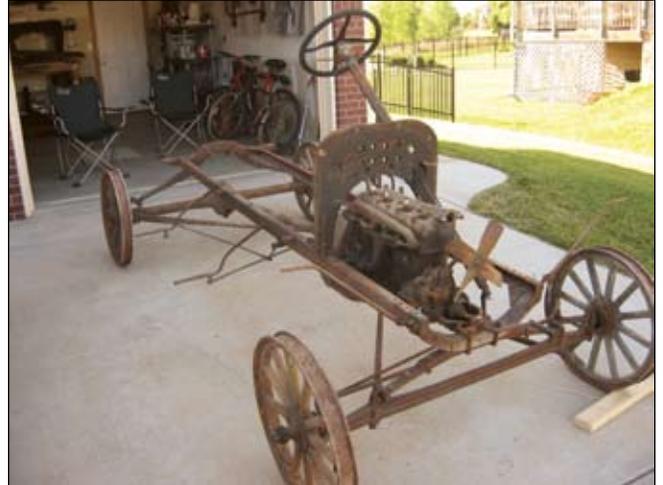
Stripped car chassis with engine still installed. With the removal of the steering column and firewall, the chassis was headed to the sandblaster shop.

I called a tow truck and hauled the naked Model T to the sandblasting shop, while carting all the other parts in my pick-up truck. I had the freshly sandblasted car back in my workshop the next day. All the bare metal was light gray in color and I had to spray primer immediately to protect the freshly-sanded parts from flash rusting because of humidity.

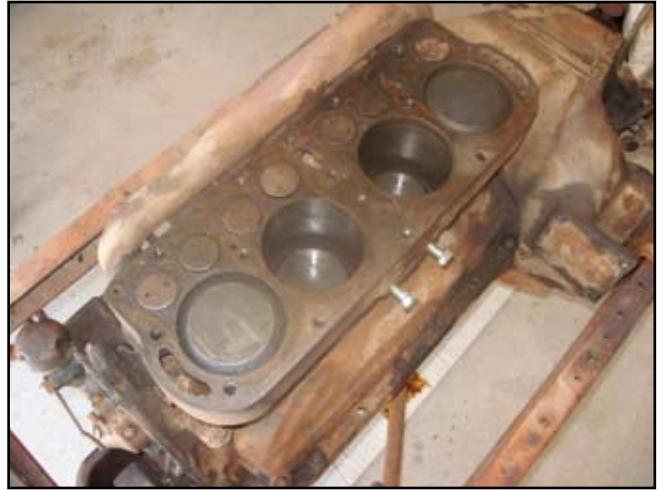
The engine appears to be amazingly clean inside. The vehicle was left for dead about 70 years ago. I suspect an ignition or fuel issue made the owners walk away during the Great Depression.

With the head off, I was amazed at how clean the engine was inside (except for the nut shells in the water jacket). There was no rust and very little carbon. I decided I would try to start the engine without an overhaul.

Though I suspected that the engine was in good enough condition to run on its own, I had to do a partial tear-down to replace all the seals. I cleaned the inside of the engine and then installed a new seal kit.

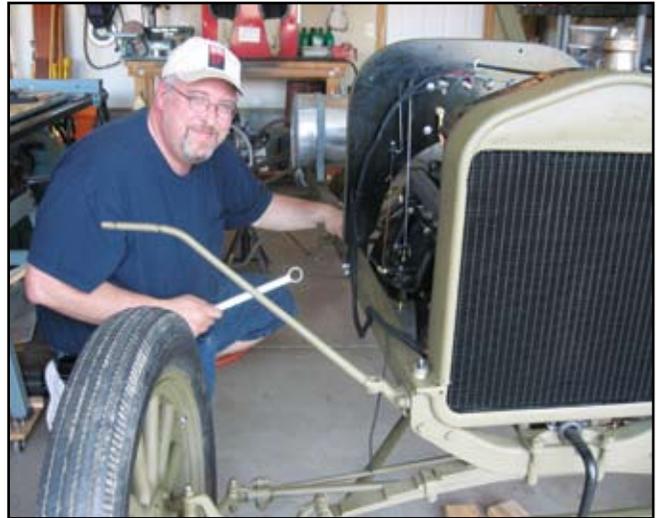
The author making final adjustments prior to the first engine start. The rear wheels are on jack stands for the initial engine runs.

By my estimate, this car had been last started sometime back in the 1930s when it was driven into or towed into a field and abandoned, left for dead. It was now time to try and start the old “Tin Lizzy” and bring her to life in the next century, 70 years later. It took about 10 hand cranks and the “Tin Lizzy” coughed, sputtered a little and smoothed right out. After a successful test drive of the chassis, construction of the ambulance body began.

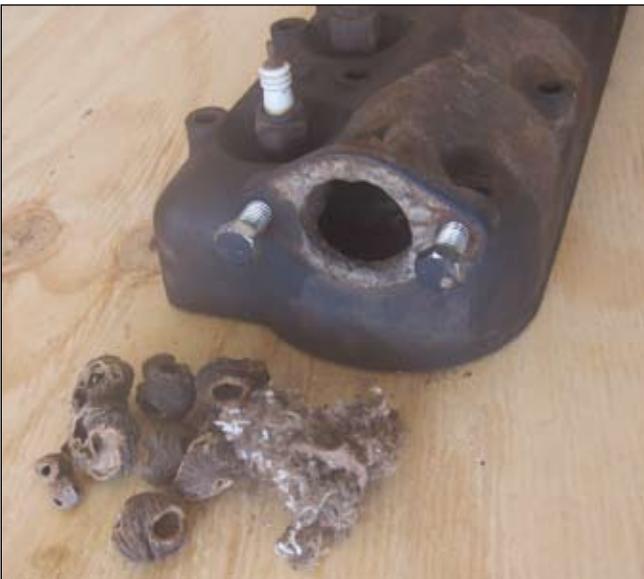
NUTS! A critter's winter stash was found inside the engine. No telling how long ago he was there, but he ate all the nuts and left the shells.

Removing the engine head, I planned to inspect the valves and pistons for carbon build up. What I found was that a squirrel had made a winter nest inside many years ago. I also found a nice cache of acorn and walnut shells with some soft bedding inside the head—he had a good winter. He must have gotten in where the hoses had rotted away long ago, leaving an open door for the little guy to come and go as he pleased.

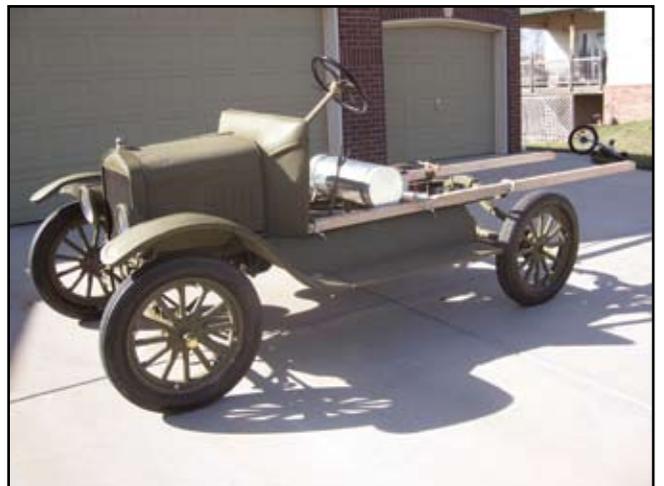
The LH and RH main sills are temporarily fitted using clamps. The sills are made of hardwood (ash) and will support the weight of the ambulance body.

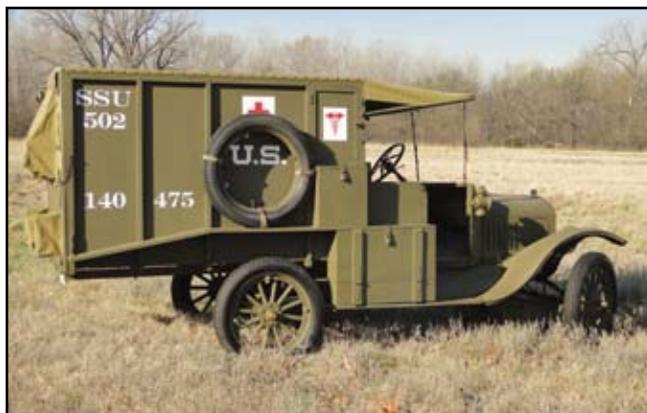
The completed U.S. Army M1917 ambulance showing the RH Side. The upper storage box was used to hold ambulance records and the driver's personal items.

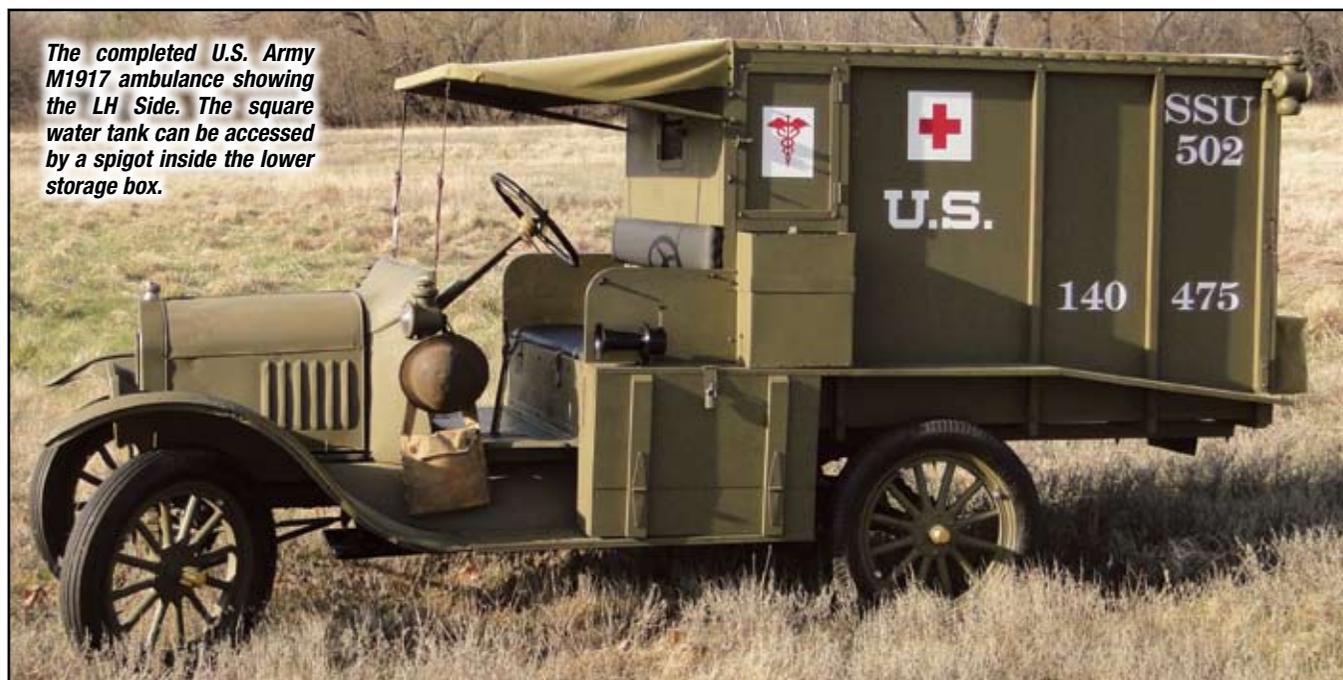
The completed U.S. Army M1917 ambulance showing the LH Side. The square water tank can be accessed by a spigot inside the lower storage box.

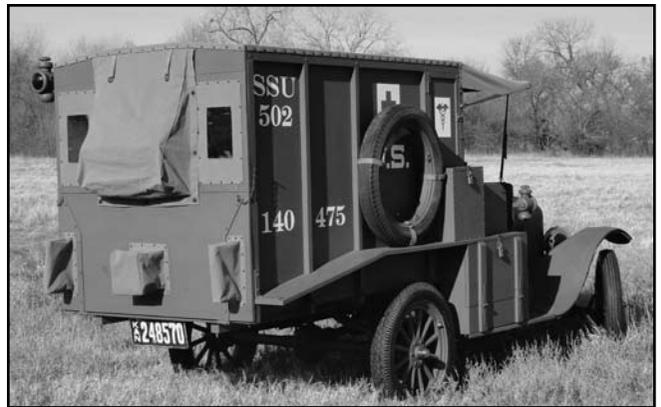
The completed U.S. Army M1917 ambulance showing the Tail Gate. The square canvas pouches allowed the stretcher handles to pass through the tail gate.
