Century Lateral Arm Awning

ADJUSTMENTS AND REPAIRS

Revised September 2008

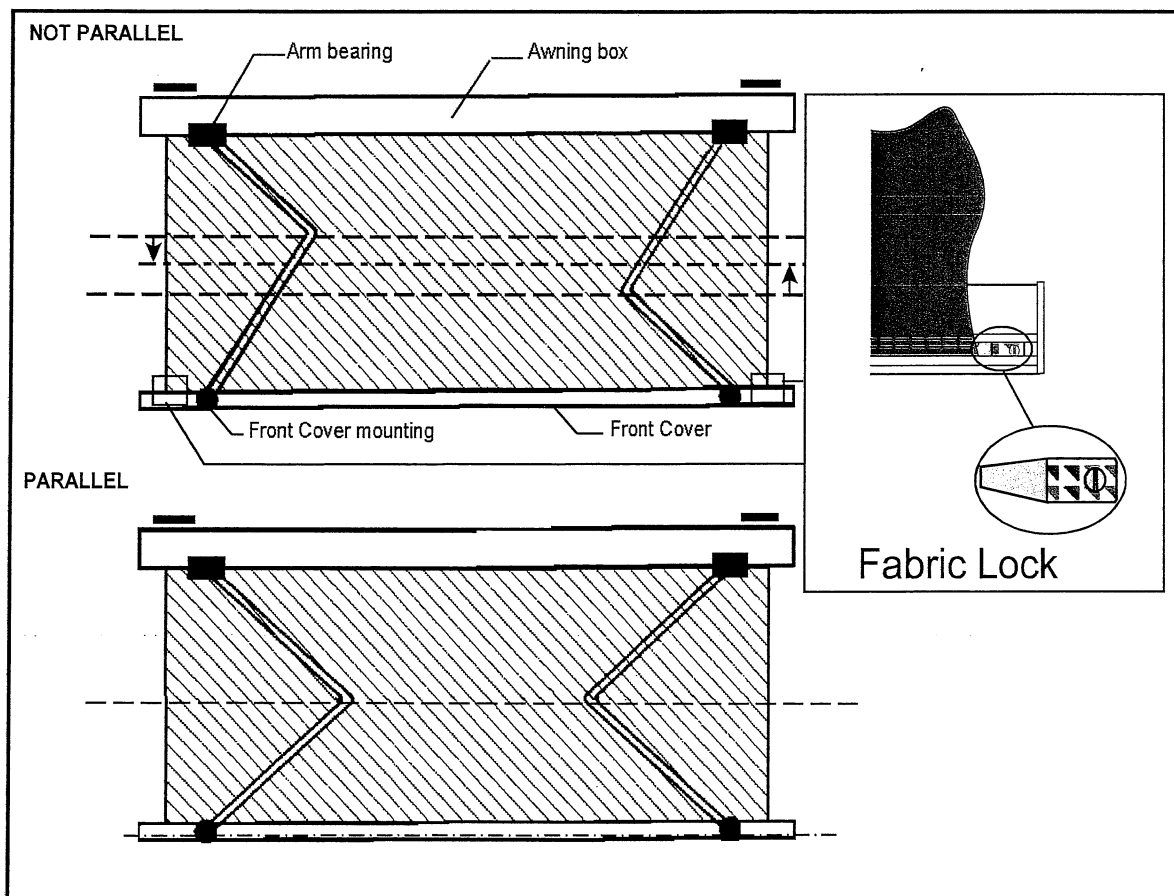
Fig. 1

- Roll out awning all the way.
- Retract awning and take care that the arms are bending uniformly.
- If needed, loosen fabric locks, located in the channel of the front cover on both ends of the awning and push one of the two arms inwardly and pull the other arm outwardly until both are in the same position (Fig1).
- Tighten fabric locks.

- Retract awning all the way and check whether the Front Cover closes properly.

Note: If the above procedures do not remedy the problem (e.g. extreme displacement of the joints), try to adjust according to "Adjustment of Tensions in the Front Cover".
