Protruding Windows - Bay, Bow, and Box Style

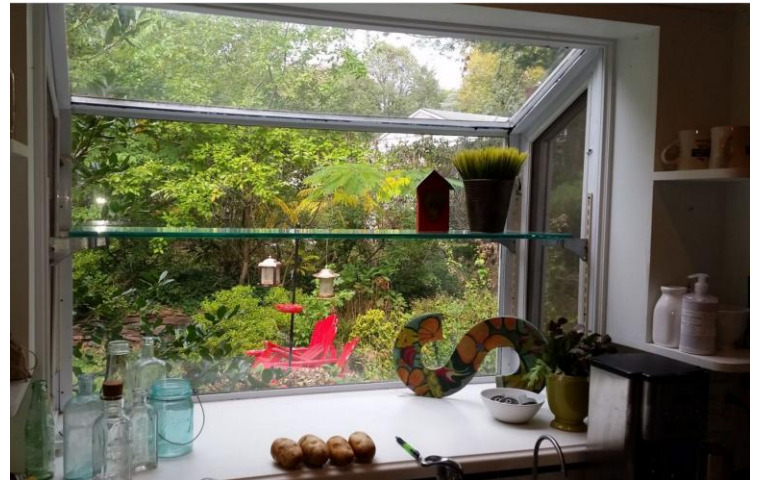
Before

Protruding windows are a beautiful addition to any room but they are usually completely un insulated. The sill portion of the window is just plywood. This means that the only thing between your cozy living space and the sub zero winter temperatures outside is a thin piece of plywood. The sill allows cold air to leak in and conditioned air to leak out. In many cases, the home owner's who have these features cannot even go near the window in the winter.

Bay Window Sill - No Insulation

The good news is that these beautiful windows do not need to be removed or replaced to fix this issue. Our solution to this problem is to seal the underside of the sill with foam and then fill the sill with closed cell spray foam or 2" polyiso foam board. This eliminates air leakage and results in a much more comfortable living space year round.
