BioLuxing Case Studies

Shadow Mountain Mustang Gas Station: Grand Lake, CO

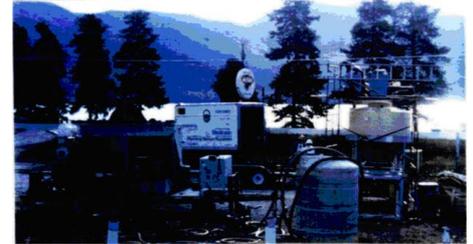
Pictured above is the equipment used to inoculate Isolite®CG on site and to simultaneously fracture and inject the microbe-laden pellets into the contaminated zone. Recessed pipes allowed for surface access in order to provide oxygen and nutrients to the BioLuxes™ if necessary. The well caps that cover the recessed pipes were the only signs left behind to indicate that remediation had been conducted at the site. The installation took two days.
