August 2008 • Vol. XXVI • No. 7 • \$10.00

WET SEALING

By Karl Schaack, RRC, PE

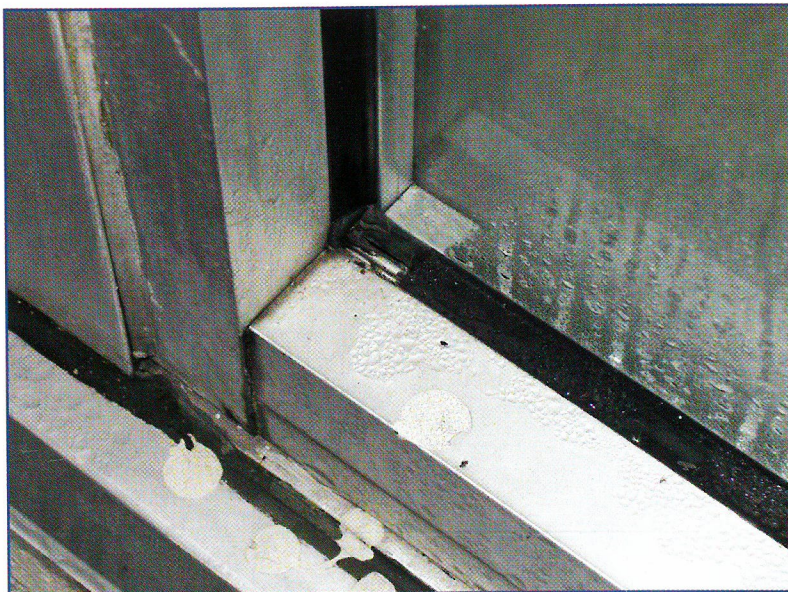
Figure 1 – Short gasket at corner of frame.

As a result of these actions, a relatively large gap ($\frac{1}{4}$ in to $\frac{1}{2}$ in) can occur at the corners of the sill and jamb intersections, which can allow water to migrate into the internal network of the assembly (Figure 1). The gaskets are traditionally composed of EPDM rubber that, upon exposure and aging, will begin to shrink and develop crazing/cracking of the gasket surface (Figure 2). This shrinkage and development of cracks (particularly along the outer, thinner edges of the gasket) can result in a loss of compression between the gasket and the glass, which can then allow moisture migration into the assembly (Figures 3 and 4). Therefore, the purpose of the wet seal is to completely conceal the gasket with the new sealant.

Water infiltration typically occurs at preformed gaskets, due to either shrinkage (resulting from weathering/aging) or improper installation. Improper installation can result in gaps and/or openings between adjoining gaskets that occur at the corners of the sill and jamb intersections. During installation of the gaskets, adjoining gaskets might

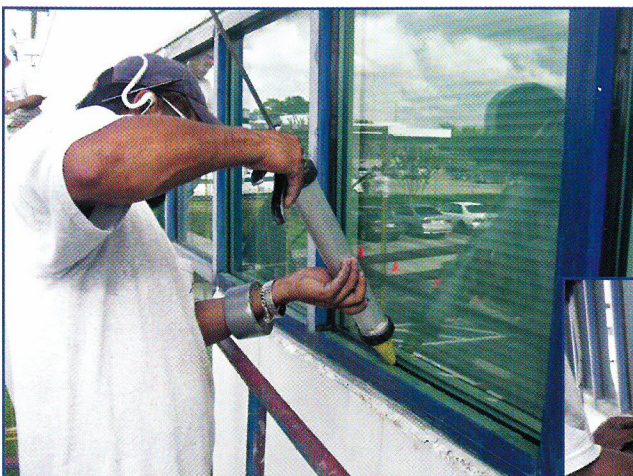
Figure 6 – Wet sealing window frame.

the sealant is “gunned” in place, the sealant is tooled to achieve bond interfaces (“bite”) with both the glass and the frame (Figures 6 and 7).

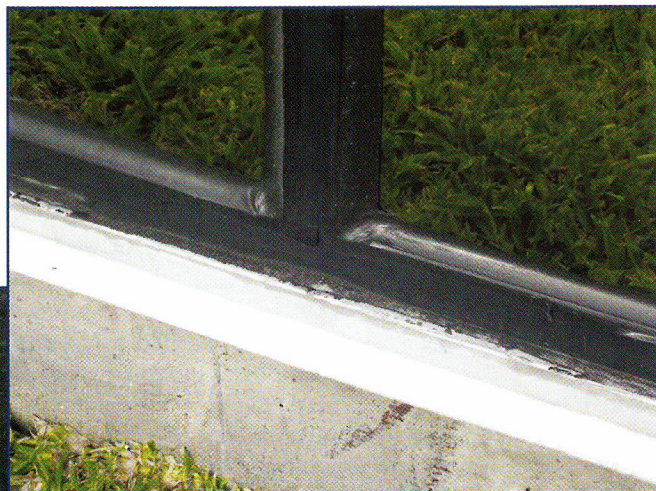
Figure 11 – Wet-sealed lockstrip.

Figure 10 (below) – Wet seal applied along edge of gasket.

into the glazing pocket and manifesting as leakage in the interior at joints in the gaskets. Wet-sealing of these assemblies can include injecting sealant behind the lip of the gasket and allowing the sealant to exude out to be tooled flush. Sealant is then applied in a cap bead centered over the lip or outer edge of the gasket and adhered to the gasket and the glass (Figures 10 and 11). Sealant is also applied over the gasket intersections at the corners of the four glass units and at any gasket joint that may occur in vertical or horizontal runs of the assembly (Figures 12 and 13). Mock-ups using the proposed sealant should be performed to test for compatibility issues and adhesion properties. In the past, polyurethane sealants were commonly used for this application, due to their ability to bond readily to the gaskets.
