Types of Marine Corrosion

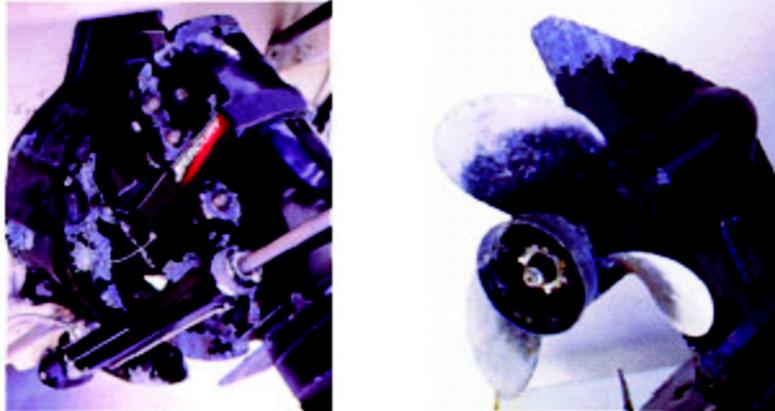
Typical signs of corrosion on marine lower drive units and propellers include blistering paint and the formation of a white powdery substance on the exposed metal areas

The first sign of galvanic corrosion is paint blistering (starting on sharp edges) below the water line- a white powdery substance forms on the exposed metal

areas. As the corrosion continues, the exposed metal areas will become deeply pitted, as the metal is actually eaten away.

The first signs of corrosion below the waterline are paint blistering, usually on sharp edges, and the formation of powdery white corrosion material on exposed aluminum surfaces. If the corrosion is allowed to continue, pitting of the aluminum will occur. The chart below may help you determine the cause of the corrosion and the corrective action needed to prevent its continuance.

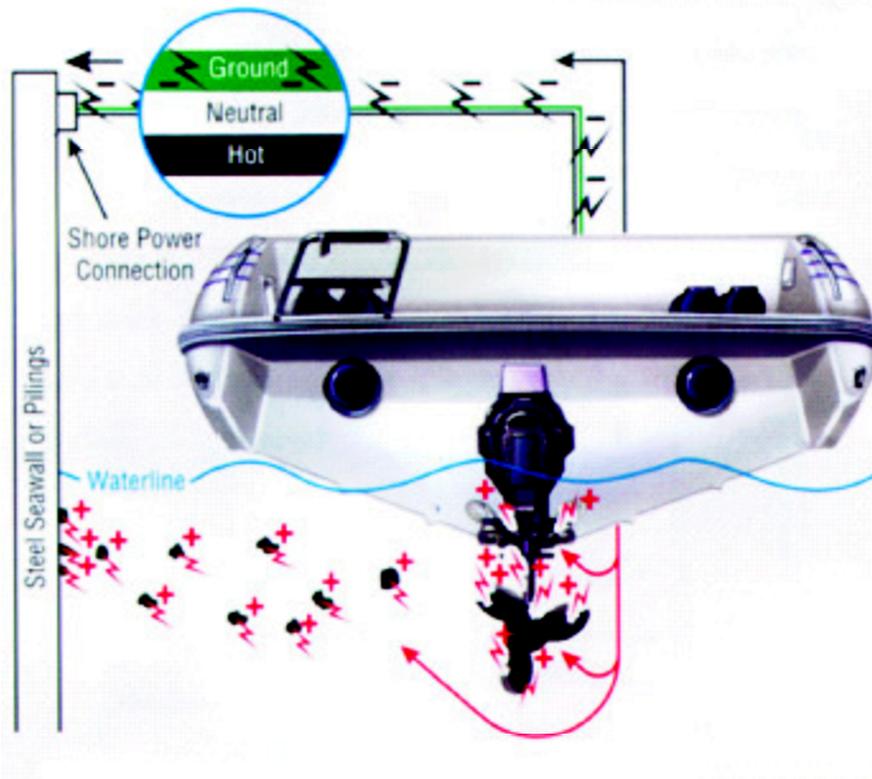
Galvanic corrosion caused by nearby grounded steel structures can occur when you dock your boat and use shorepower

Galvanic corrosion can also occur without any stainless steel components on your boat. For example, you have an aluminum drive unit and an aluminum propeller, but you dock at a pier with steel pilings or a steel seawall, then plug into shorepower. The ground wire, which is grounded, connects your aluminum components with the submerged steel because the steel is also grounded. Considering the mass of a seawall or even a single piling, your drive and propeller can sustain serious damage. This damage could be prevented with a galvanic isolator.
