## OHIO HISTORIC INVENTORY

1. IRI-1612		4. Present Name(s) Marcus Village	
2. County ERIE		5. Other Name(s) Henry Worden House	
3. Location of Negatives O.H.S.			
5. Specific Location West side of Division St. diagonally across to the north west from Estes Sch.		16. Thematic Category Agriculture	28. No. of Stories Up 2/wg 1

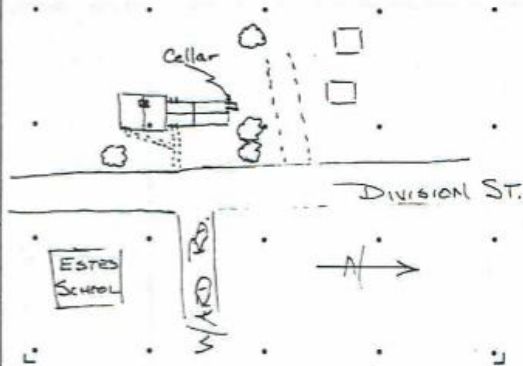
## 53. Farmstead Plan

4. Description of Environment and Outbuildings The house is situated about 80 feet south of a glacial beach line that bounds the Sweet Valley. A limestone slab walk leads from a door in the wing to Division St. The property line is marked by a row of large (24"-

30") maples. Two board and batten frame cottages on masonry piers are located to the north along the old beach line.
