# RIO GRANDE DIVERSION INFRASTRUCTURE INVENTORY

**Structure Name:** ANTLERS PARK D

**Reported By:** Daniel Boyes

**Date:** April, 2019

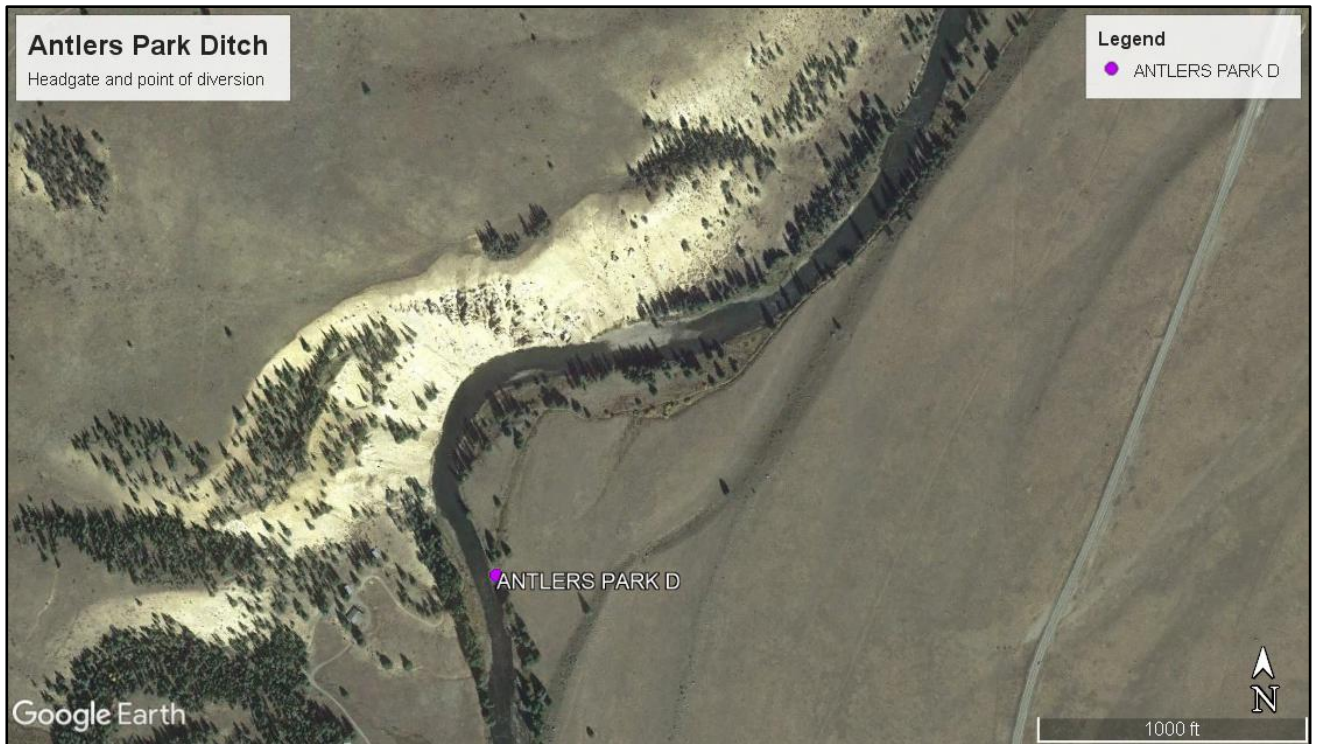
**Upstream Configuration:** This ditch is located ~1 mile downstream of Marshall Park Campground. There is no diversion dam serving this structure. The structure is located on the east bank of the river. The water rights holder cannot access the ditch's full decree due to the ditch's location on the river and the poor condition of the headgate. According to the water commissioner, the point of diversion will likely move in the future.

Antlers Park Ditch point of diversion location

**Repair(s) or Improvement(s) Currently Needed:** The primary recommendation is to relocate the point of diversion for this ditch. Existing fish and boat passage should be maintained and riparian restoration should be considered as part of any future repairs or improvements.
