USD #286
ROOFING
PROJECT @
GYMNASIUM
& AG SHOP
BUILDING

ROOF PLAN

Project number	H&A1204
Date	6/30/19
Drawn by	JEH
Checked by	JEH
Sheet	A-1
Scale	3/32" = 1'-0"

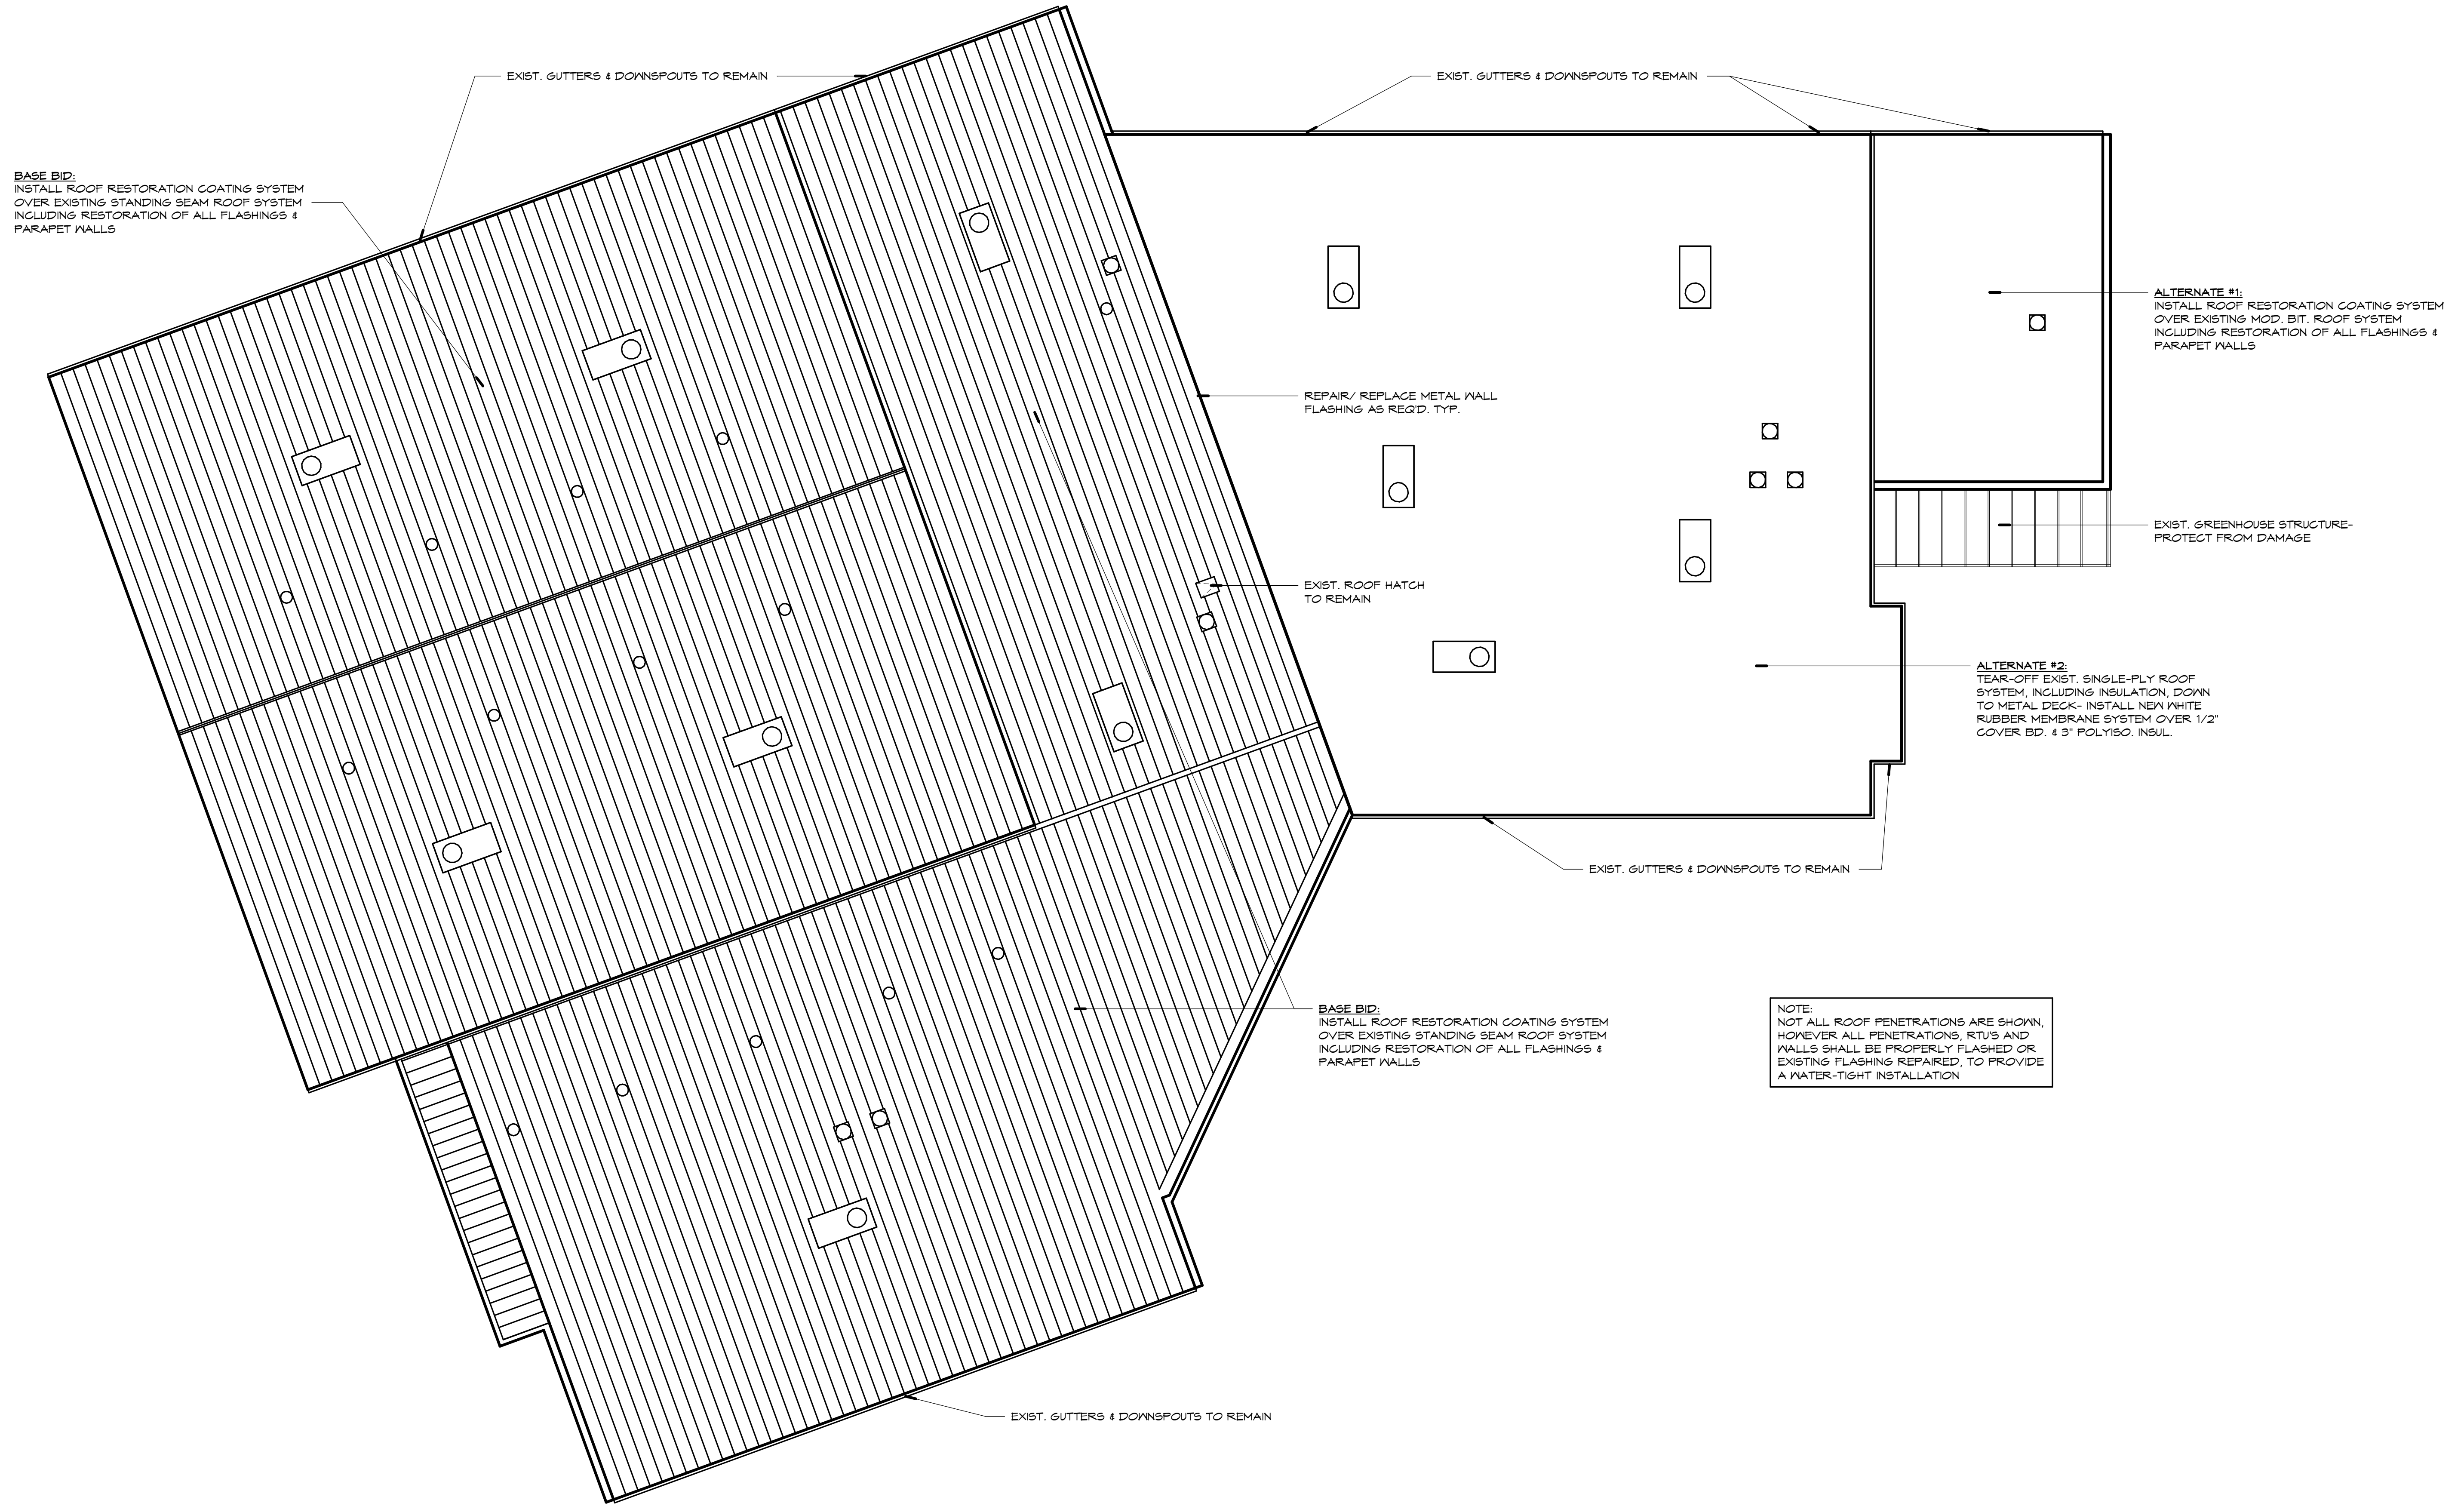
1 **ROOF PLAN**
3/32" = 1'-0"

BASE BID:
INSTALL ROOF RESTORATION COATING SYSTEM
OVER EXISTING STANDING SEAM ROOF SYSTEM
INCLUDING RESTORATION OF ALL FLASHINGS &
PARAPET WALLS

REPAIR/ REPLACE METAL WALL
FLASHING AS REQ'D. TYP.

ALTERNATE #1:
INSTALL ROOF RESTORATION COATING SYSTEM
OVER EXISTING MOD. BIT. ROOF SYSTEM
INCLUDING RESTORATION OF ALL FLASHINGS &
PARAPET WALLS

ALTERNATE #2:
TEAR-OFF EXIST. SINGLE-PLY ROOF
SYSTEM, INCLUDING INSULATION, DOWN
TO METAL DECK- INSTALL NEW WHITE
RUBBER MEMBRANE SYSTEM OVER 1/2"
COVER BD. & 3" POLYISO. INSUL.

NOTE:
NOT ALL ROOF PENETRATIONS ARE SHOWN,
HOWEVER ALL PENETRATIONS, RTUS AND
WALLS SHALL BE PROPERLY FLASHED OR
EXISTING FLASHING REPAIRED, TO PROVIDE
A WATER-TIGHT INSTALLATION
