# OHIO HISTORIC INVENTORY

1. No. ERI -1663		4. Present Name(s) Camp Patmos		ERI-1663
2. County ERIE		5. Other Name(s)		
3. Location of Negatives OHS		Samuel and Robert Hamilton Residence

Camp Patmos  
 Samuel & Robert Hamilton House

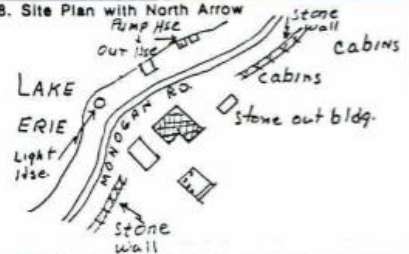
8. Site Plan with North Arrow

19. Description of Environment and Outbuildings Outbuildings include shiplap-sided frame cabins; a miniature light-house, swimming pool; stone pump house and outhouse with concrete slab roof; and an underground stone boathouse with segmentally arched entry-		30. Foundation Material Ashlar limestone

way. These stone outbuildings may be vestiges of the original farmstead. The original stone cabins are similar in design and construction to the dining hall addition. The camp is located near the base of the Long Point Peninsula and faces the shore road. It is flanked by two long, dry-laid stone walls (ERI-1664).
