PROJECT PROFILE

9900 Westpark Parking Garage

Houston, Texas

Services Provided:
Assessment

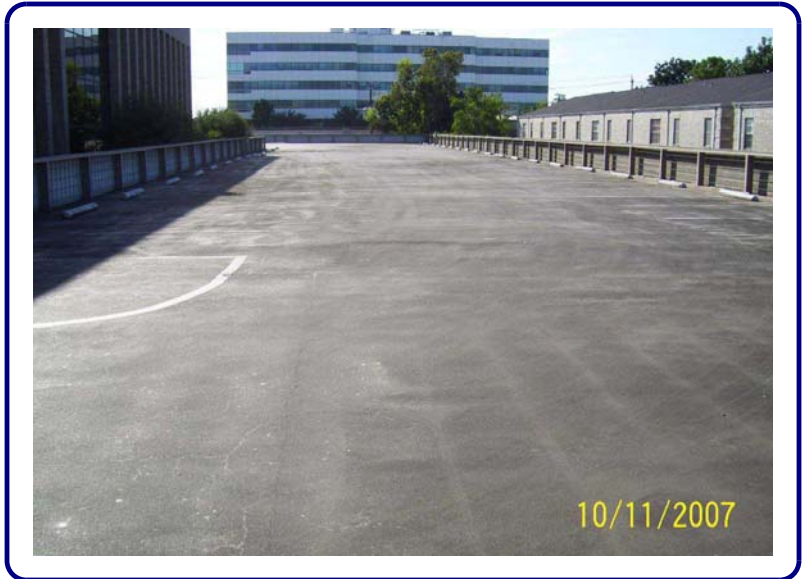
The parking garage adjacent to the Office Building at 9900 Westpark is a 2-level structure comprised of structural steel columns and beam framing with an elevated cast-in-place concrete deck on metal form deck supported by open-web steel bar joists. The elevated deck encompassed approximately 38,100 square feet with an access ramp encompassing approximately 1,100 square feet. CMU walls and metal panel cladding occurred along the perimeter of the garage.

PCI was retained by Boxer Properties to perform a condition assessment on the garage structure. Upon completion of our assessment, PCI noted the following conditions: water infiltration through the elevated deck at numerous locations; corrosion of the metal form deck; ponding water on the surface of the concrete deck; corrosion of the steel beams and columns; peeling paint on the underside of the metal form deck; detached lateral bridging on the bar joists; broken welded connections in the bar joists; spalled areas in the top of the concrete deck; craze cracks and linear cracks in the concrete deck; efflorescence on the surface of the concrete deck; ; cracks and lateral displacement in the exterior CMU walls; deteriorated expansion joints in the deck; missing fasteners in perimeter clip angles used to secure metal wall panels; and improperly installed wire rope barriers. Upon completion of the assessment, PCI presented our findings in an Engineering Report with recommendations for corrective action.
