Preserving Concrete on “The Rock”

A team of students and veterans is working to preserve the storied history of Alcatraz Island, much of which is cast in concrete.

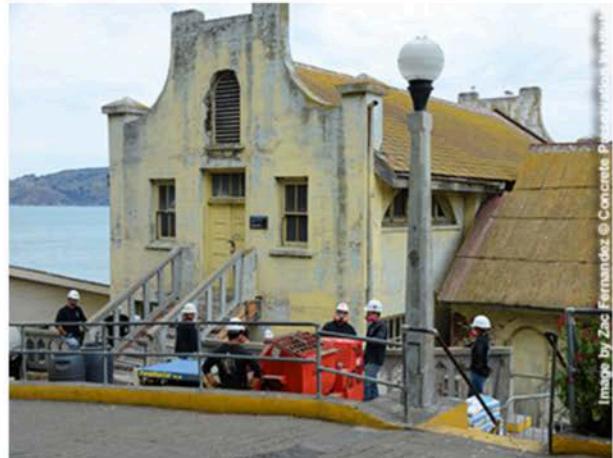
The team prepares structural repairs for a beam, stair stringers, and stairs to the schoolhouse on Alcatraz Island. Image by Zac Fernandez © Concrete Preservation Institute

The complexity of the primary project has grown each year since its inception in 2010. Last year the team conducted structural repairs utilizing a form-and-pump approach for a beam, a set of stair stringers, and stairs over a walkway. Each project begins with structural engineering consultations, and progresses

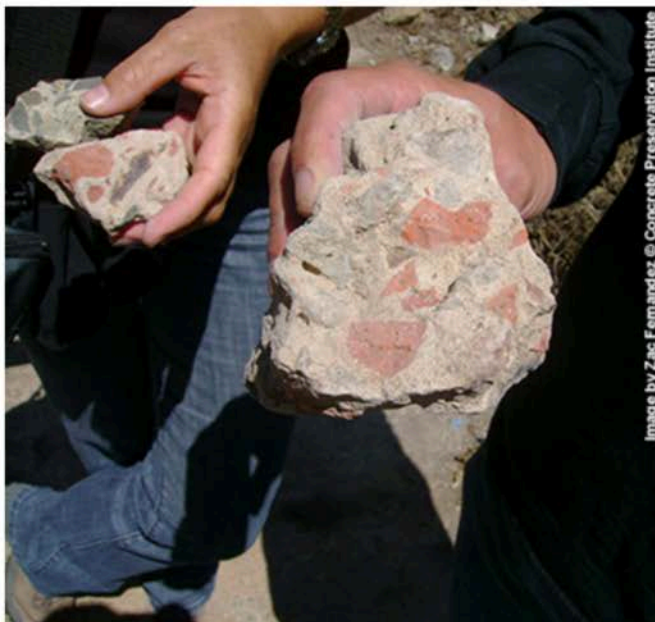
The team has found crushed bricks from an earlier structure used as aggregate in the main cell house. Image by Zac Fernandez © Concrete Preservation Institute

Once a repair begins, the team often makes startling discoveries connected to the island's past. "We're dealing with something that—when it was built—they weren't thinking 'this is going to be a landmark.' It's utilitarian," Komas says. Many of the structures were built by prison labor to less than exacting standards and using creative material choices. When a smaller structure was demolished early in the 20th century to make way for the existing cell house, for example, inmate laborers smashed the old bricks and used them as aggregate in the new concrete.

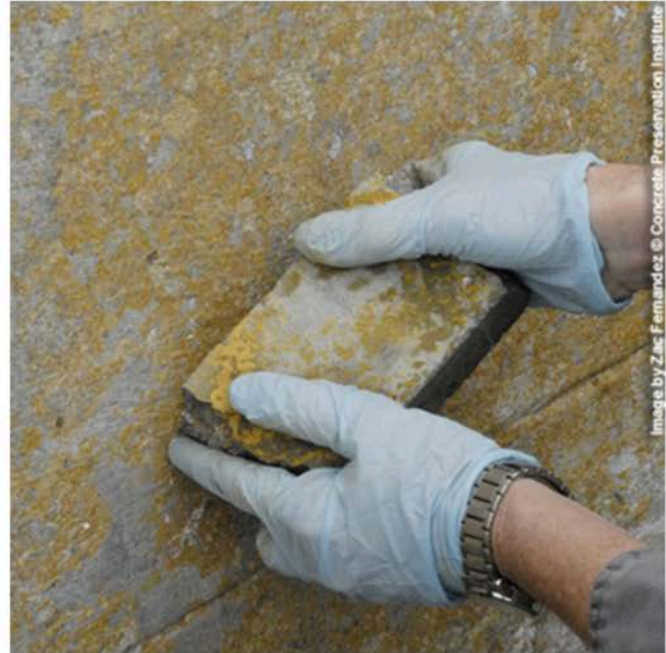
A variety of methods are used to replicate the appearance of the existing concrete, some of which has more than 100 years of patina and color. Image by Zac Fernandez © Concrete Preservation Institute

"You have 100 years of patina on this concrete," Komas adds. "It has texture and color. How do you replicate that so it doesn't look like patches all over the place?" These aesthetic elements create another kind of learning experience. The team has used rough brush strokes, special form-liners, and pigmented microtoppings to match the historic concrete.

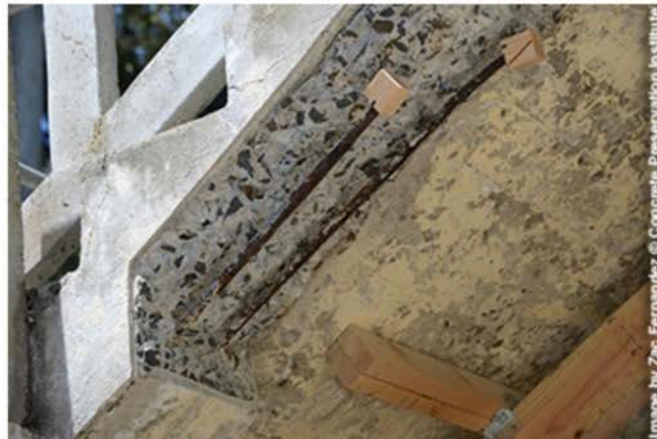
Each project is approached with a bias toward preservation. The goal is to remove as little historic concrete as possible for a safe and durable repair. Image by Zac Fernandez © Concrete Preservation Institute
