1949 Packard Super Deluxe
Part 2
The Restoration
By Bruce Sedel

As a follow-up to the acquisition of my 1949 Packard Super Deluxe sedan at an auction in Atlanta Georgia, this part of the story provides some of the details of its restoration.

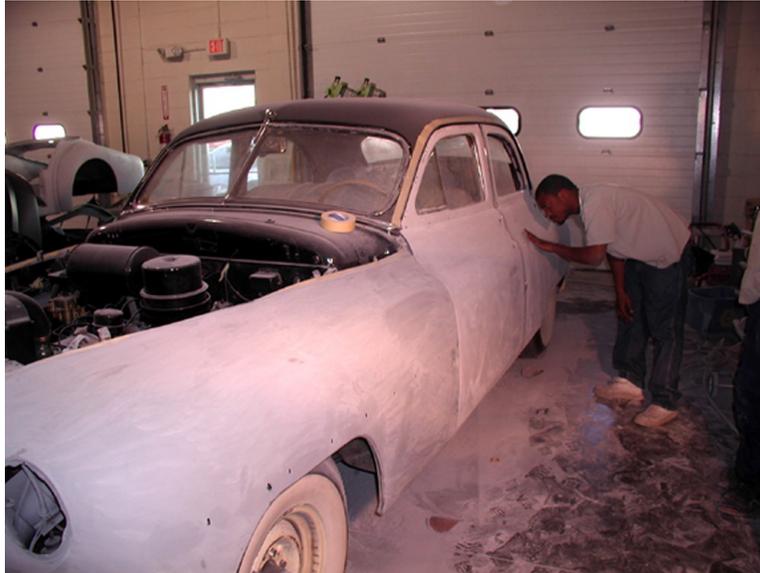
As I stood there looking at the car in the driveway, I couldn't stop noticing how beautifully straight the body lines appeared. It was obvious this car had not been damaged or if it had, somebody certainly performed quality body work. But that was the good news. The bad news was the fact that the atrocious yellow paint that I had previously alluded to had to go. So began the disassembly process, little by little, step by step, day by day, bright work, front end grille and bumper assemblies and exterior door handles were all carefully removed. All fasteners were bagged and labeled and notes were made as to what pieces needed to be replaced. Interior window mouldings, door panels, carpet, front and back seats and finally the side window glass panels were removed. As the richly appointed niceties were being removed, the car was becoming

less and less representative of its former elegance and high society and slowly looking more and more unsightly like a ragged old pauper at an urban orphanage.

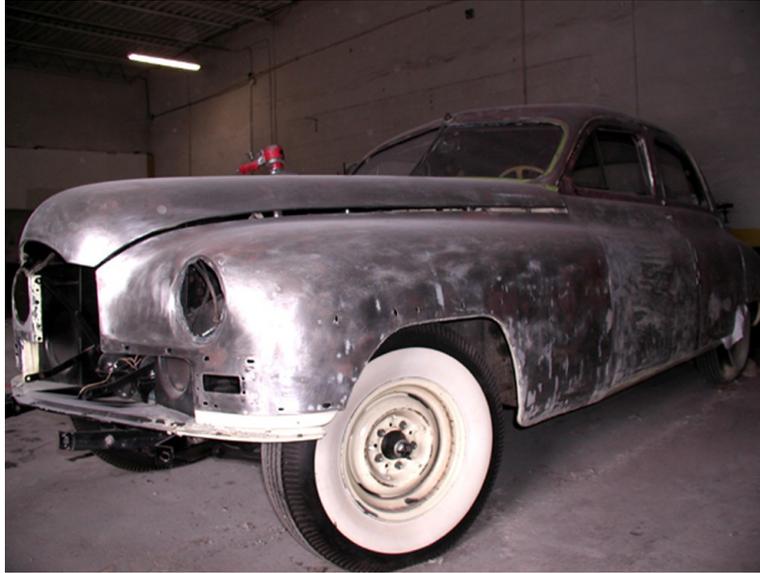
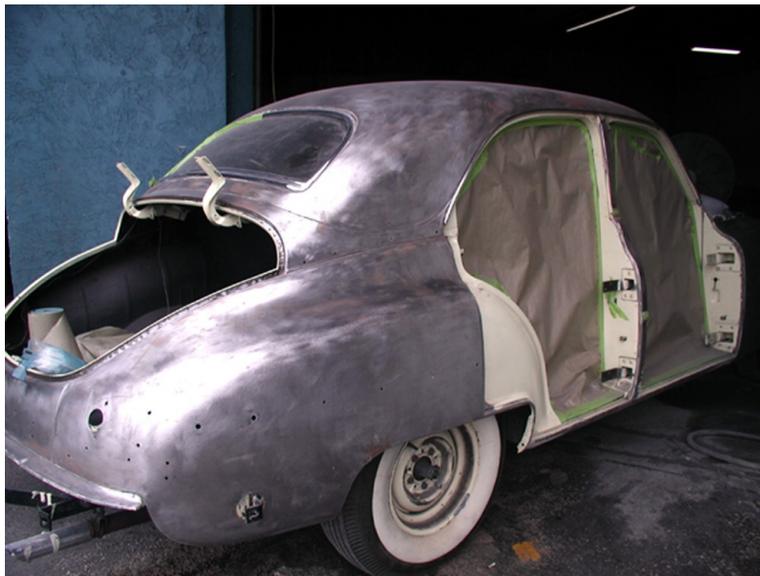
It was about the end of June when I drove the bare metal car over to Auto Elite Collision Center in Virginia Beach where painter Brian Dodson began the process of returning the Packard back to its original color of Packard Blue Metallic. That was to say at least as closely as possible. As many of us know, most manufacturers of automobiles built through the post-war period used lacquer-based paint material. Body shops today are so regulated, most no longer use lacquer paints and instead utilize acrylic and other urethane-based two-part systems such as flat base colors topped with high gloss clear. This is what the body shop recommended for the re-paint of the Packard and I was fine with it.

I drove by the shop often to check on the progress and happened to be there on a day in early August when the guys had just pulled a partially painted vehicle out of the paint booth. Brian and his staff were always amazed at the amount of surface area and the fact that it was all curves with hardly a flat spot anywhere on the car. In order to achieve a better overall job, Brian painted the car in two stages doing the top and the door jams first and then the rest of the fully prepped and primed body followed. Everyone in his shop appeared very pleased with the way it turned out and, from the comments I got from the paint staff, everyone seemed to enjoy working on the old Packard. The stately old beast was looking better and better clad in its fresh new urethane clothing!

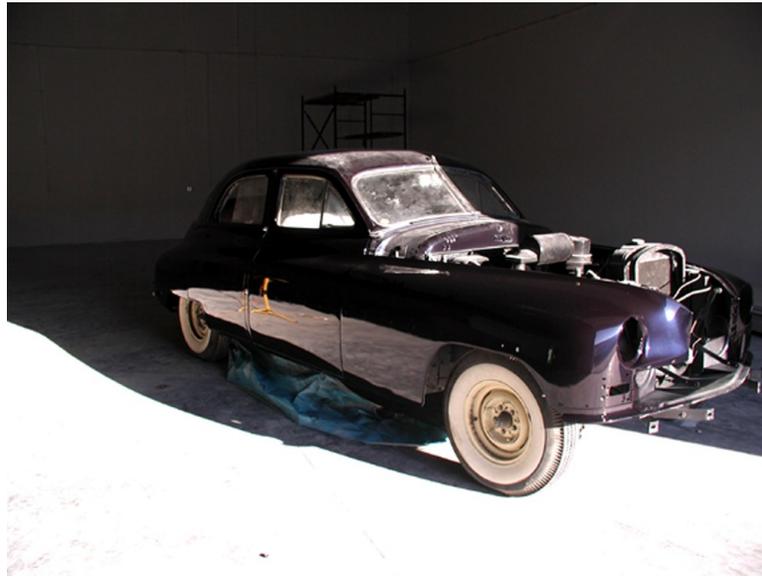
The following week paint work was complete, but Brian informed me he wanted to wait thirty days for the clear coat to cure before his guys would do the finish polishing. The high-volume low-pressure application of paint material resulted in an extremely smooth finish. The minimal “orange peel” was eliminated with a good amount of wet sanding

and polishing which finished off a beautiful and professional job. I was so pleased I simply couldn't wait to begin re-assembly of the stainless and bright work.
