Inspection Report

John Residence

1234 city road
City AR 72034

Home Inspections of Central Arkansas, LLC

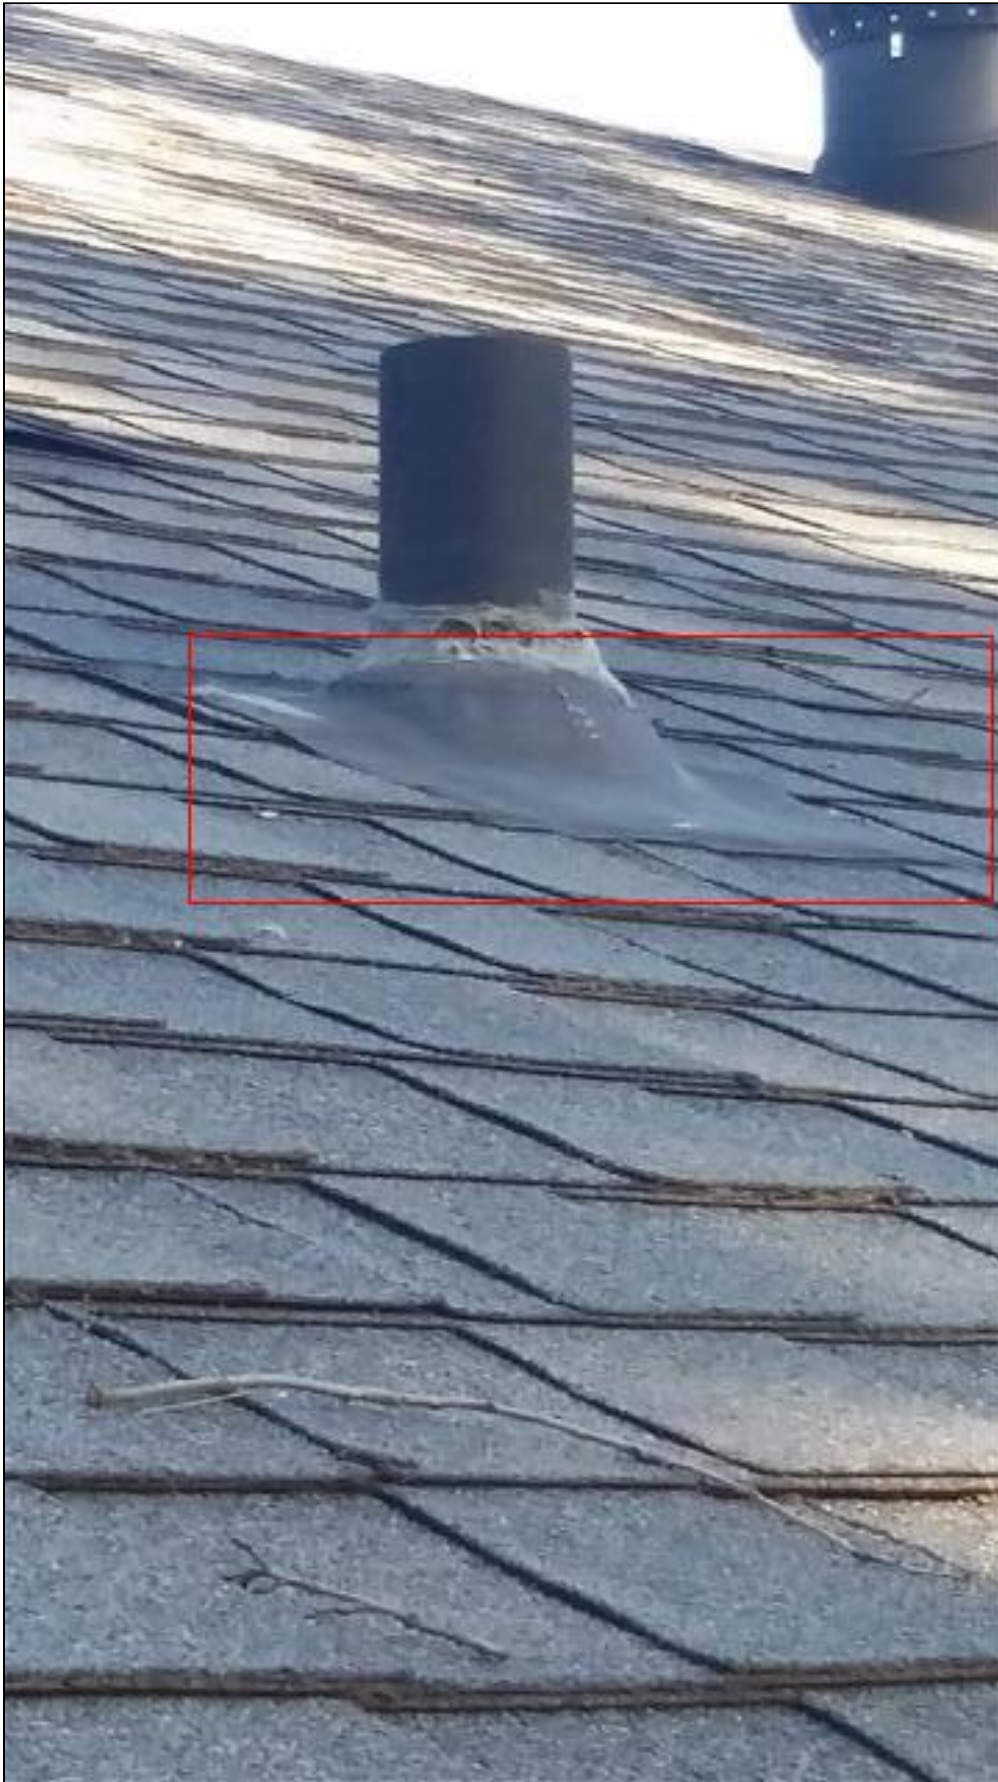
1.1 Item 1(Picture) plumbing vent on back of home

1.1 plumbing vent improperly installed. flashing should be under shingles. could cause leaking in future. recommend further evaluation from licensed plumber.

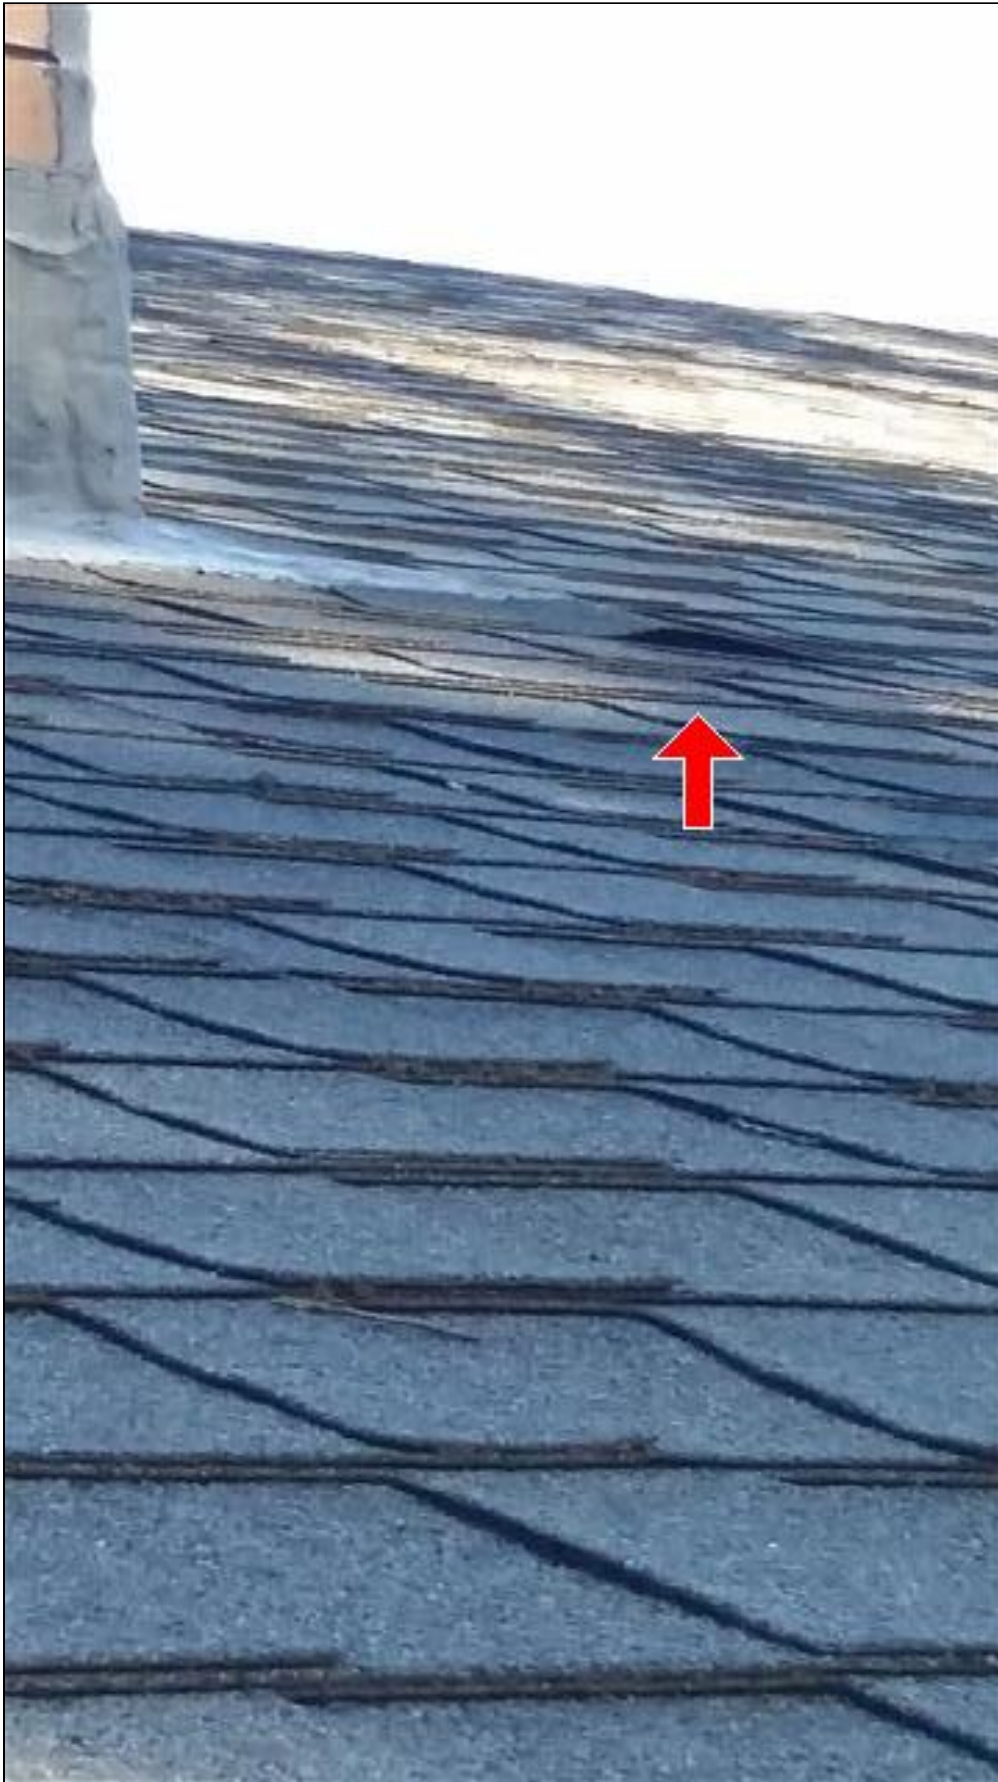
1.2 Item 1(Picture)

1.2 shingles next to base of chimney are loose due to nail popping. recommend further evaluation from licensed roofer.

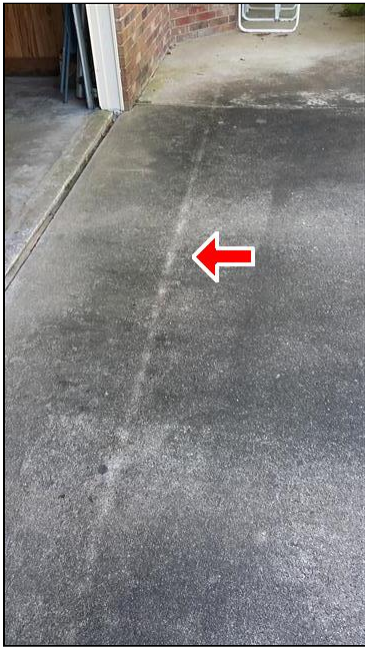
1.3 Item 1(Picture) driveway in front of garage

1.3 Gutters and drain lines are needed or erosion or water intrusion can occur.

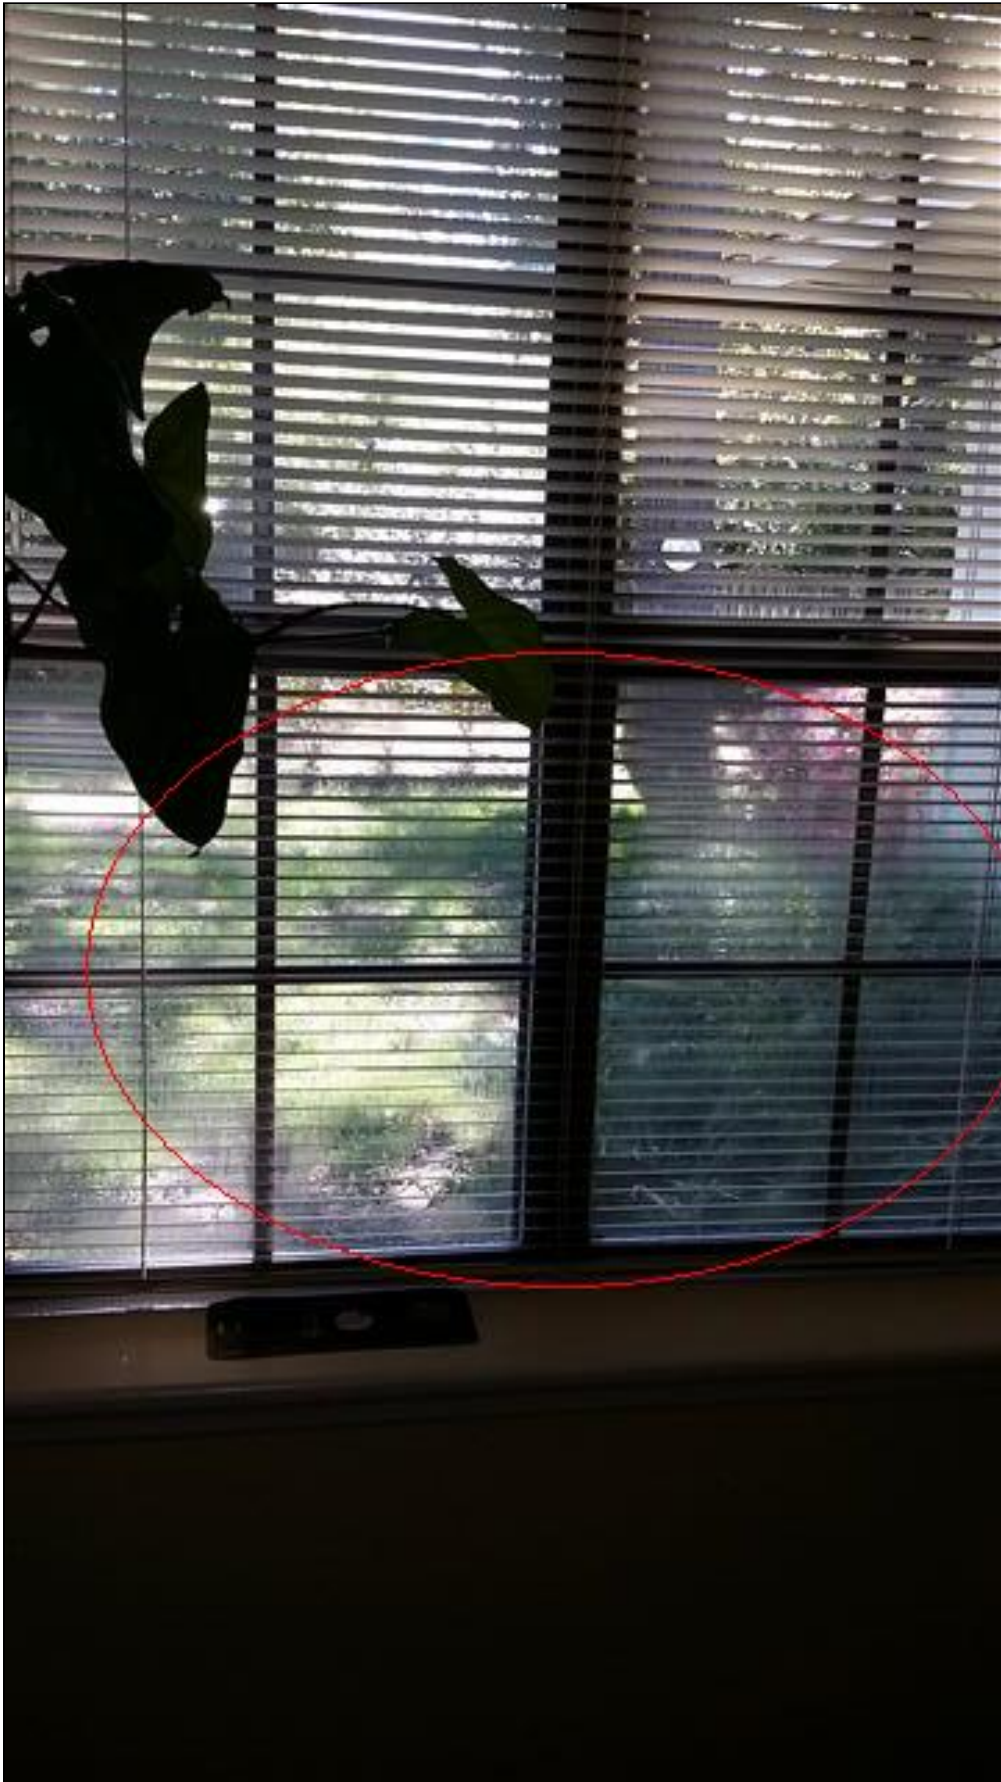
2.2 Item 1(Picture) windows in dining area of kitchen

2.2 The glazing between glass panes are failing at some windows.

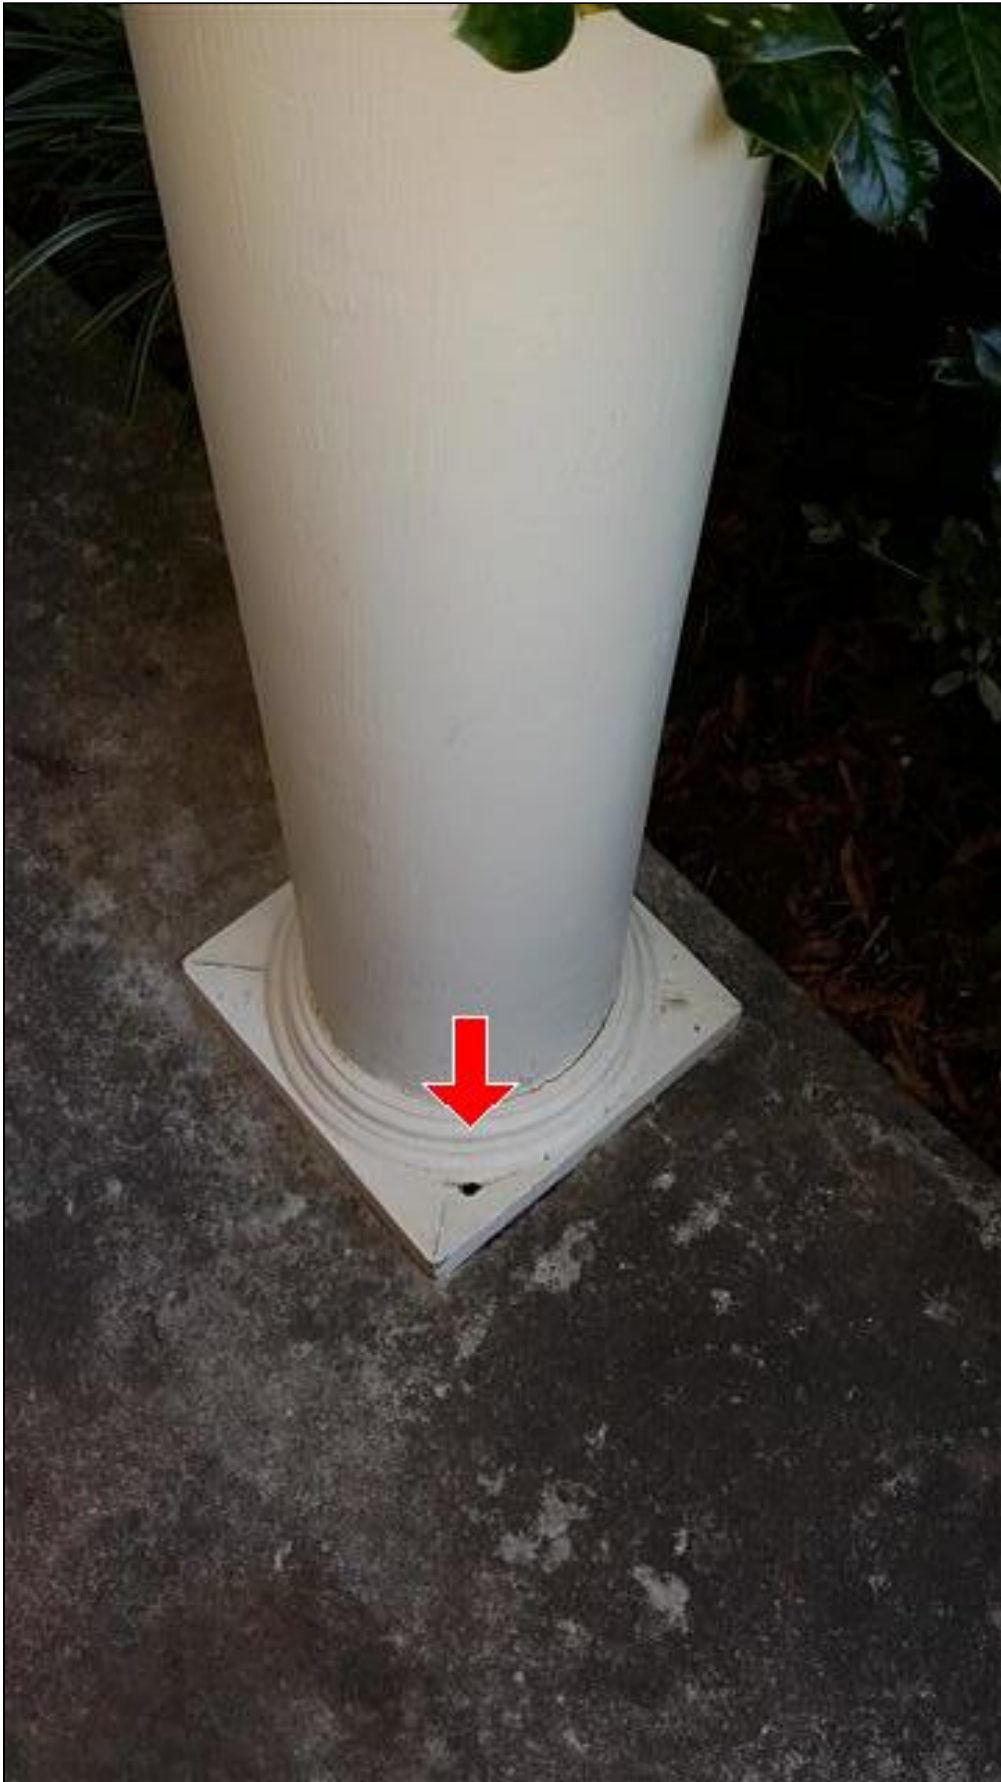
2.3 Item 1(Picture) column on front porch

2.3 moisture damage to base of support column. recommend repairing to prevent further damage.

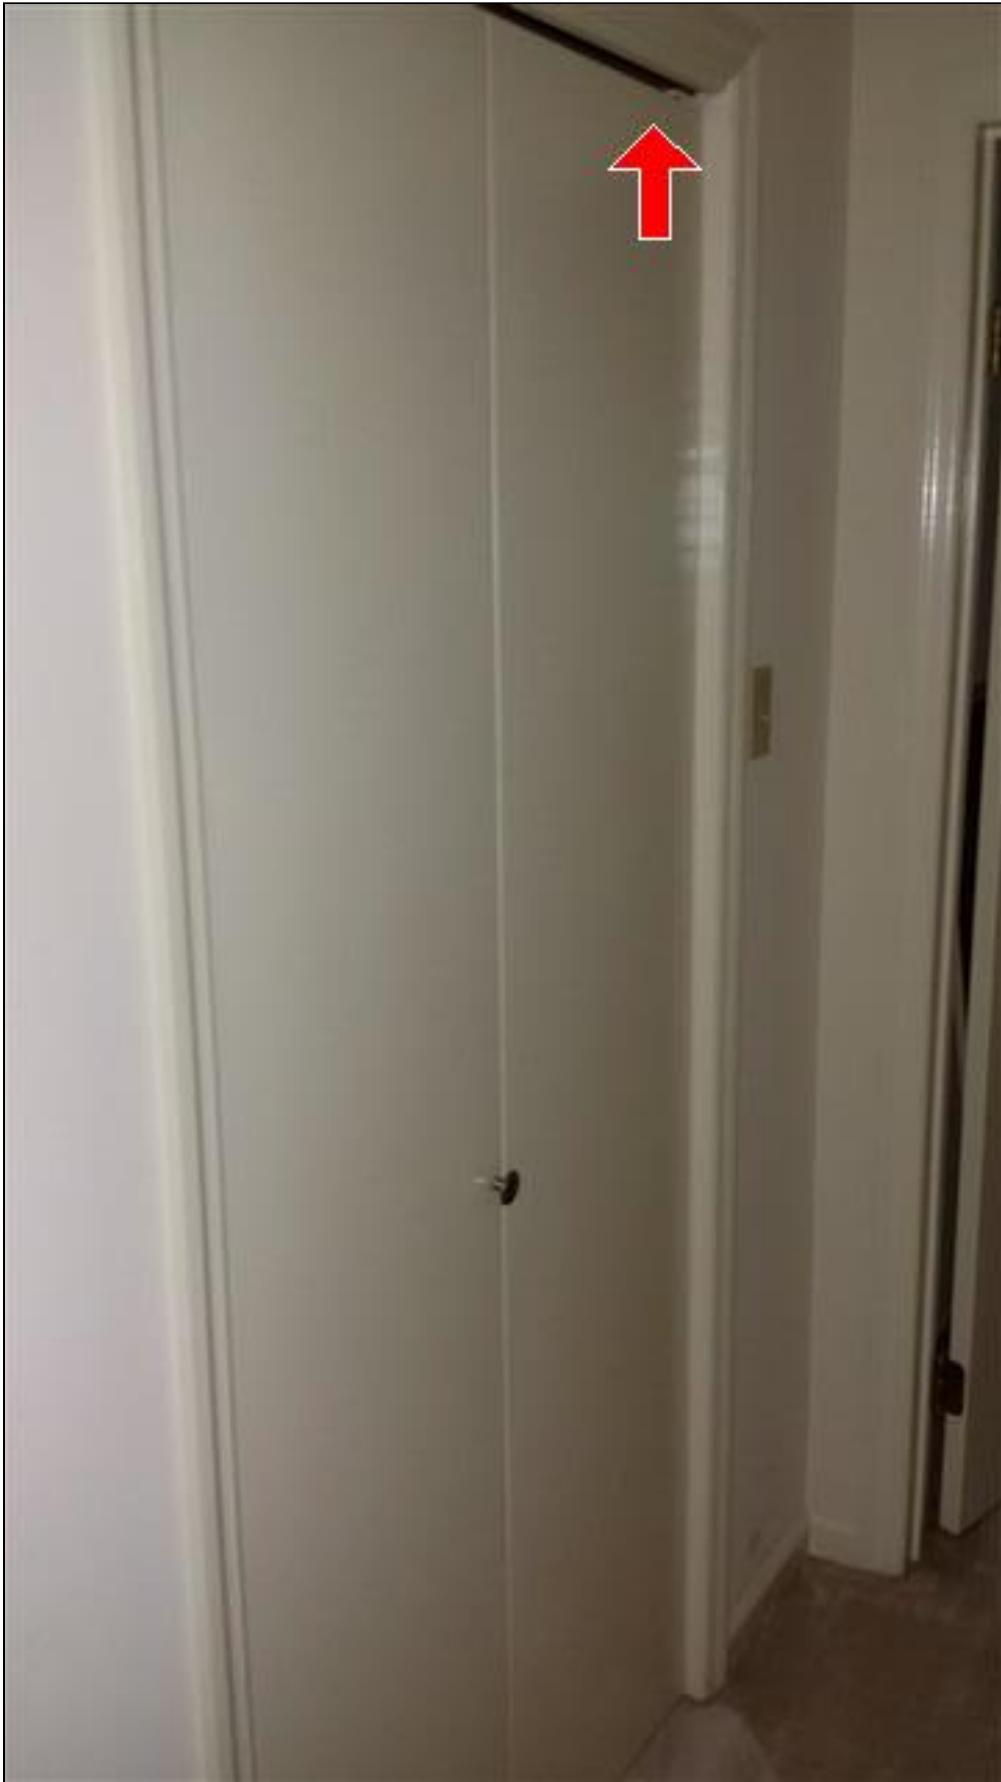
4.5 Item 1(Picture) hallway closet door

4.5 hardware securing door is missing on top and needs to be replaced

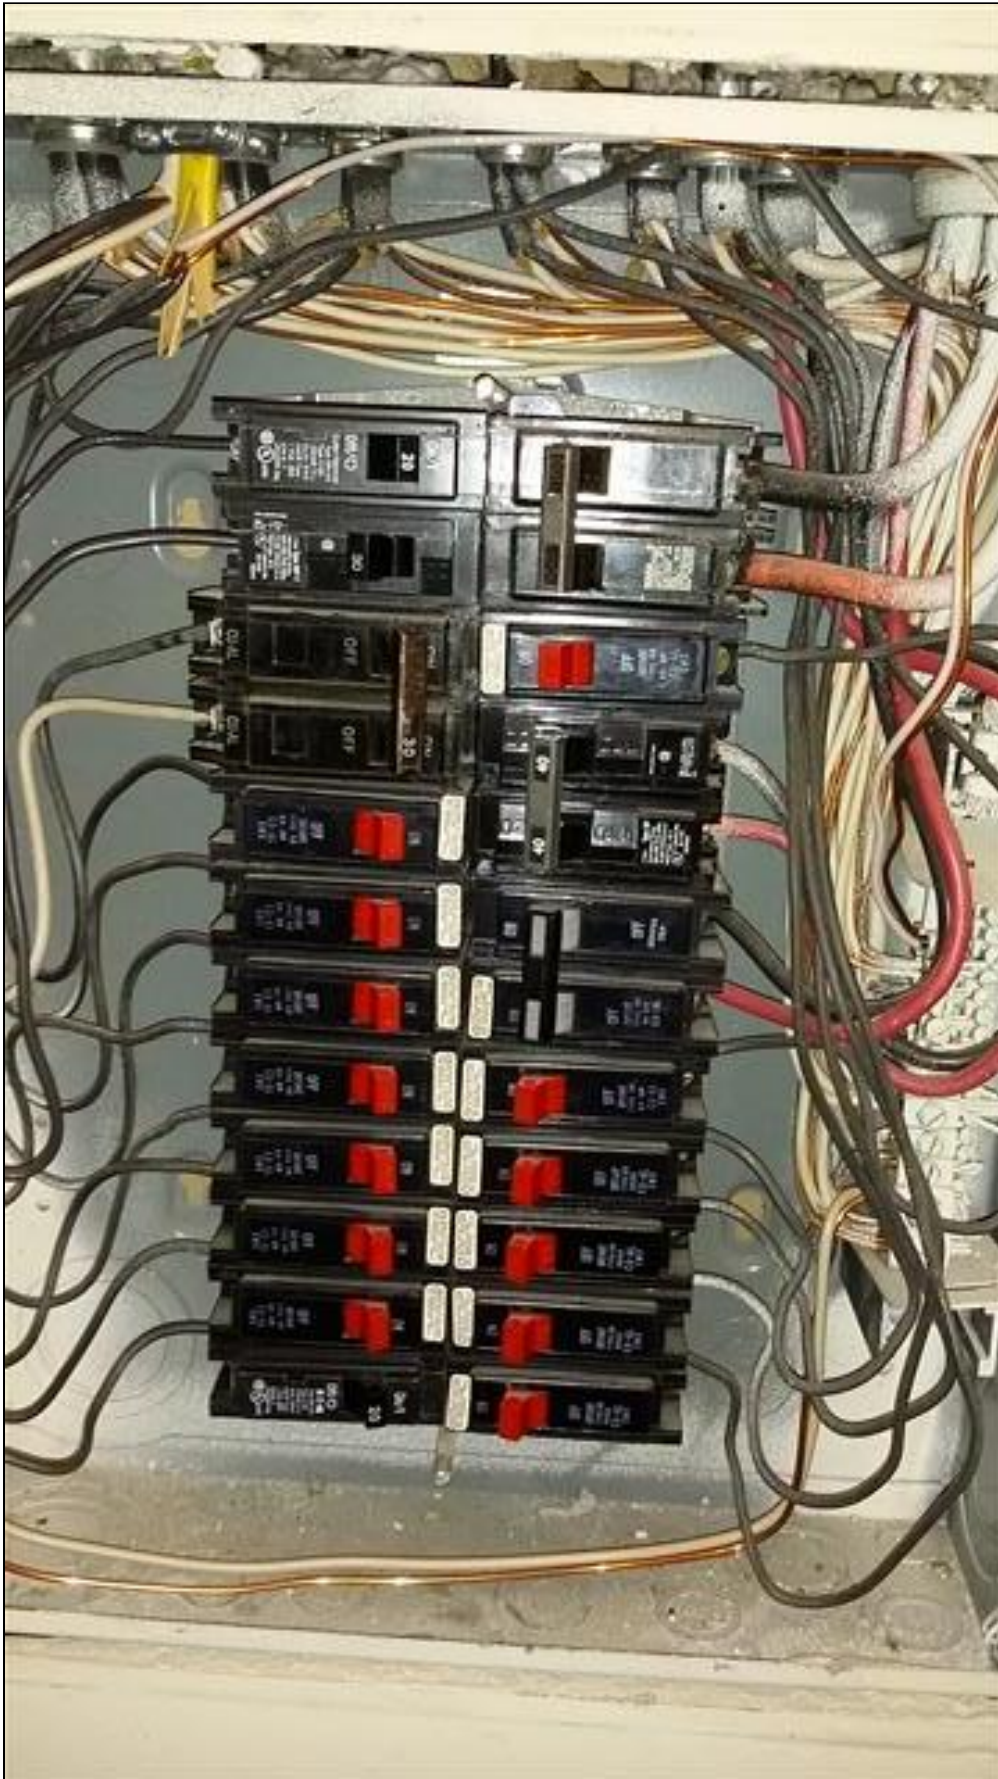
7.2 Item 1(Picture)

7.2 Several circuit breakers in main panel are of a different brand than panel manufacturer. The manufacturer requires that in order for the panel to be safe, only their brand is allowed to be used inside the panel. Even though these circuit breakers are all "UL approved," they are not approved to be used in panels of different manufacturers unless so indicated on the panel label.

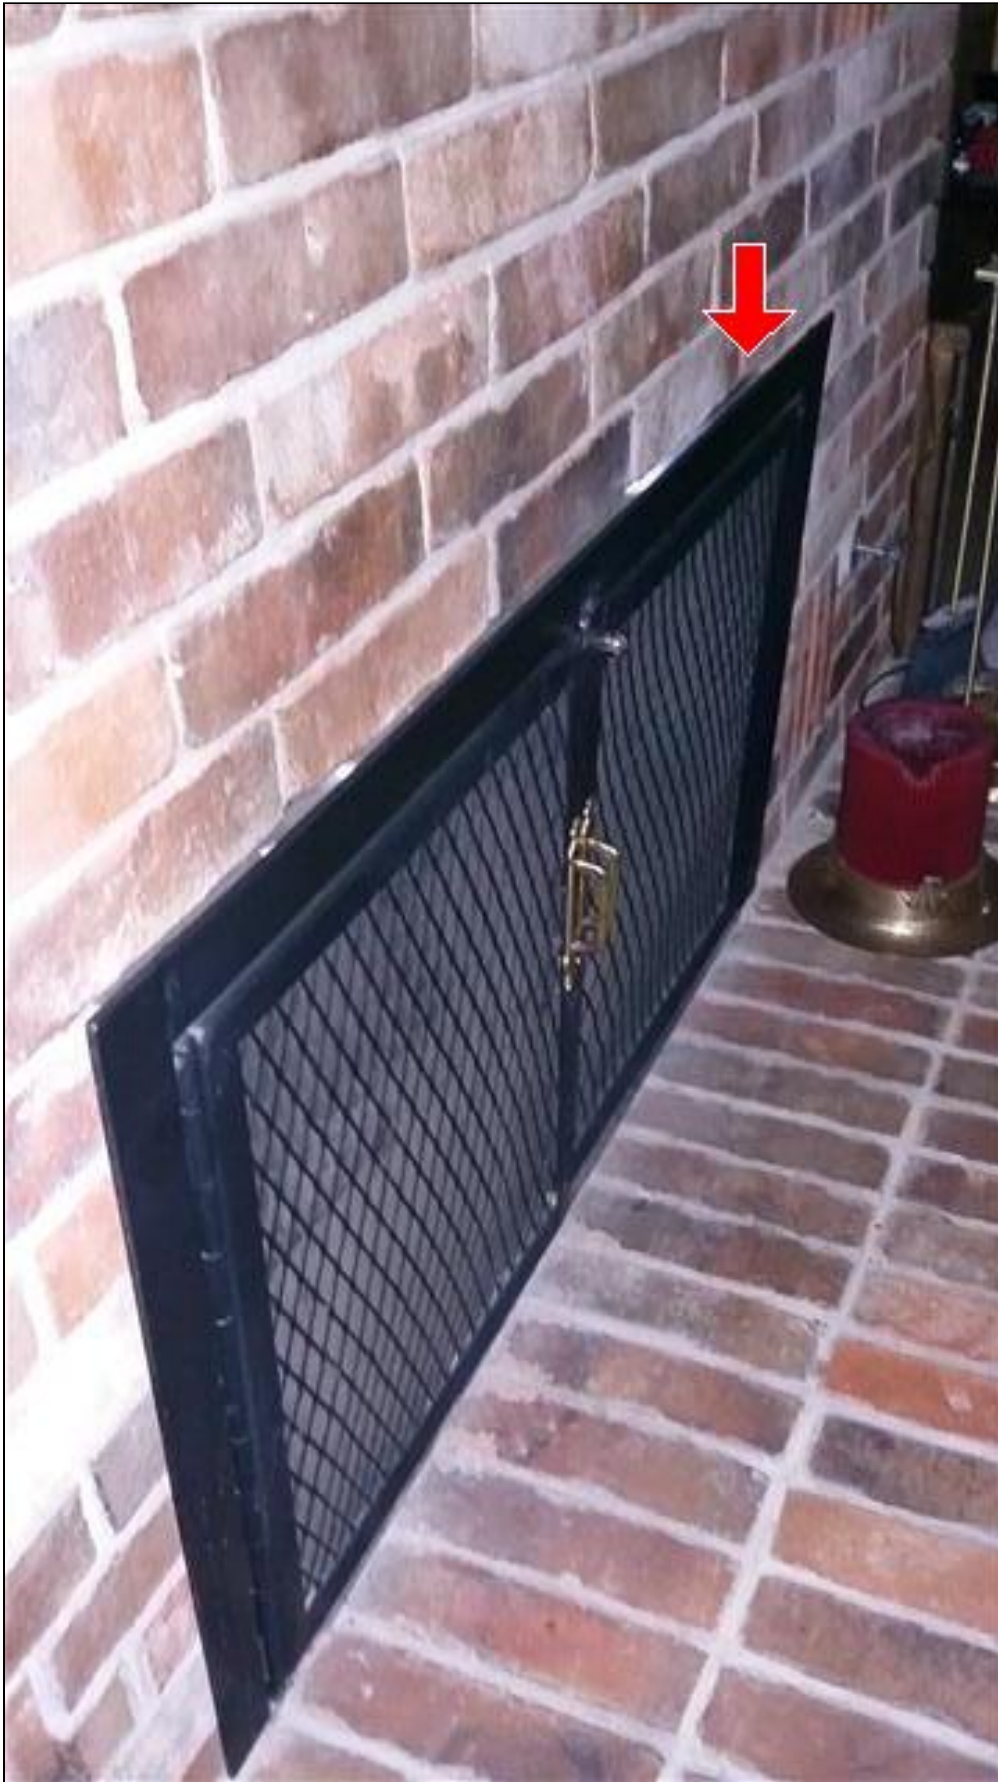
8.5 Item 1(Picture)

8.5 The liners for furnace or fireplaces were not inspected by our company. I recommend a qualified chimney sweep inspect for safety. fireplace cover is loose. recommend repairing.
