Obama Dr./127th Street at Ashland Avenue
Calumet Park, IL

- RLR Photo Enforcement System monitors violations occurring on the eastbound approach of the intersection
- RLR Photo Enforcement System installed: January 1, 2015

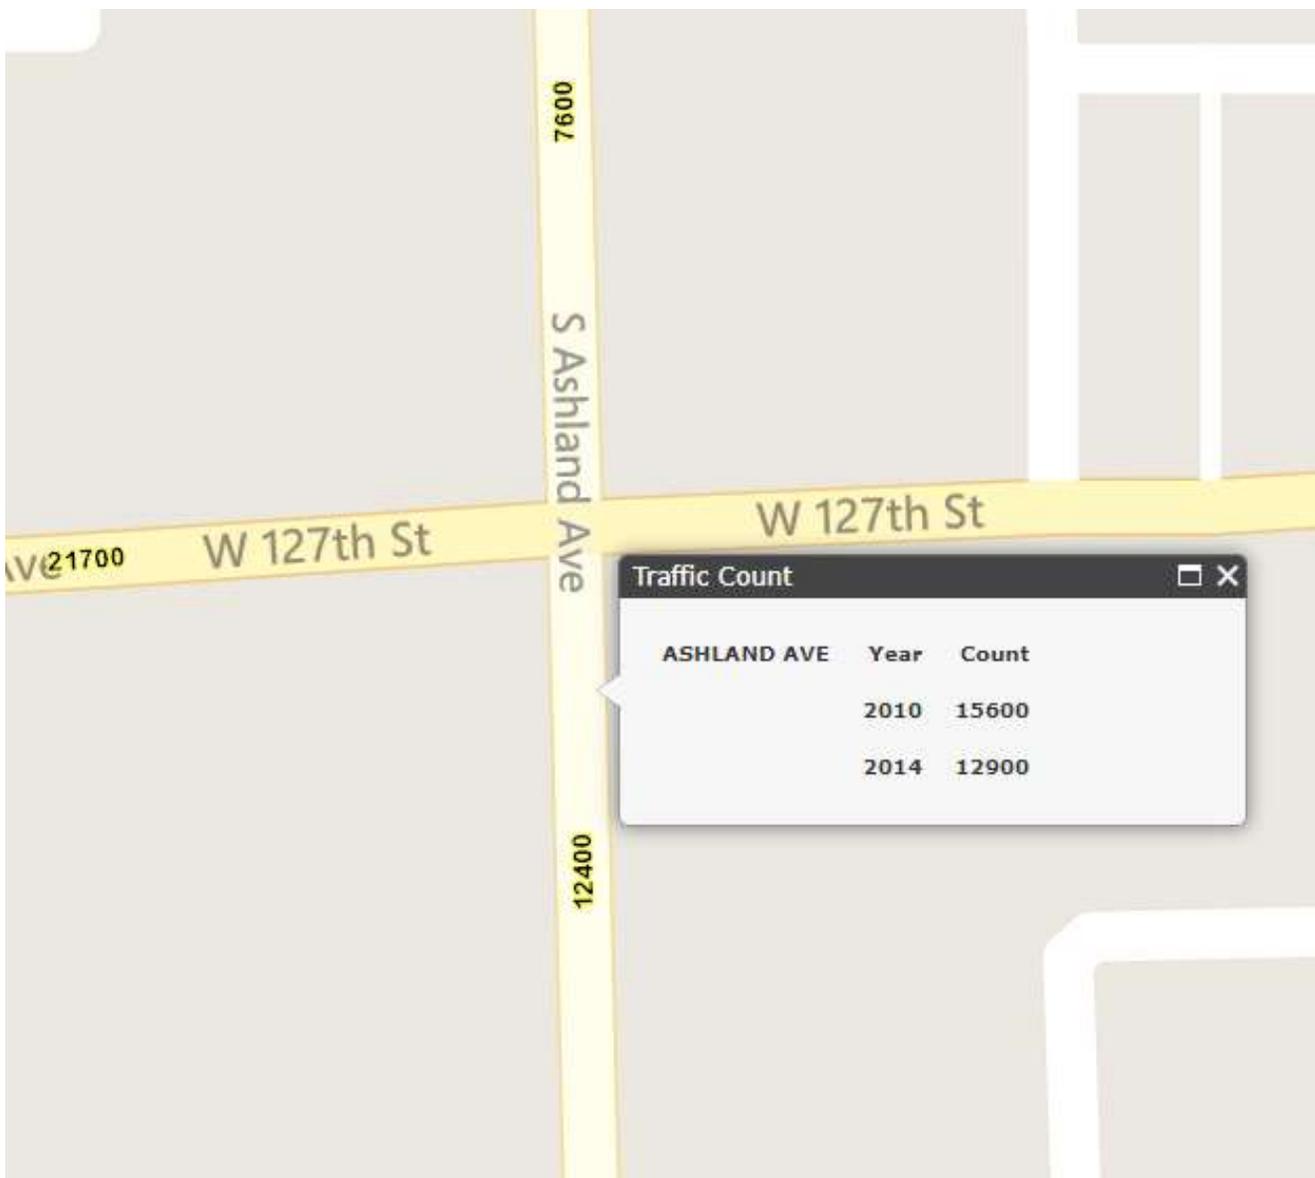
127th Street/Obama Drive at Ashland Avenue (Northbound)

- 15,600 (2010)
- 12,900 (2014)

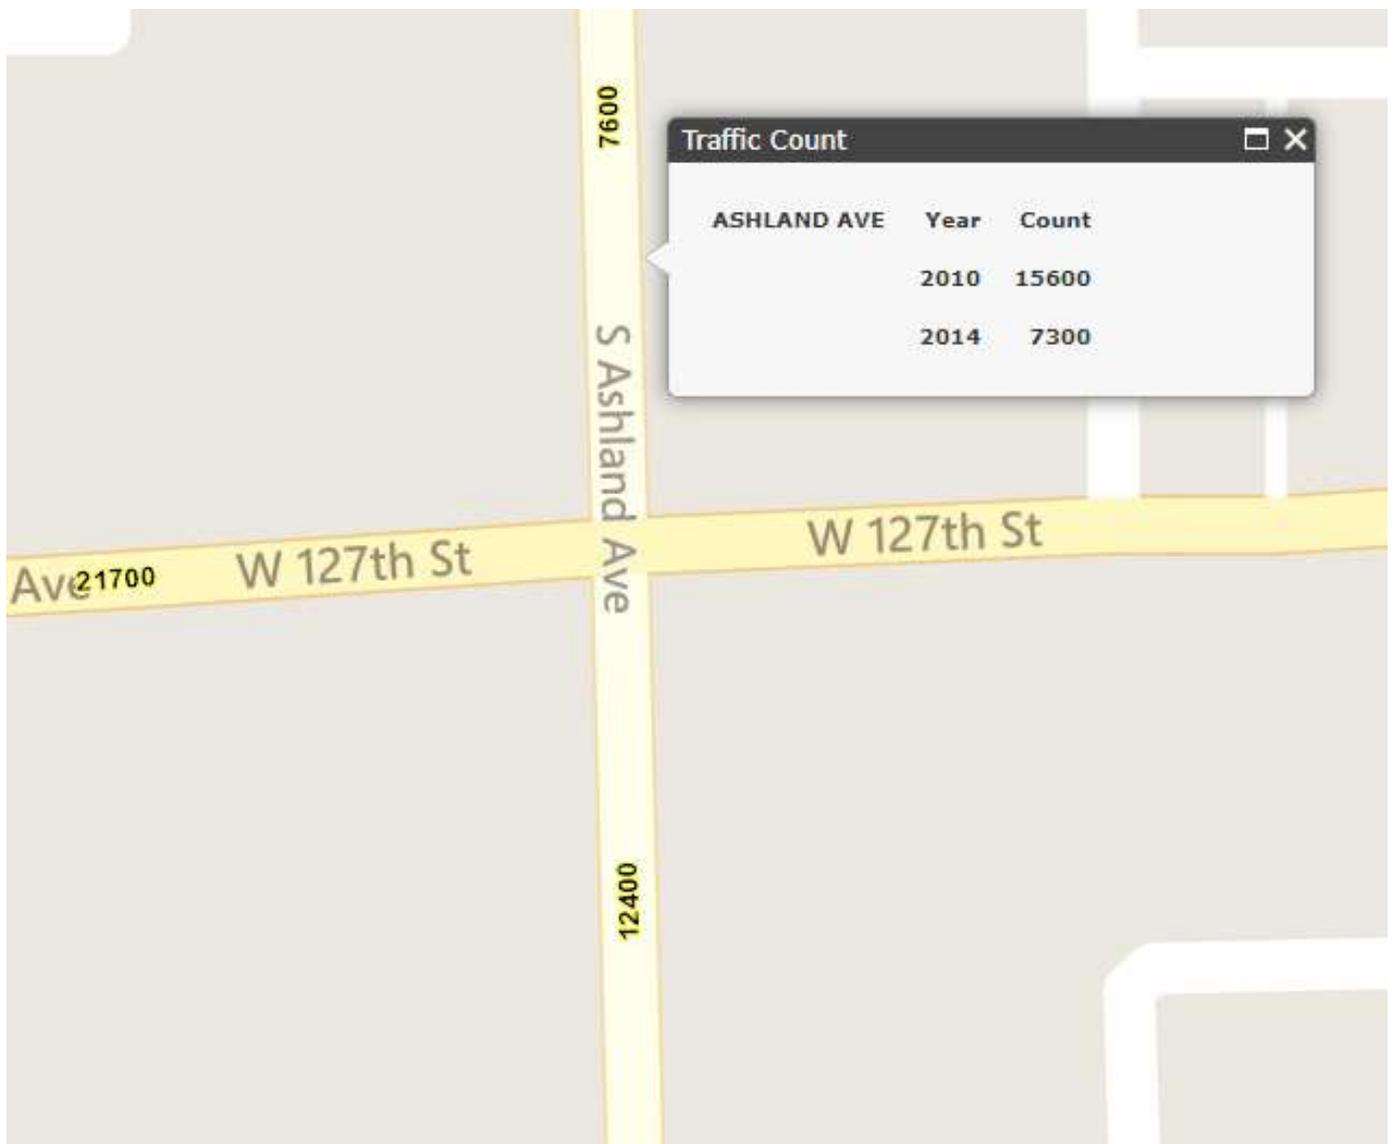
127th Street/Obama Drive at Ashland Avenue (Southbound)

- 15,600 (2010)
- 7,300 (2014)

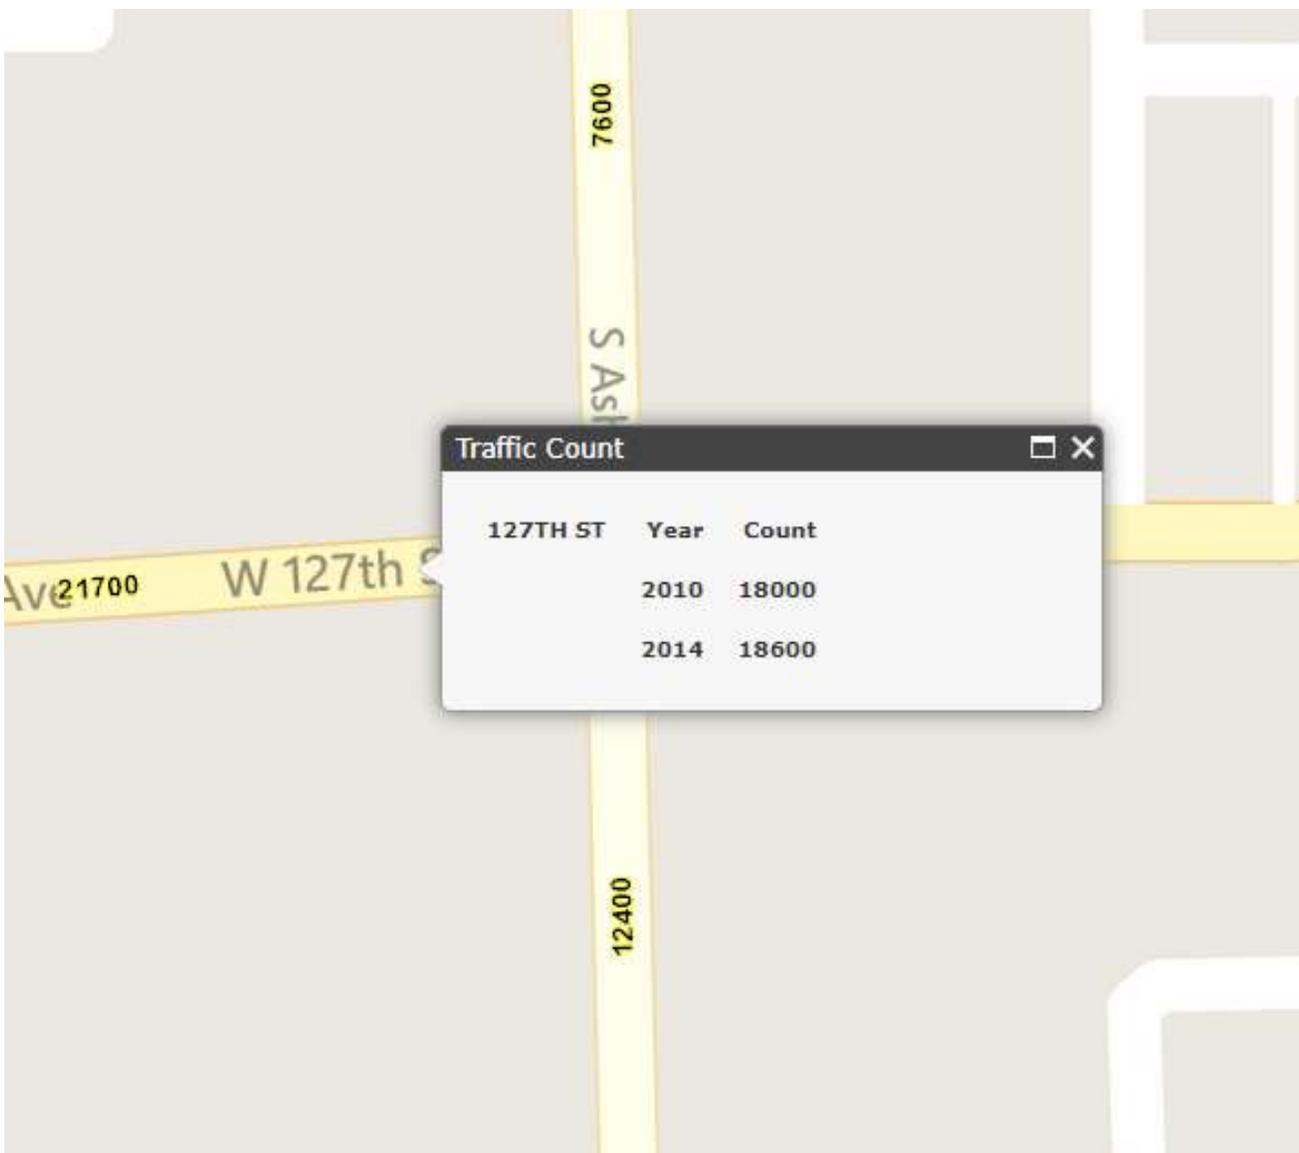
127th Street/Obama Drive at Ashland Avenue (Eastbound)

- 18,000 (2010)
- 18,600 (2014)

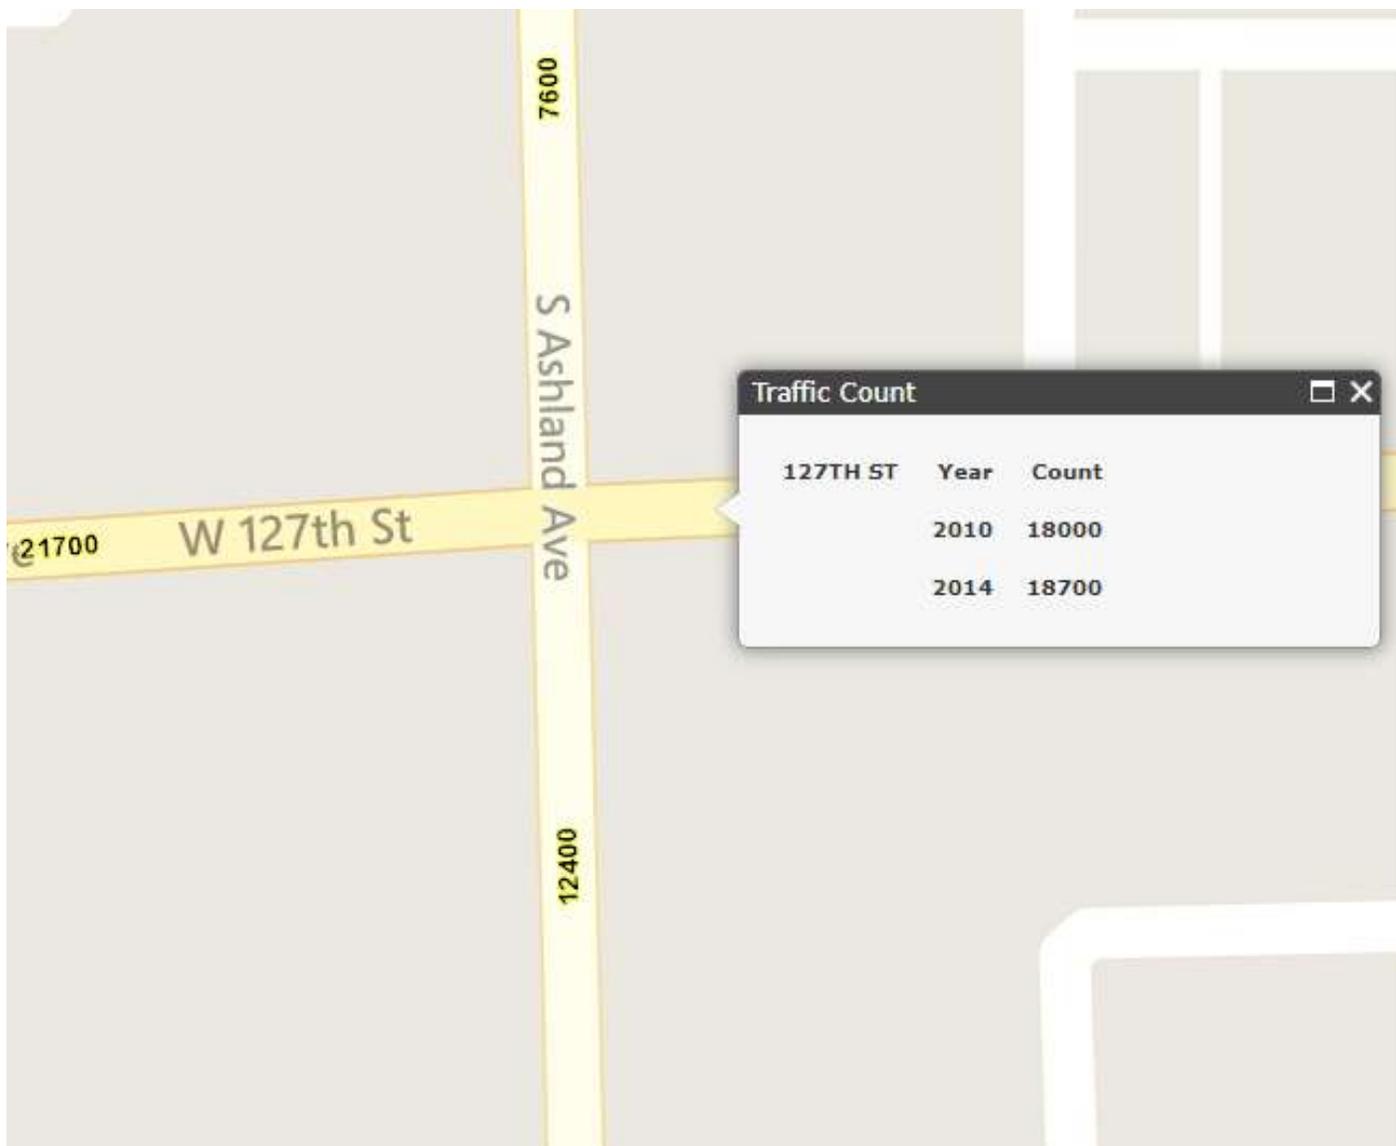
127th Street/Obama Drive at Ashland Avenue (Westbound)

- 18,000 (2010)
- 18,700 (2014)
