OHIO HISTORIC INVENTORY

1. No. ERI-1601		4. Present Name(s) Livosz Residence	
2. County ERIE		5. Other Name(s) Robert Riedy House	
3. Location of Negatives O.H.S.			
6. Specific Location East side of Division St. 750 ft. south of Bookerman Road.		16. Thematic Category Ethnic, agriculture

LIVOSZ RESIDENCE

ROBERT RIEDY HOUSE

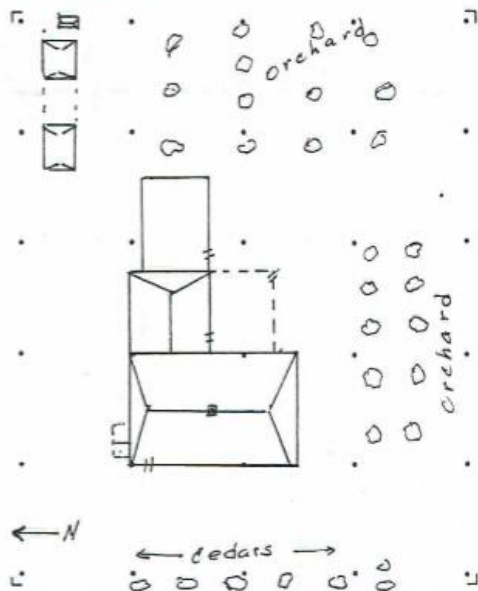
53. Farmstead Plan

outbuildings set in a linear configuration. Furthest from the house is a gabled privy with ship lap siding; next is a gabled smokehouse with stucco-covered rubble limestone walls; there are two sheds, one metal and the other board and batten.
