## DETAILED INFORMATION ON THE REDMOND LIVE FIRE PROJECT

### Live Fire Exercises September 9, 2006

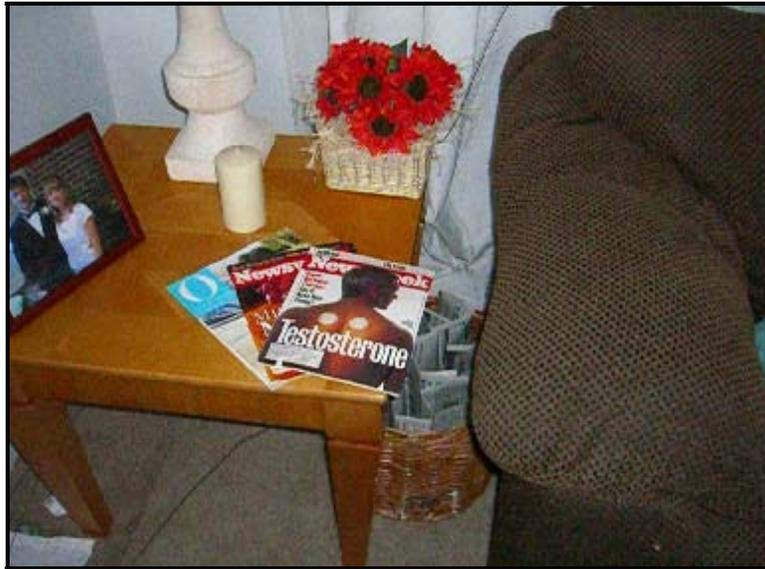
Two different ignition scenarios were used in the live fire exercises. Both of the ignition scenarios were based on fire data published by the U.S. Fire Administration (USFA). The ignition scenario used in the living room fires simulated placing burning material into a wastebasket that contained combustible material, which is a well-documented cause for residential structure fires.

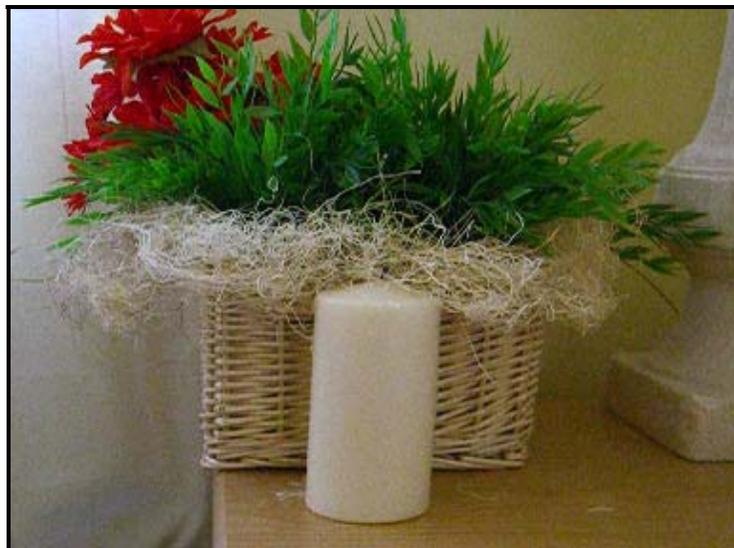
The ignition scenario used in the bedroom fires consisted of a candle placed too close to adjacent combustible material. This scenario was selected based on data published by the U.S. Fire Administration (USFA) that concluded that 50 percent of residential candle fires were caused by placing a candle too close to combustible material, and that one-third of residential candle fires originated in the bedroom.

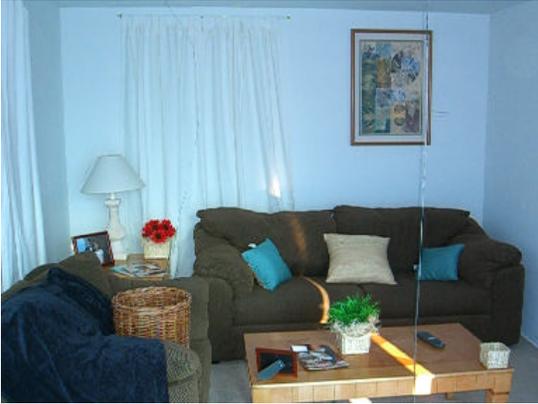
**Sprinkler Protected Living Room**

The living room fire scenarios were set up in the burn house's detached two-car garage. Two 11-foot by 14-foot rooms were constructed by local firefighters, with one side open for viewing. The living rooms were fully finished, including paint and carpeting. The furnishings in both rooms were identical, and consisted of a sofa and chair, coffee table, end table, 25-inch TV with stand, framed artwork, draperies, a table lamp, miscellaneous pictures, throw pillows, wicker wastebasket, and decorative baskets. A smoke alarm was also installed in each living room.

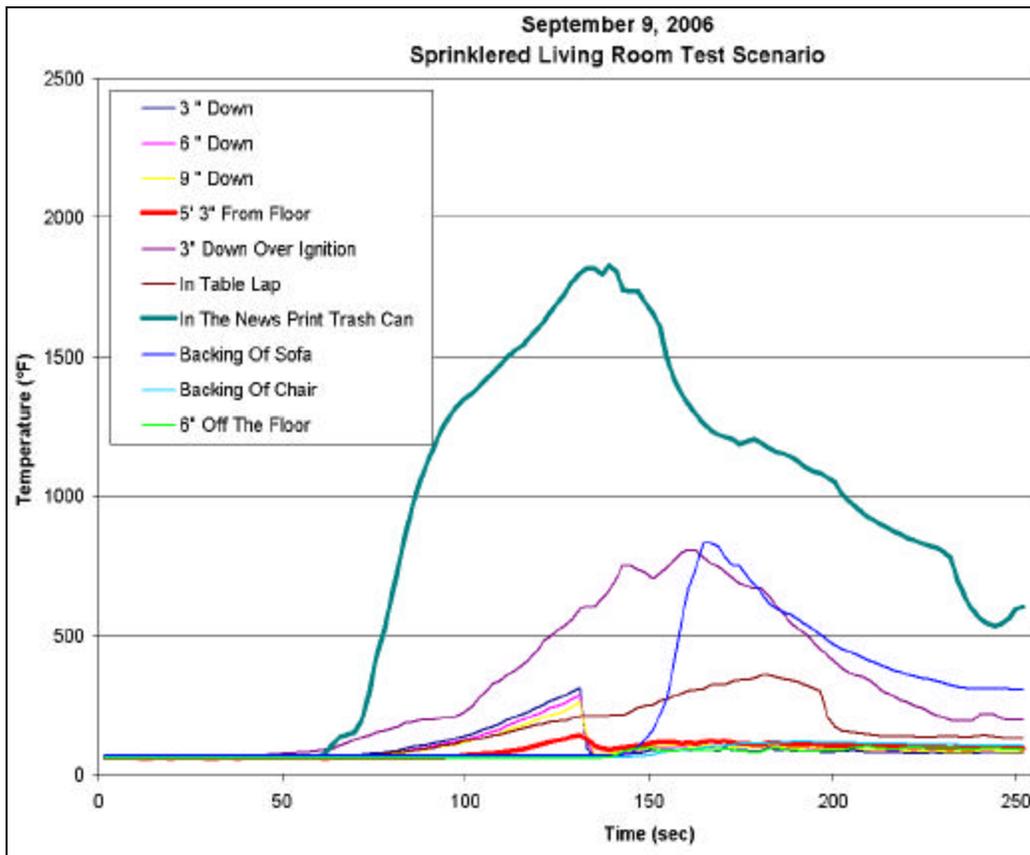
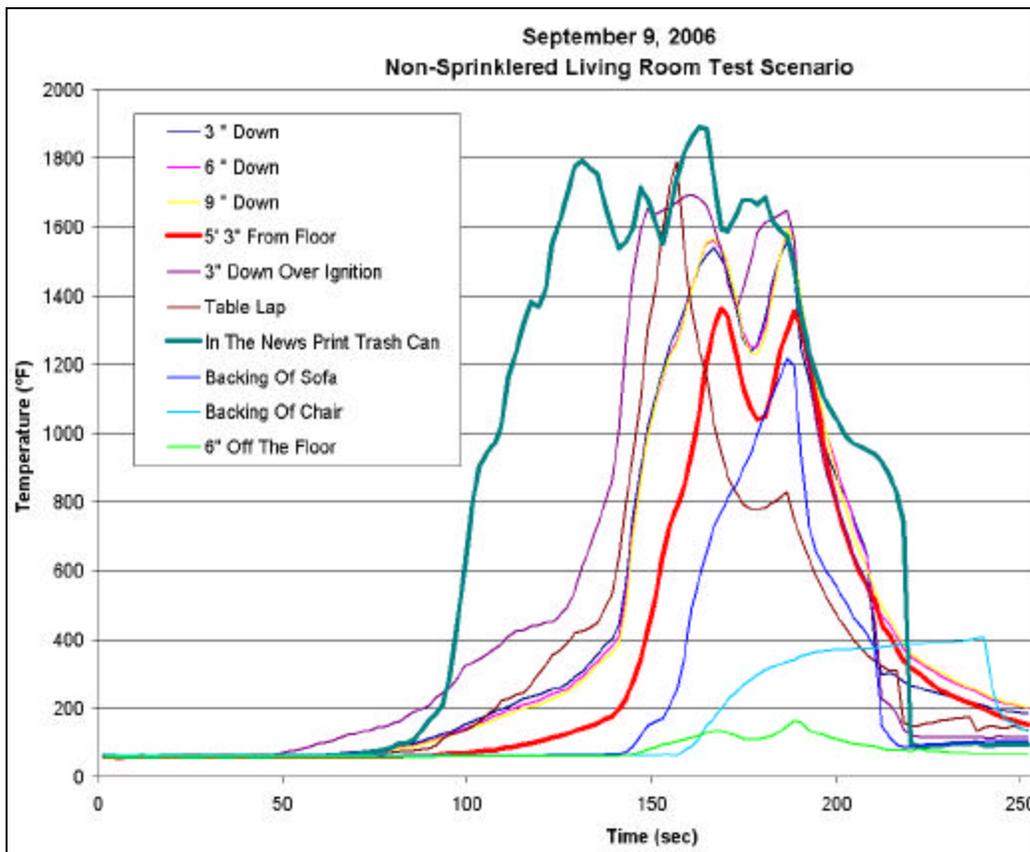
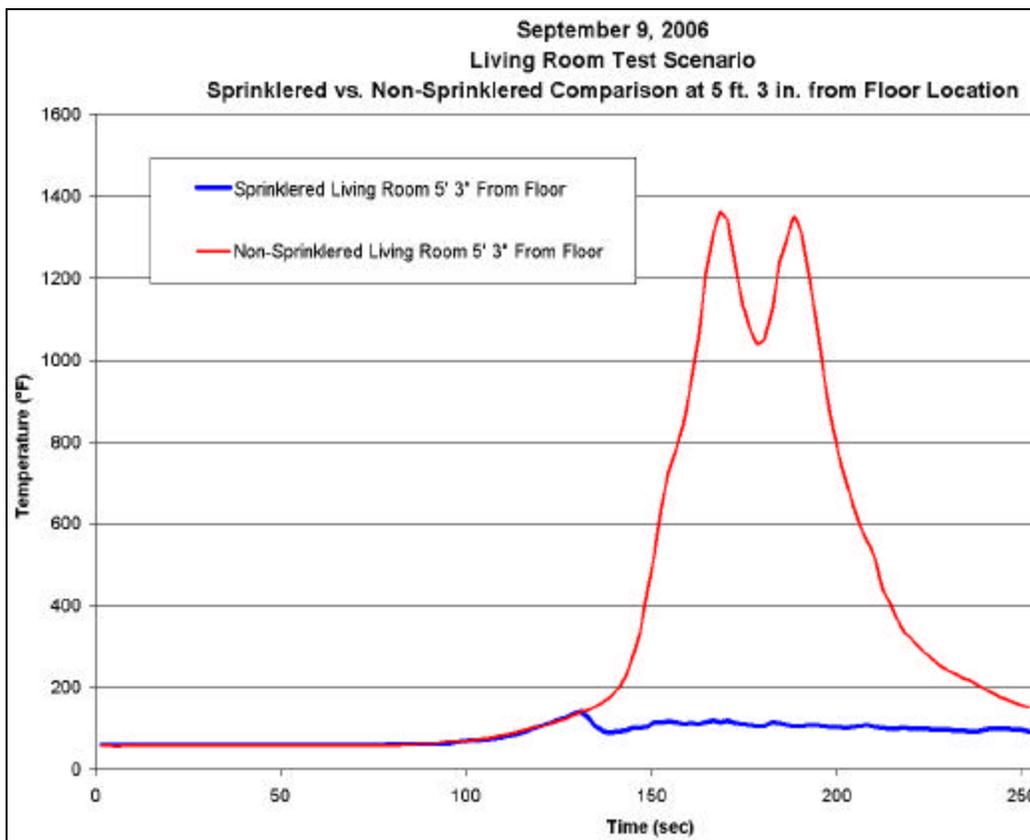
The time/temperature information from the living room fire scenarios are shown in the preceding tables. As can be seen, the living room fires were ignited simultaneously, and spread swiftly from the point of origin in the wastebasket to the draperies and sofa. The smoke alarms in both living rooms sounded quickly, which would have alerted the occupants of the danger. The fire growth in the unprotected living room developed a maximum temperature of 1,362° F at 5 feet-3 inches above the floor in three minutes and 47 seconds, compared to a maximum-recorded temperature in the living room protected with sprinklers of 120° F measured at 5 feet-3 inches above the floor. In the sprinklered living room scenario, the fire was effectively contained near the point of origin.

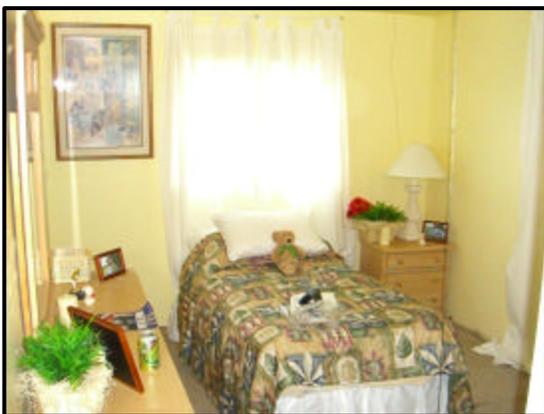
**Sprinkler Protected Bedroom**

The bedroom fire scenarios were conducted in two rooms of the burn house that were modified to make them approximately equal in size (120 square feet). Typical bedroom furnishings including a dresser with mirror, nightstand, table lamp, twin bed with mattress and box spring, bedding, pillows, draperies, pictures, and miscellaneous decorative items were placed in each. Additionally, a smoke alarm was installed in each bedroom.

The sprinkler-protected bedroom also saw rapid initial fire growth at the point of origin, with quick smoke-alarm activation. In stark contrast, however, the sprinkler activated quickly to contain the flames and fire damage near the point of origin. The maximum temperature recorded at 5 feet-3 inches above the floor was 110° F.

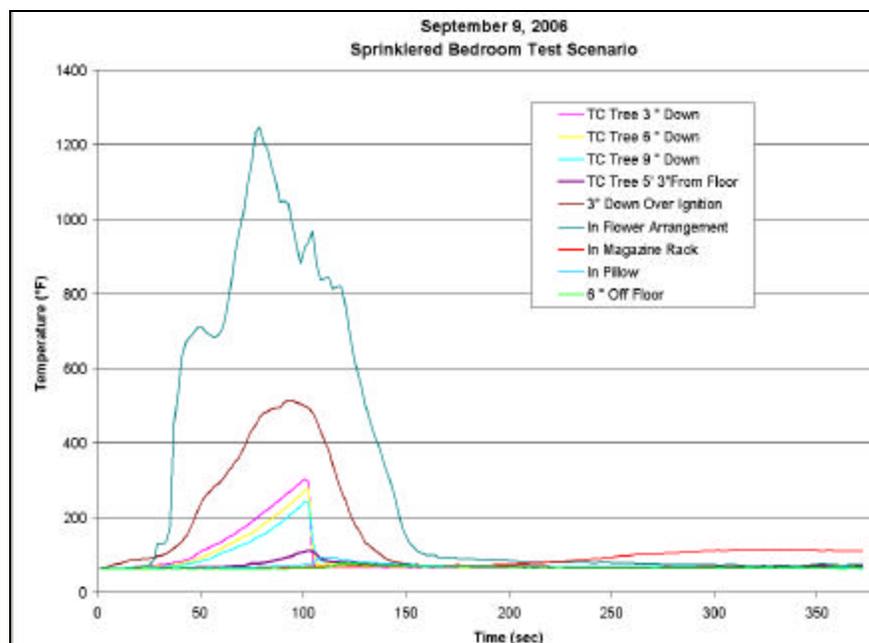
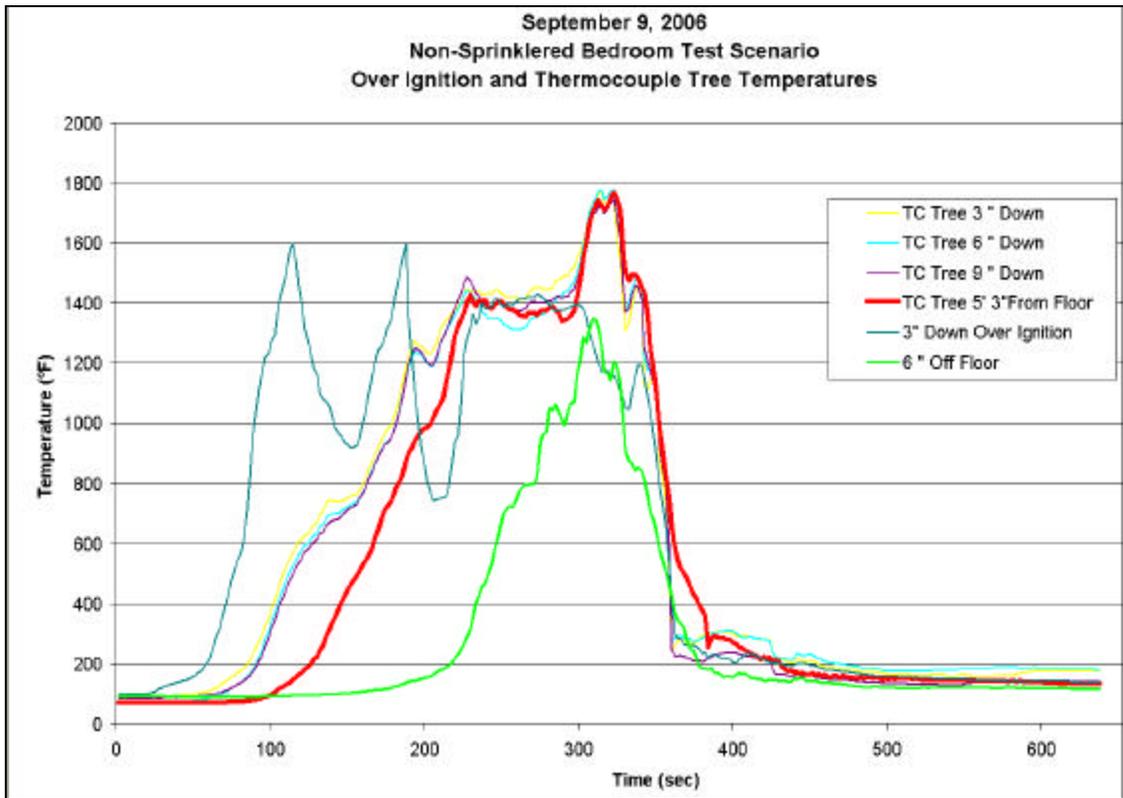
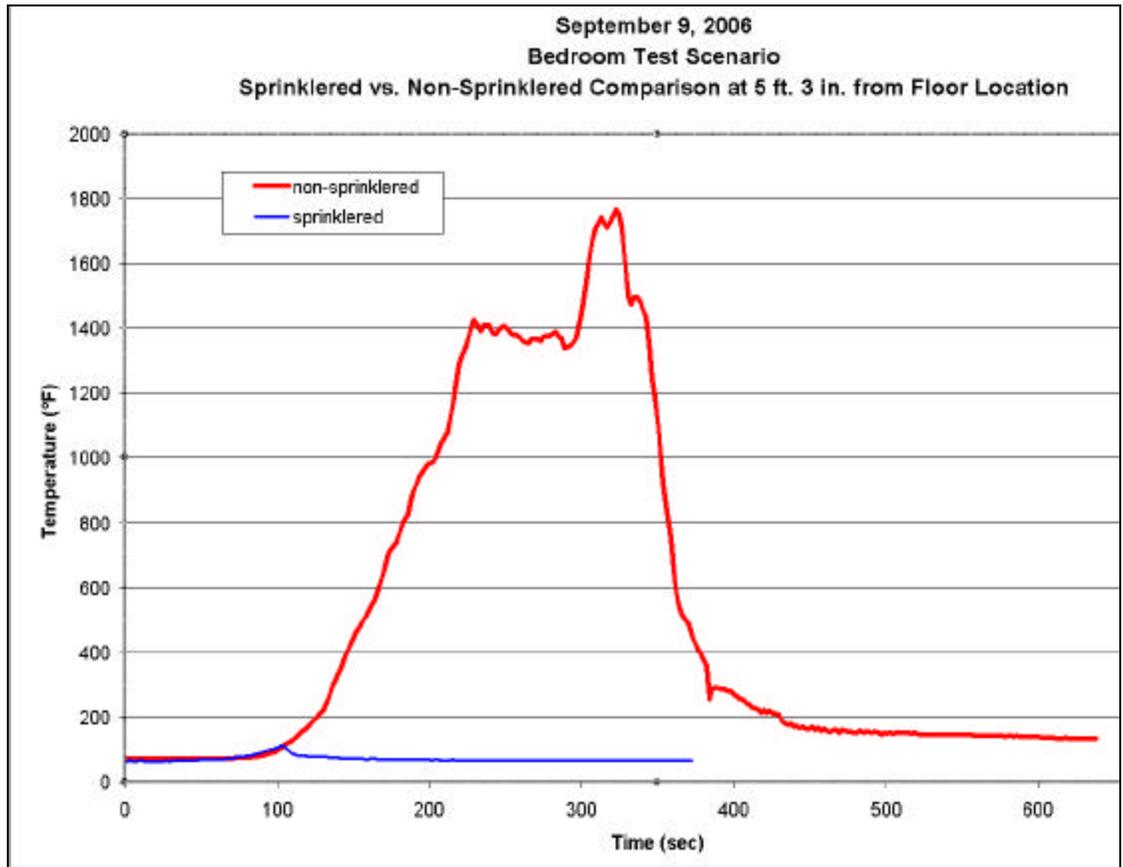
The results of the bedroom fires are shown in this table. As can be seen, the two bedroom fires generated even more dramatic results. The fire in the unprotected bedroom raced from the point of origin to the draperies and bedding, escalating rapidly in intensity. The smoke alarm activated almost immediately, but was quickly destroyed by the fire. The temperature in the bedroom reached 1,769° F at 5 feet-3 inches above the floor, and the room flashed over in less than five minutes, well before the average local fire department response time. The fire completely consumed all of the fabric materials in the room, including the mattress and box spring.
