# Bruce Wahl – Photos of Det 3 Pleiku

## 2. Dragon Mountain Photos

# Det 3, Pleiku Transmitter Sites

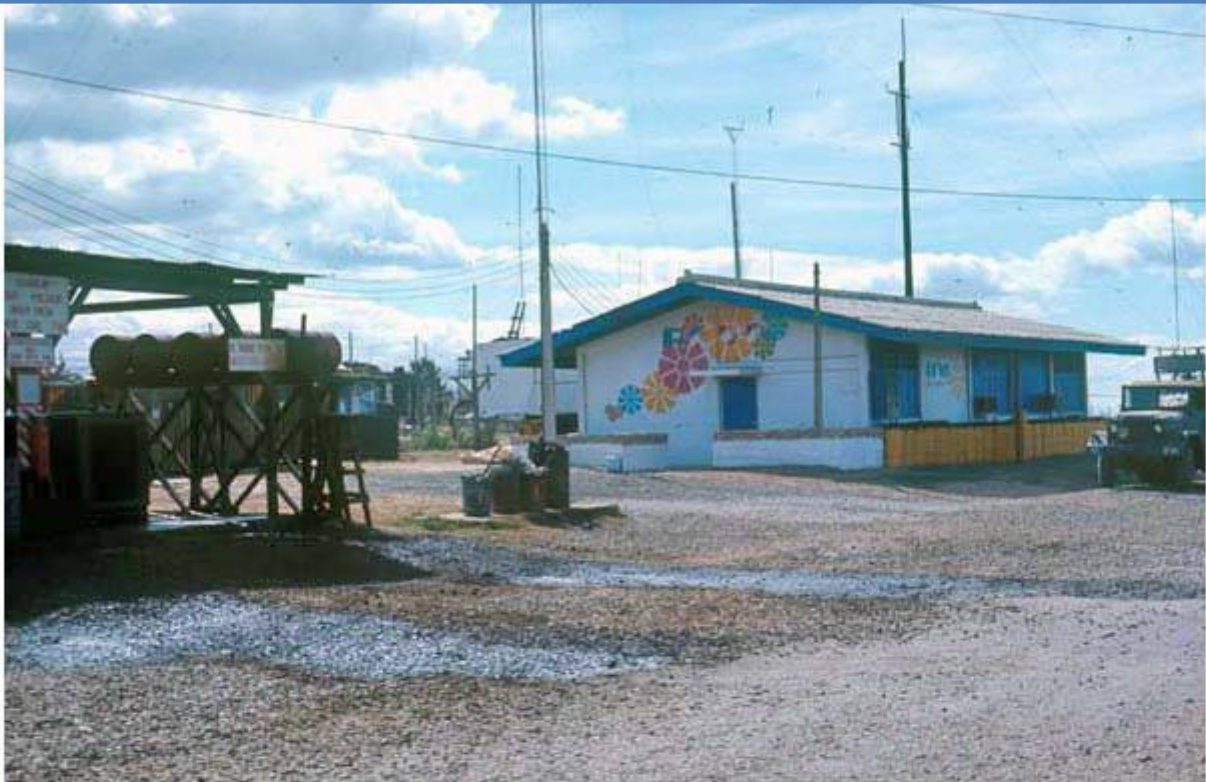
# 02 of 22

AFVN Detachment 3 Pleiku Headquarters. On the left are the two diesel generators that powered the station. Right above the concrete power pole is the TV/FM tower. The white TV van is to the left of the building. The news booth is at this end, the entrance doors and the transmitter are at the far end. II Corps headquarters is about 100 yards to the left of the TV Van.

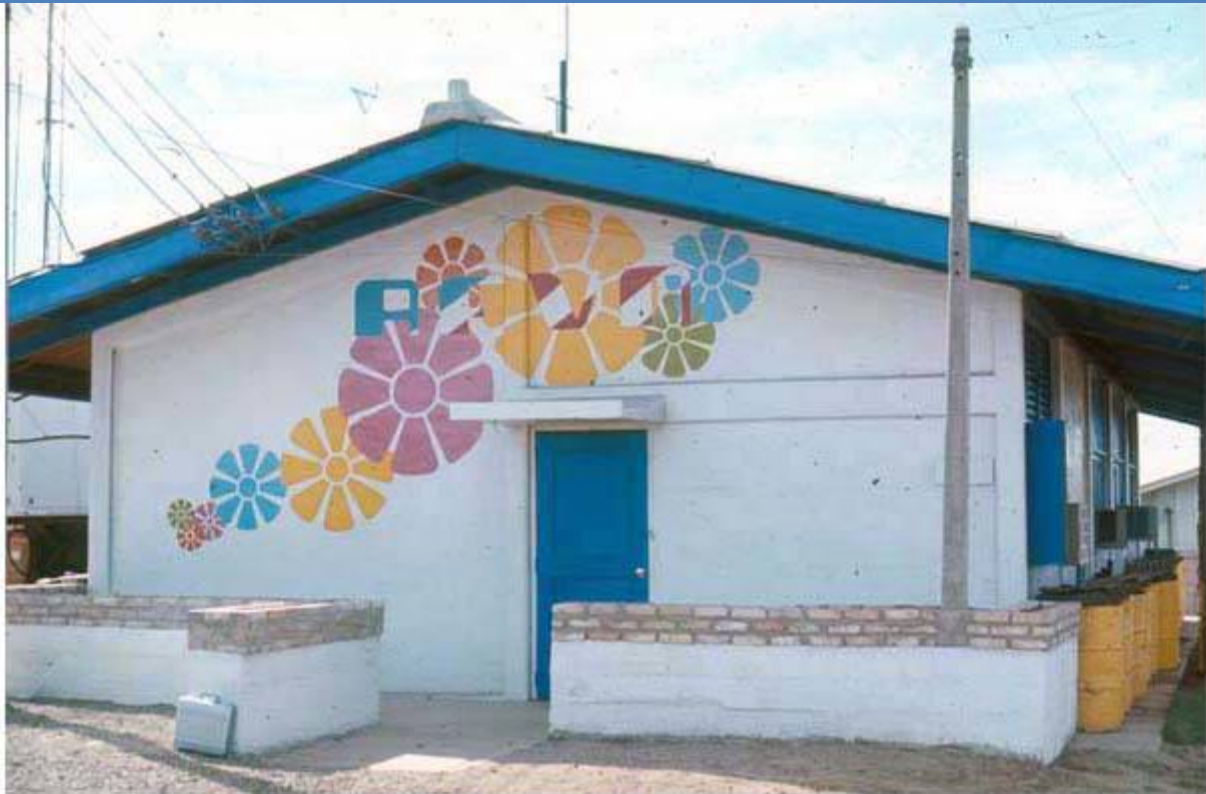
# 03 of 22

The front of AFVN Det. 3, after we decorated it for visiting officials! According to local stories, this building had previously been a stable. It housed the FM Transmitter, two radio studios, a TV studio, OIC/NCOIC office, and a huge record library. Just to the left of the building is the TV van, painted white. The FM/TV tower is visible at the left corner of the building. The 55 gallon drums filled with sandbags were our protection from shrapnel from

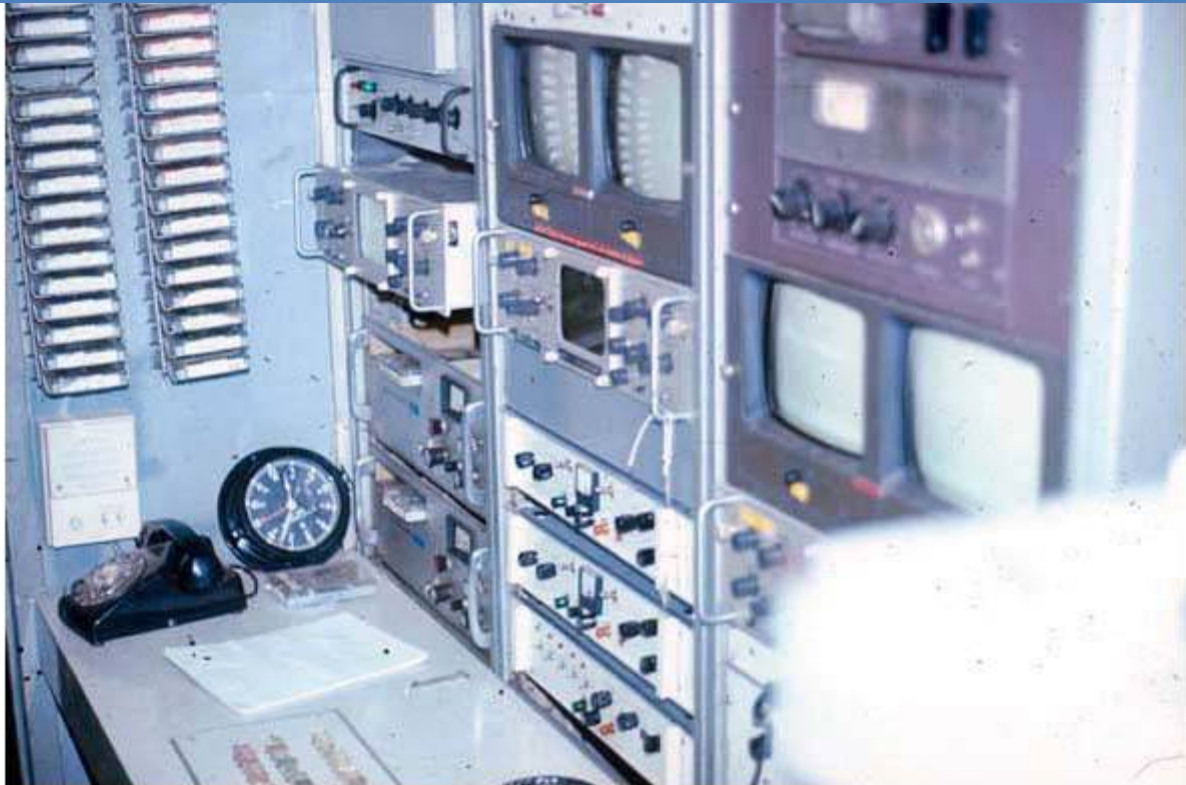
# 05 of 22

This is the TV Control Room in the van. To the rear (in this shot) is the small booth used for the news, before we built the TV studio in the main building. The video switcher is in the desktop. In the center rack is the sync generator and two camera control units, all made by Sarkes Tarzian. At the time this picture was taken, there were only two video cameras in the station, one in the news booth and the other in the film chain, located between this control position and the transmitter. The transmitter was a tube type, made by Gates. It had 5 KW for video and 400 Watts for audio.

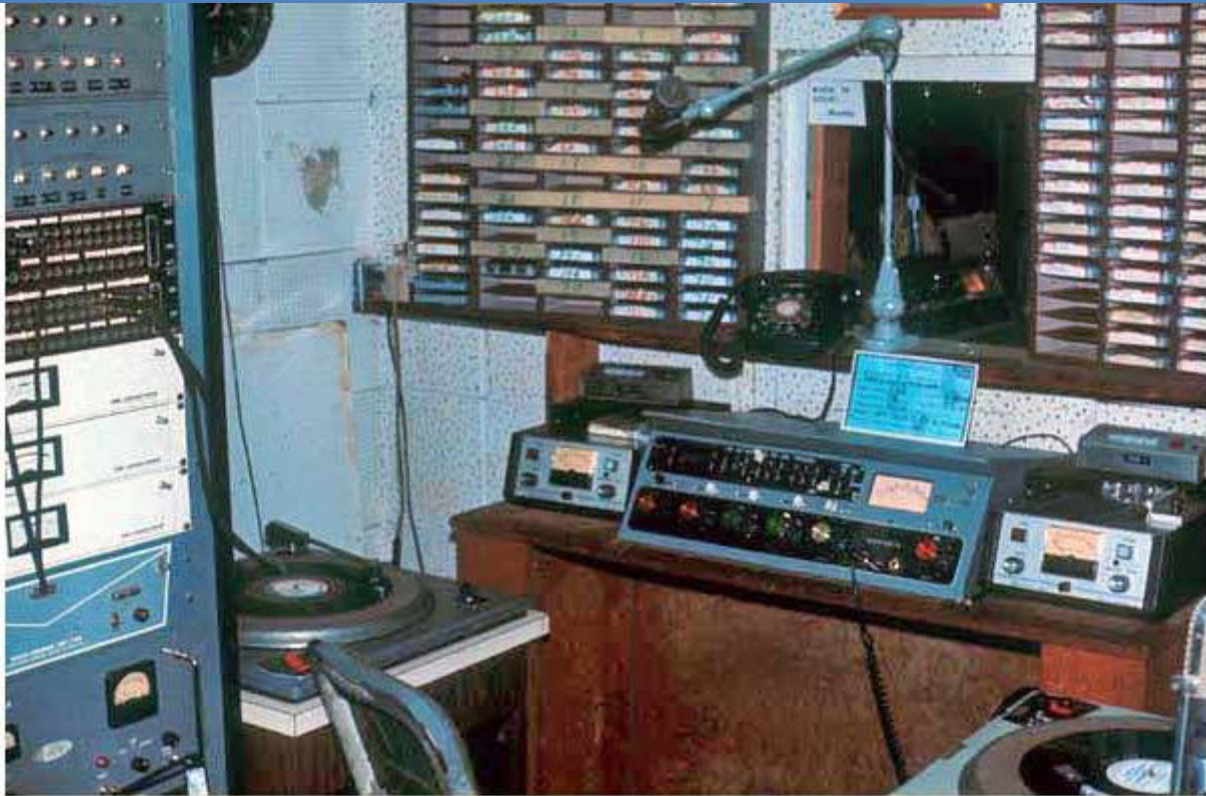
# 06 of 22

This is the first radio studio in this building. The cart machines are SpotMasters and the console is a Consolette from Gates Radio. You can see the light in the VU meter in the console in the second studio through the window behind the microphone. The clock on the wall to the right of the rack caused a serious problem once. During a rocket attack, it fell off the wall and its sharp edge cut through a bundle

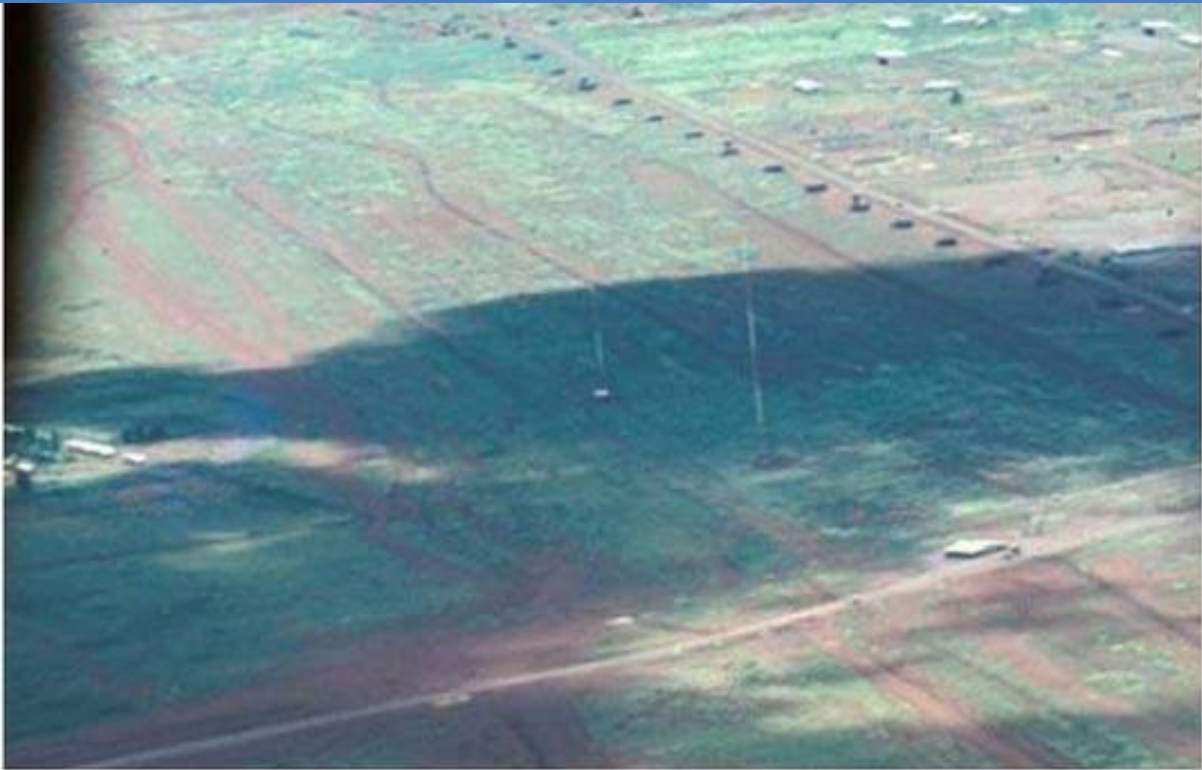
# 17 of 22

The two abandoned 440' towers.  
Note the perimeter of Camp Enari to the right.

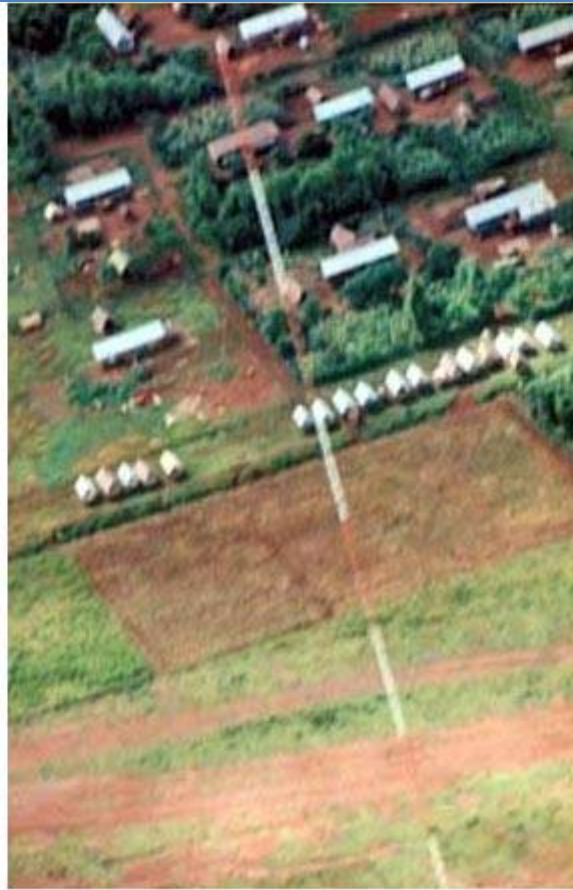
One of two abandoned 440' AM towers  
outside the perimeter of Camp Enari.  
That's a Montengard village behind  
the tower.

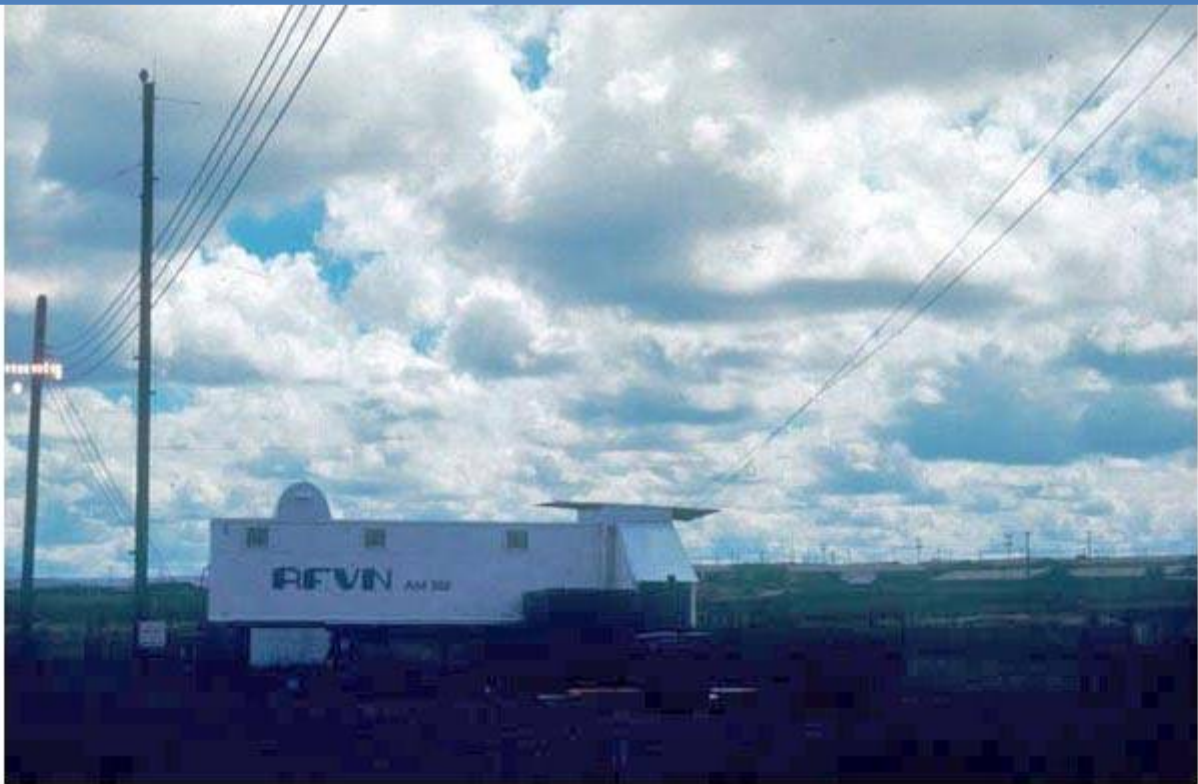
# 19 of 22

The trailer at Camp Schmidt that housed the 1KW and the 10KW AM transmitters.

We could never get the 10KW to load into the long-wire antenna which was at the top of the four tall telephone poles.

The first is seen just to the left of the trailer.

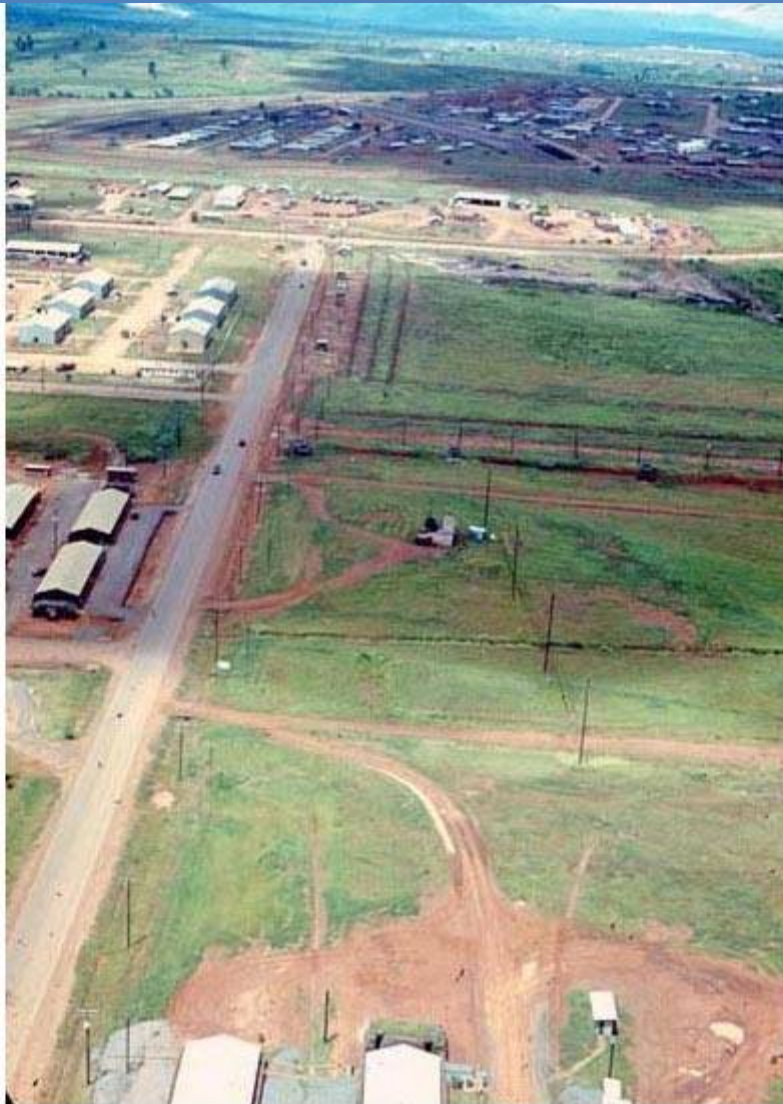
# 22 of 22

In the center of this photo is the AM transmitter trailer. The long wire antenna is atop the four tall telephone poles leading from the trailer down and to the right of the photo.
